JANUARY 1993 FLOODS PIMA COUNTY, ARIZONA

Summary Report July 1993

Pima County Department of Transportation
and Flood Control District

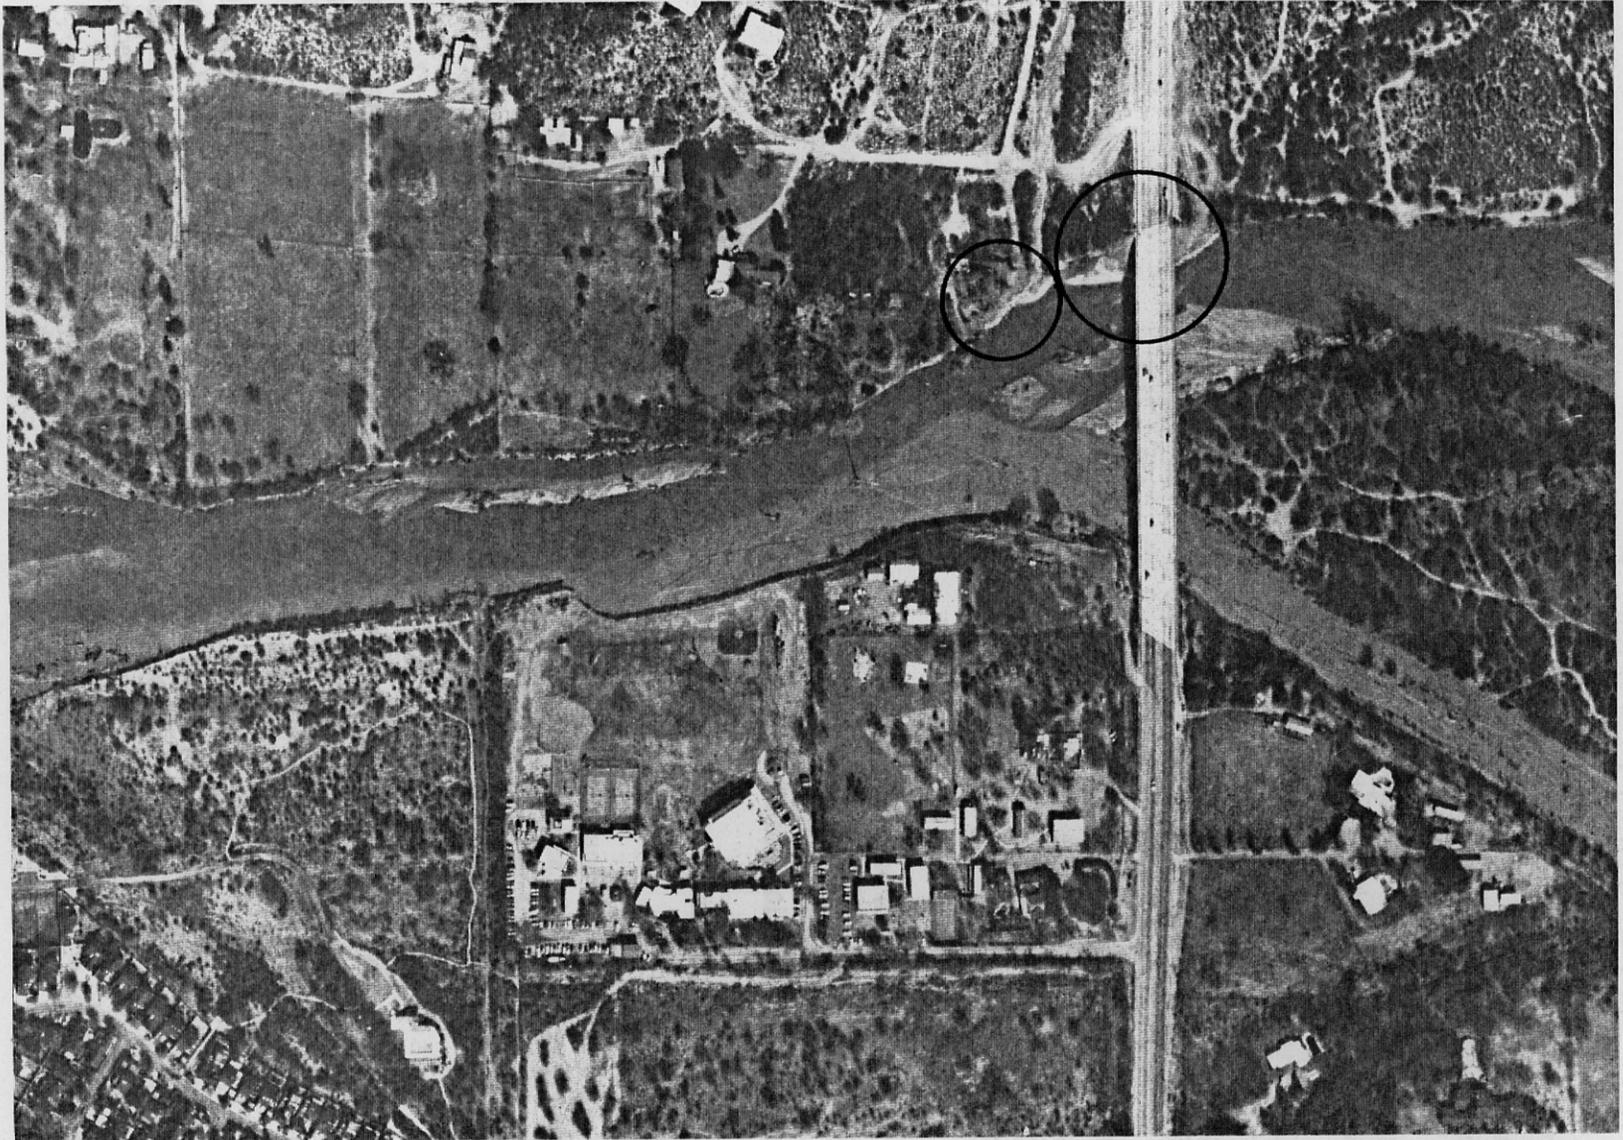
FIGURE 5.3

The SCS acting under the EWP provided interim bank protection similar to that provided by the COE at the Craycroft Bridge. Between January 13th - 14th, about 4000 tons of rock rip-rap with an average diameter of three-to-four feet was placed by SCS to prevent further erosion, at a cost of about \$ 60,000 (Figure 5.3).

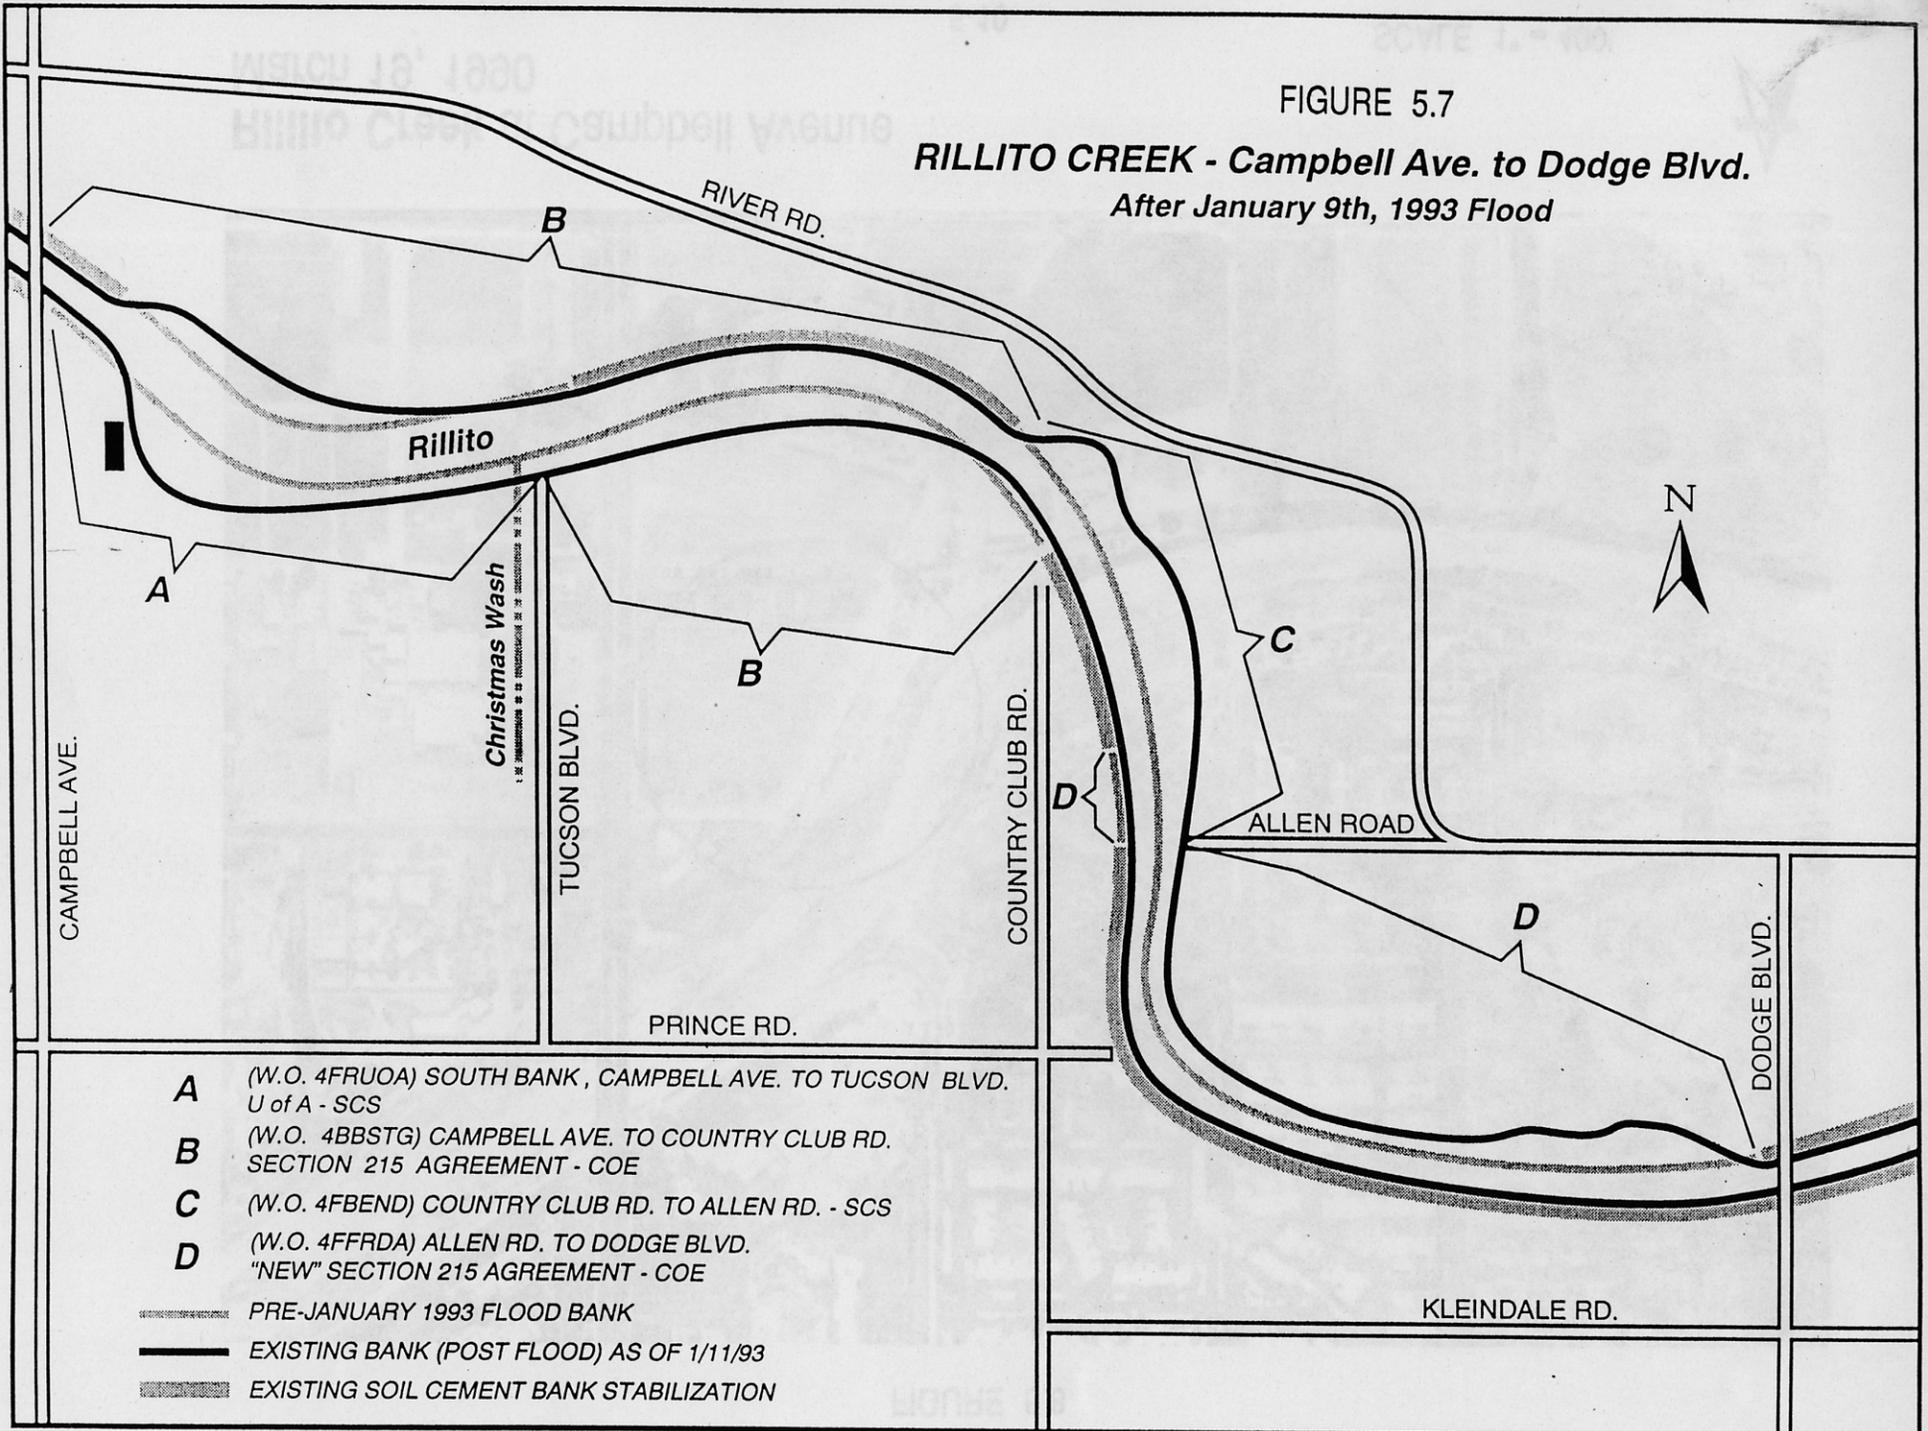
FIGURE 5.7

RILLITO CREEK - Campbell Ave. to Dodge Blvd.
 After January 9th, 1993 Flood

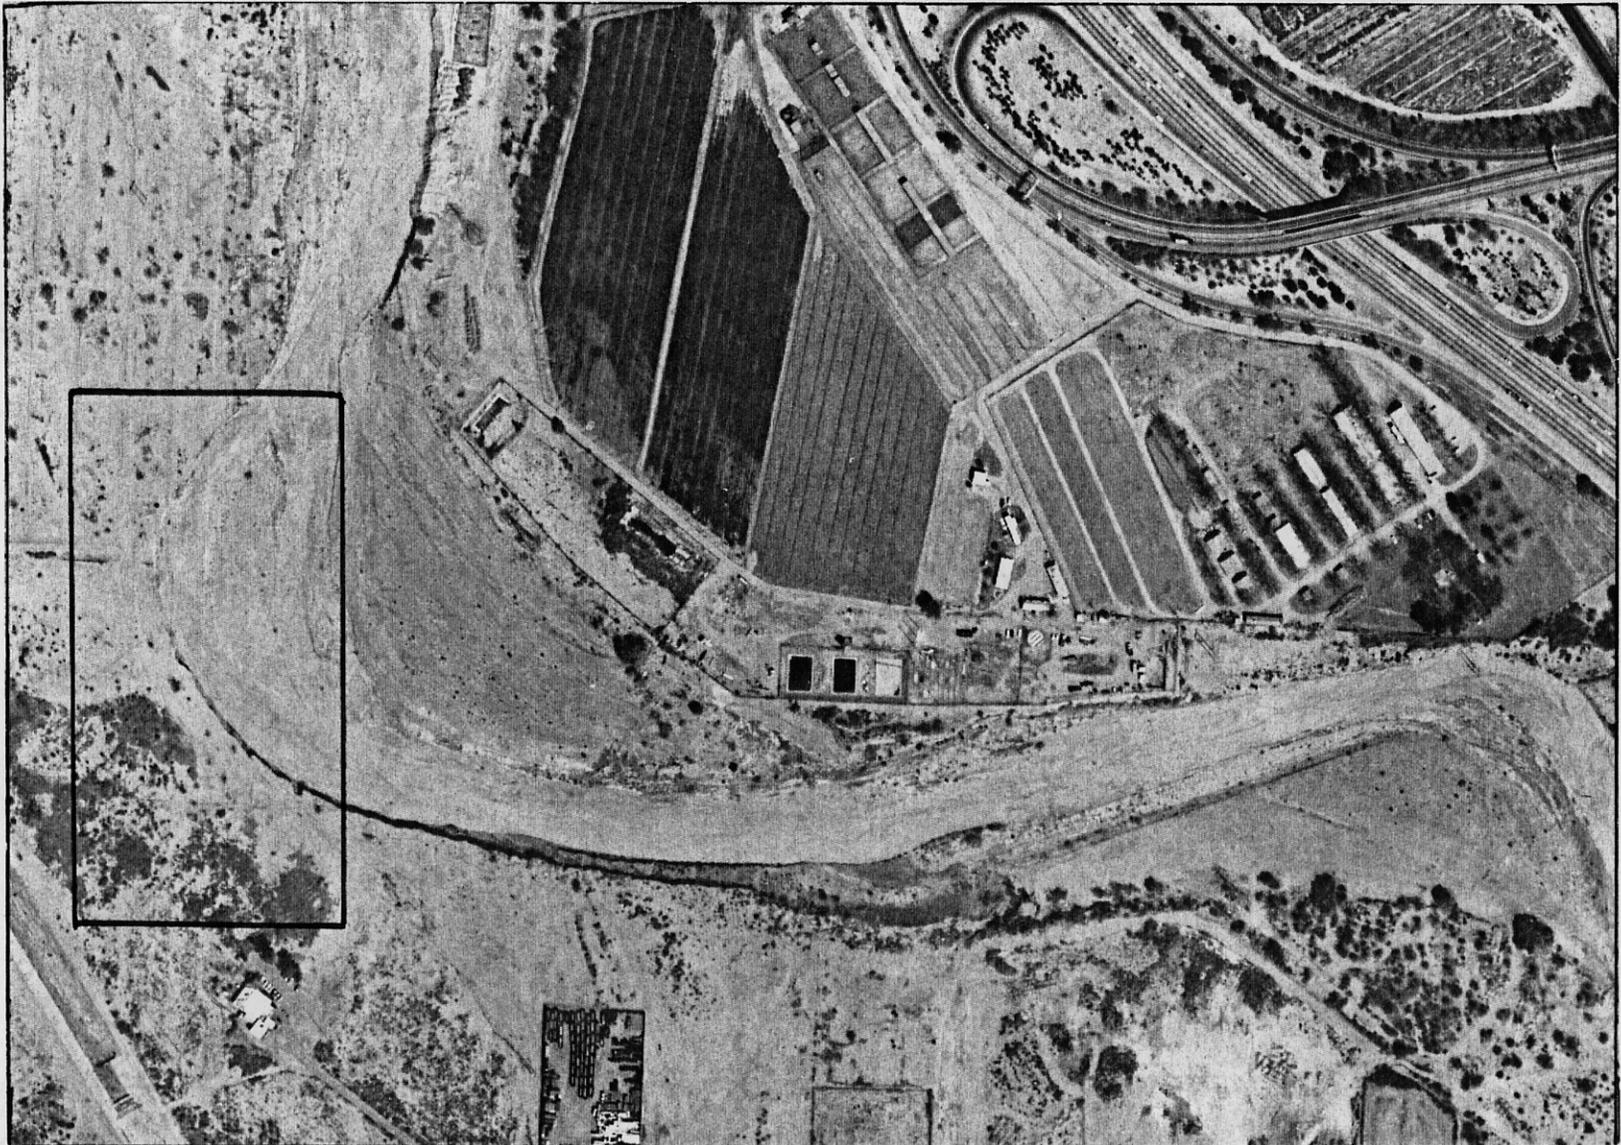
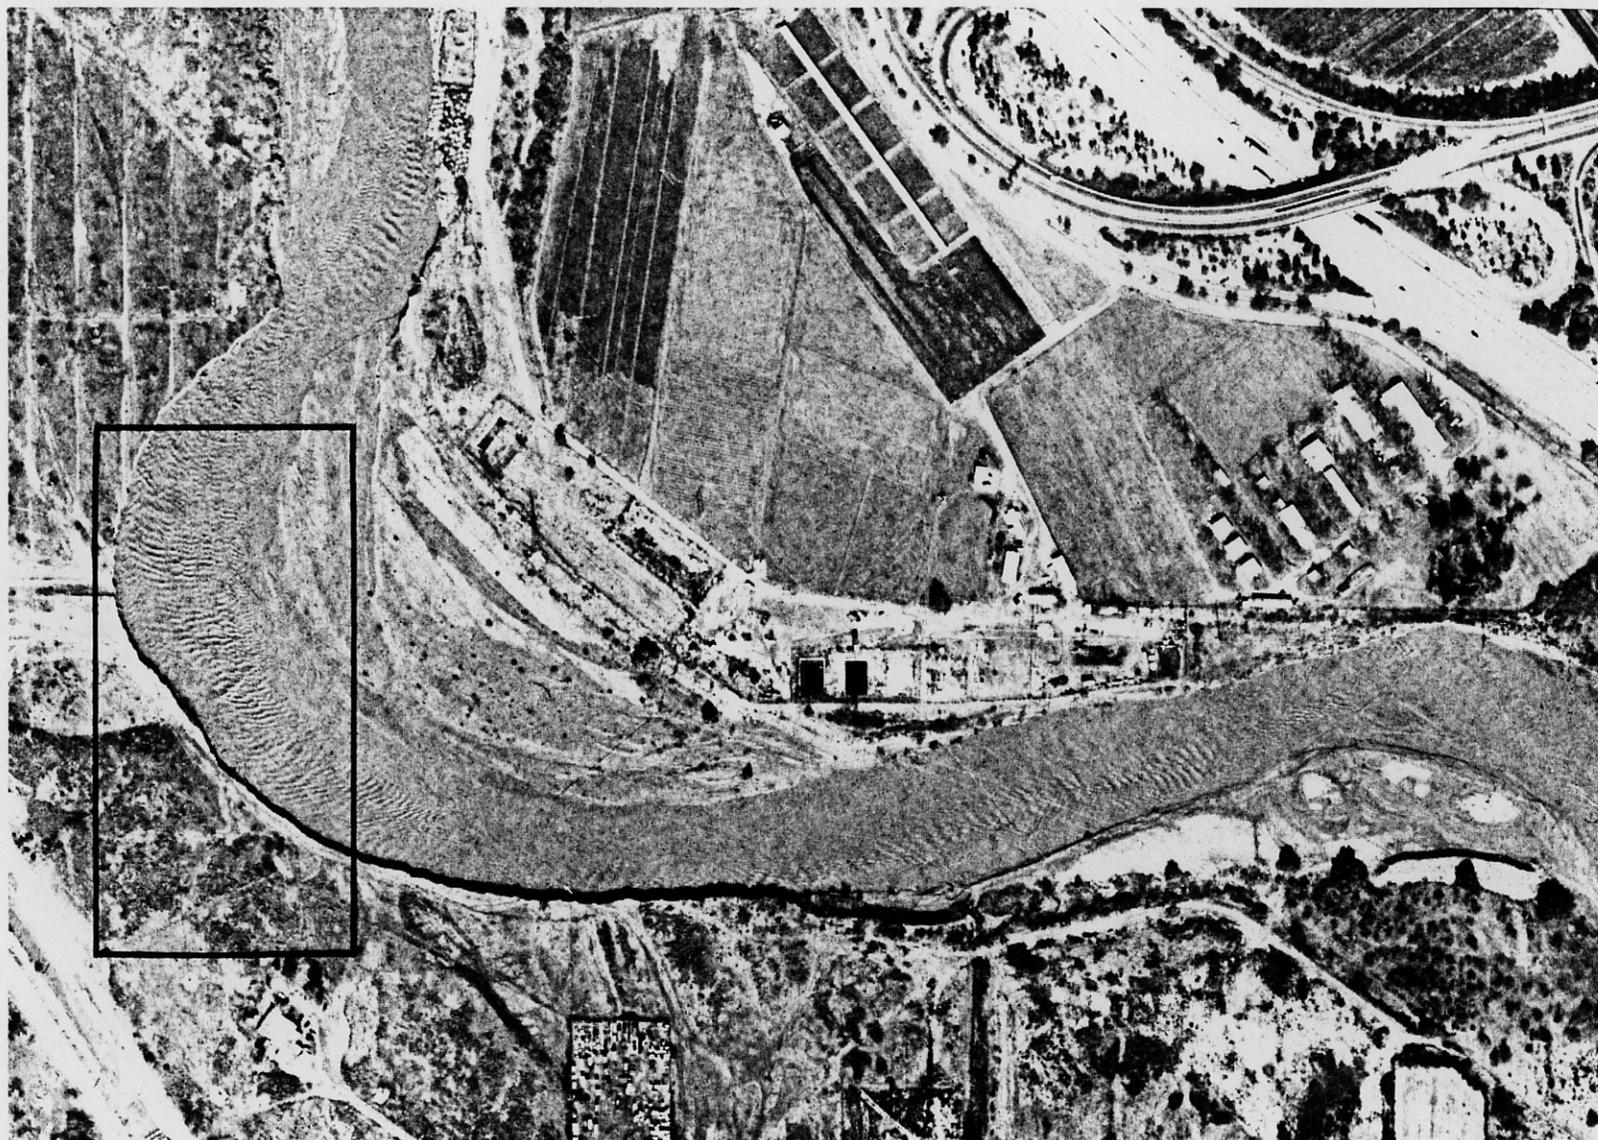
One of the three supporting tie lines for the KTKT radio tower was endangered by west bank erosion along the outer bend of the meander north of Grant Road (Figures 5.14 and 5.15). PCDOT & FCD's Operations Division staff worked with contractors to construct an earthen low-flow channel within the main channel of the Santa Cruz River, to divert flow away from the threatened bank. Emergency construction costs were about \$ 5,220.

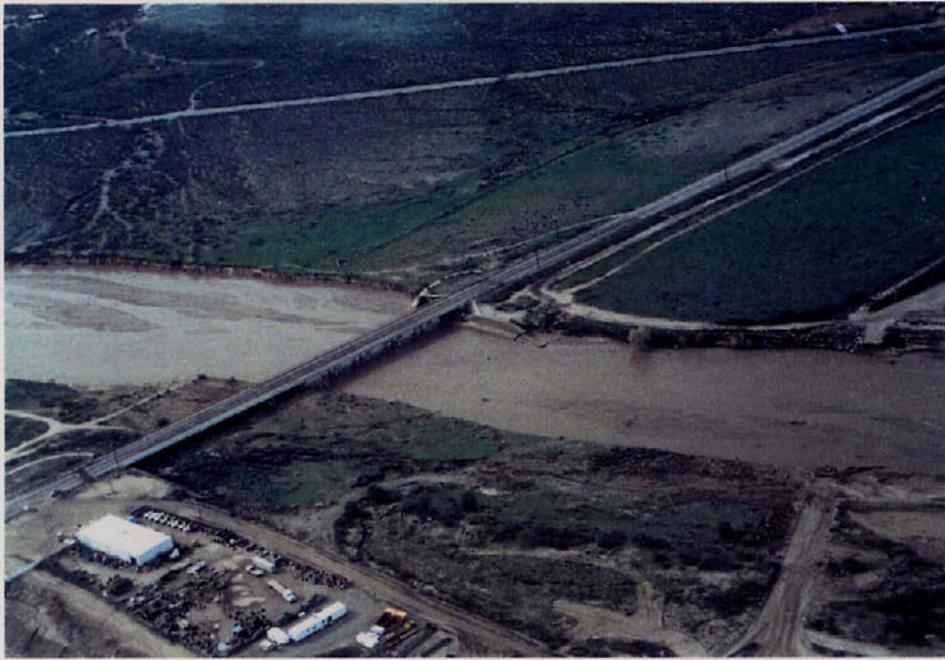
FIGURE 7.1a

7.1a) Santa Cruz River at Ina Road Bridge— looking to the southwest. Note damaged soil-cement abutment on northwest side of bridge. January 15, 1993.

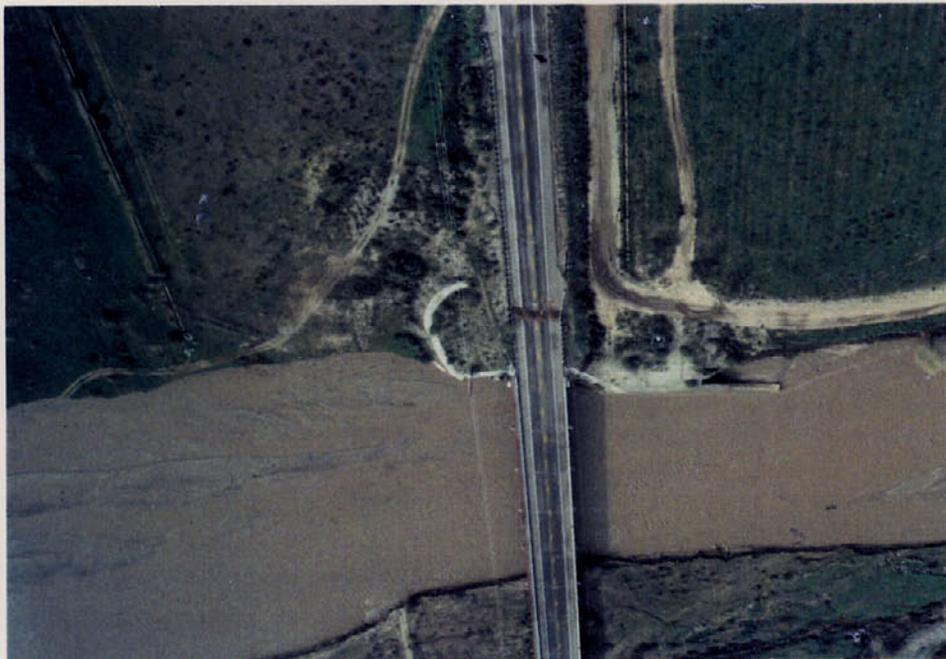
FIGURE 7.1b

7.1b) Santa Cruz River at Ina Road Bridge— View east to west, from bottom to top of photo. Note erosion behind northwest abutment and under west approach road. January 15, 1993.
