ELEVATION CERTIFICATE

A1. Building Owner's Name **Jose & Yvonne Paz**

A2. Building Street Address (including Apt., Unit, Suite, and/or Bldg. No.) or P.O. Route and Box No. **6656 W. Drexel Road**

A4. Building Use (e.g., Residential, Non-Residential, Addition, Accessory, etc.) **Accessory: Detached Garage**

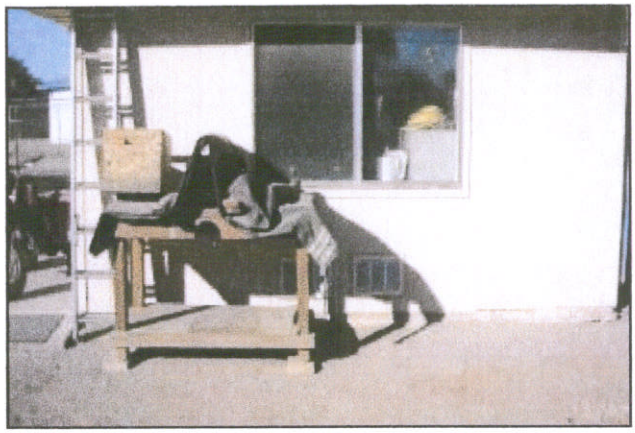
View of the north side of work shop
