ELEVATION CERTIFICATE

A1. Building Owner's Name WILLIAM & MAUREEN NEURATH

A2. Building Street Address (including Apt., Unit, Suite, and/or Bldg. No.) or P.O. Route and Box No.
3929 West Wild Life Drive

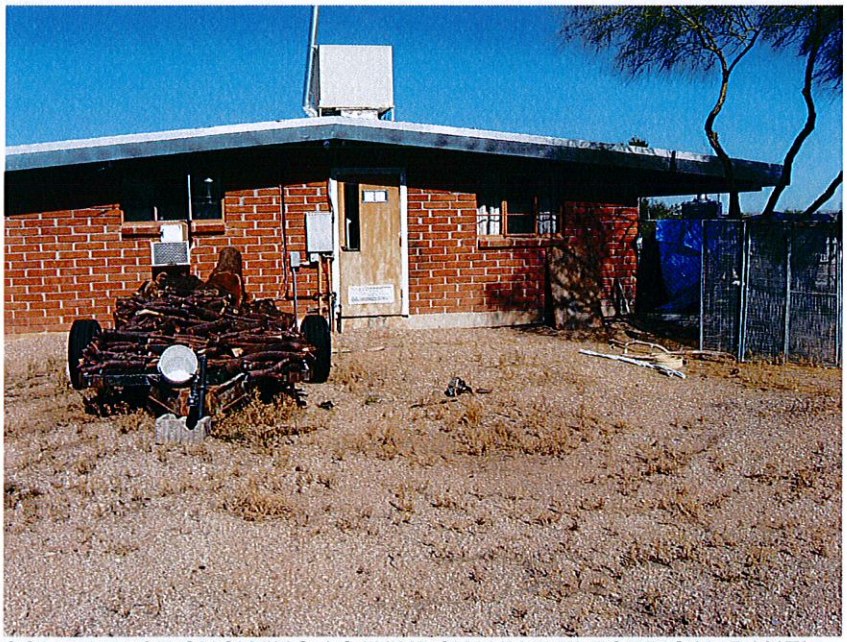
Comments There is no machinery installed on the ground level on any type of pad. There is a cooler on the roof, and a window AC unit on the South Face of the house. There is a electrical panel on the South Face of the building, it is 4.25 feet above the finished floor of the house.

SOUTH FACE SHOWING AC WINDOW UNIT ELECTRICAL PANEL AND COOLER ON ROOF 11/3/2010
