JANUARY 1993 FLOODS PIMA COUNTY, ARIZONA

Summary Report July 1993

Pima County Department of Transportation
and Flood Control District

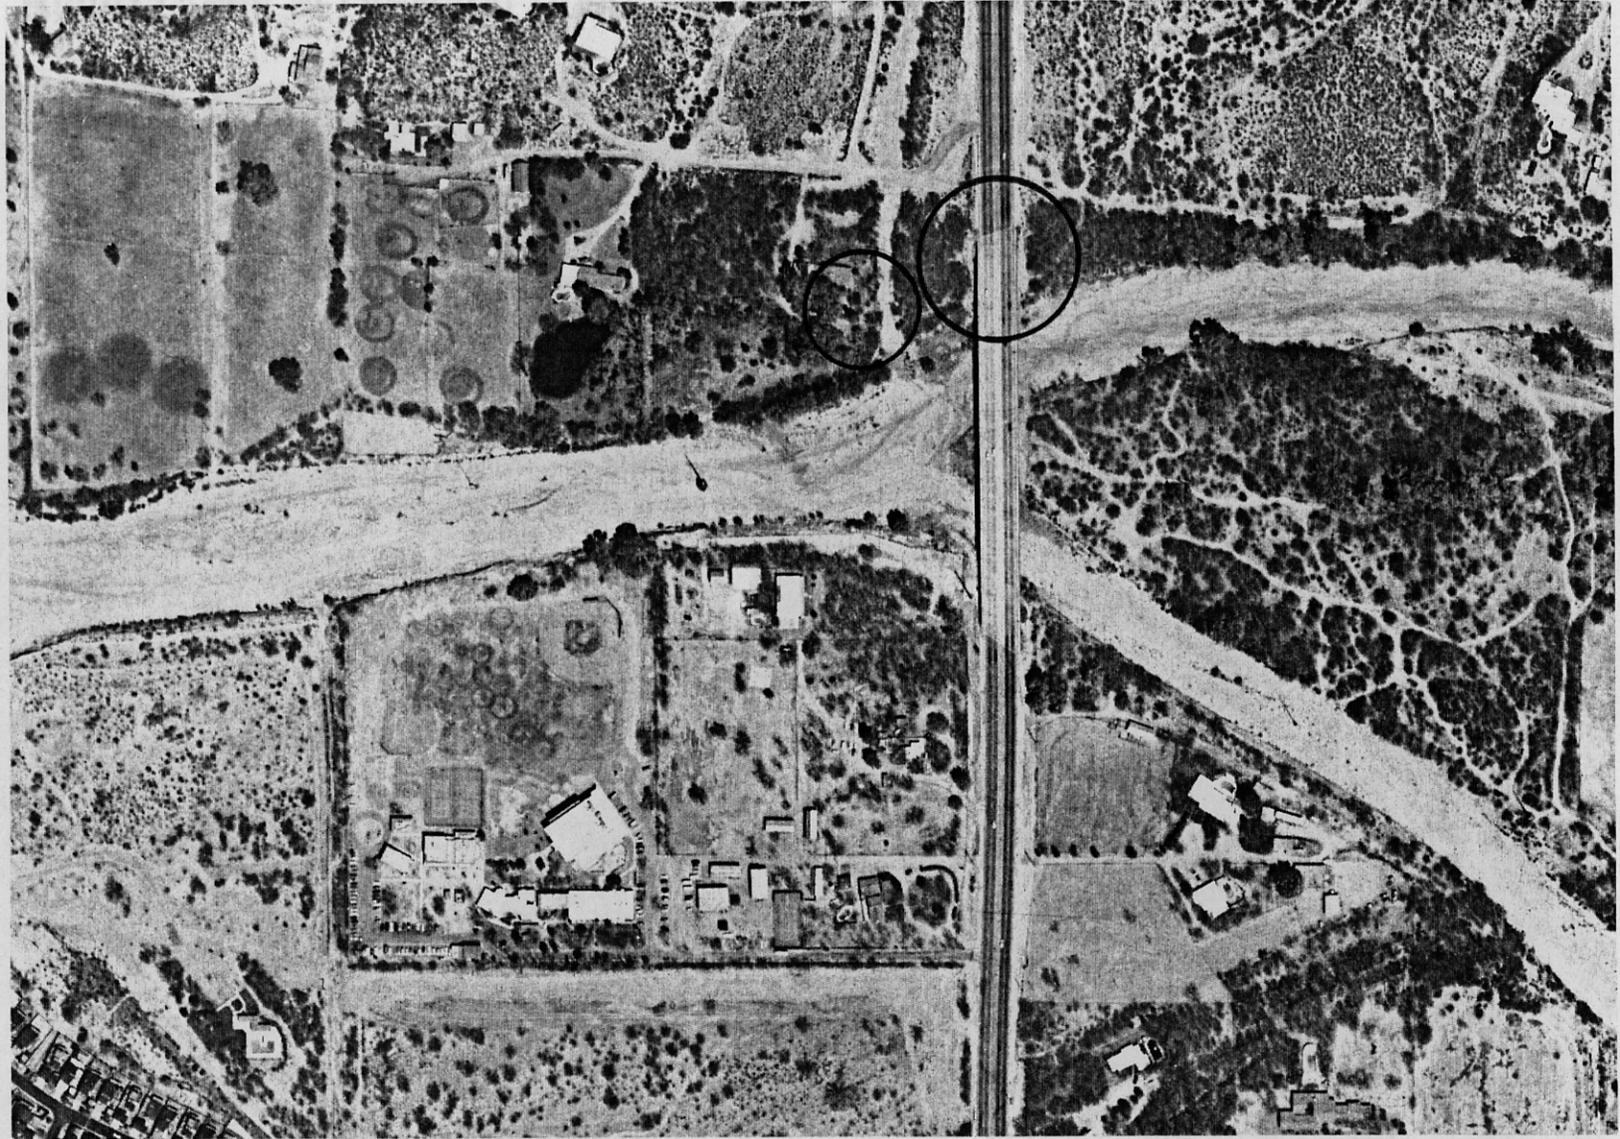
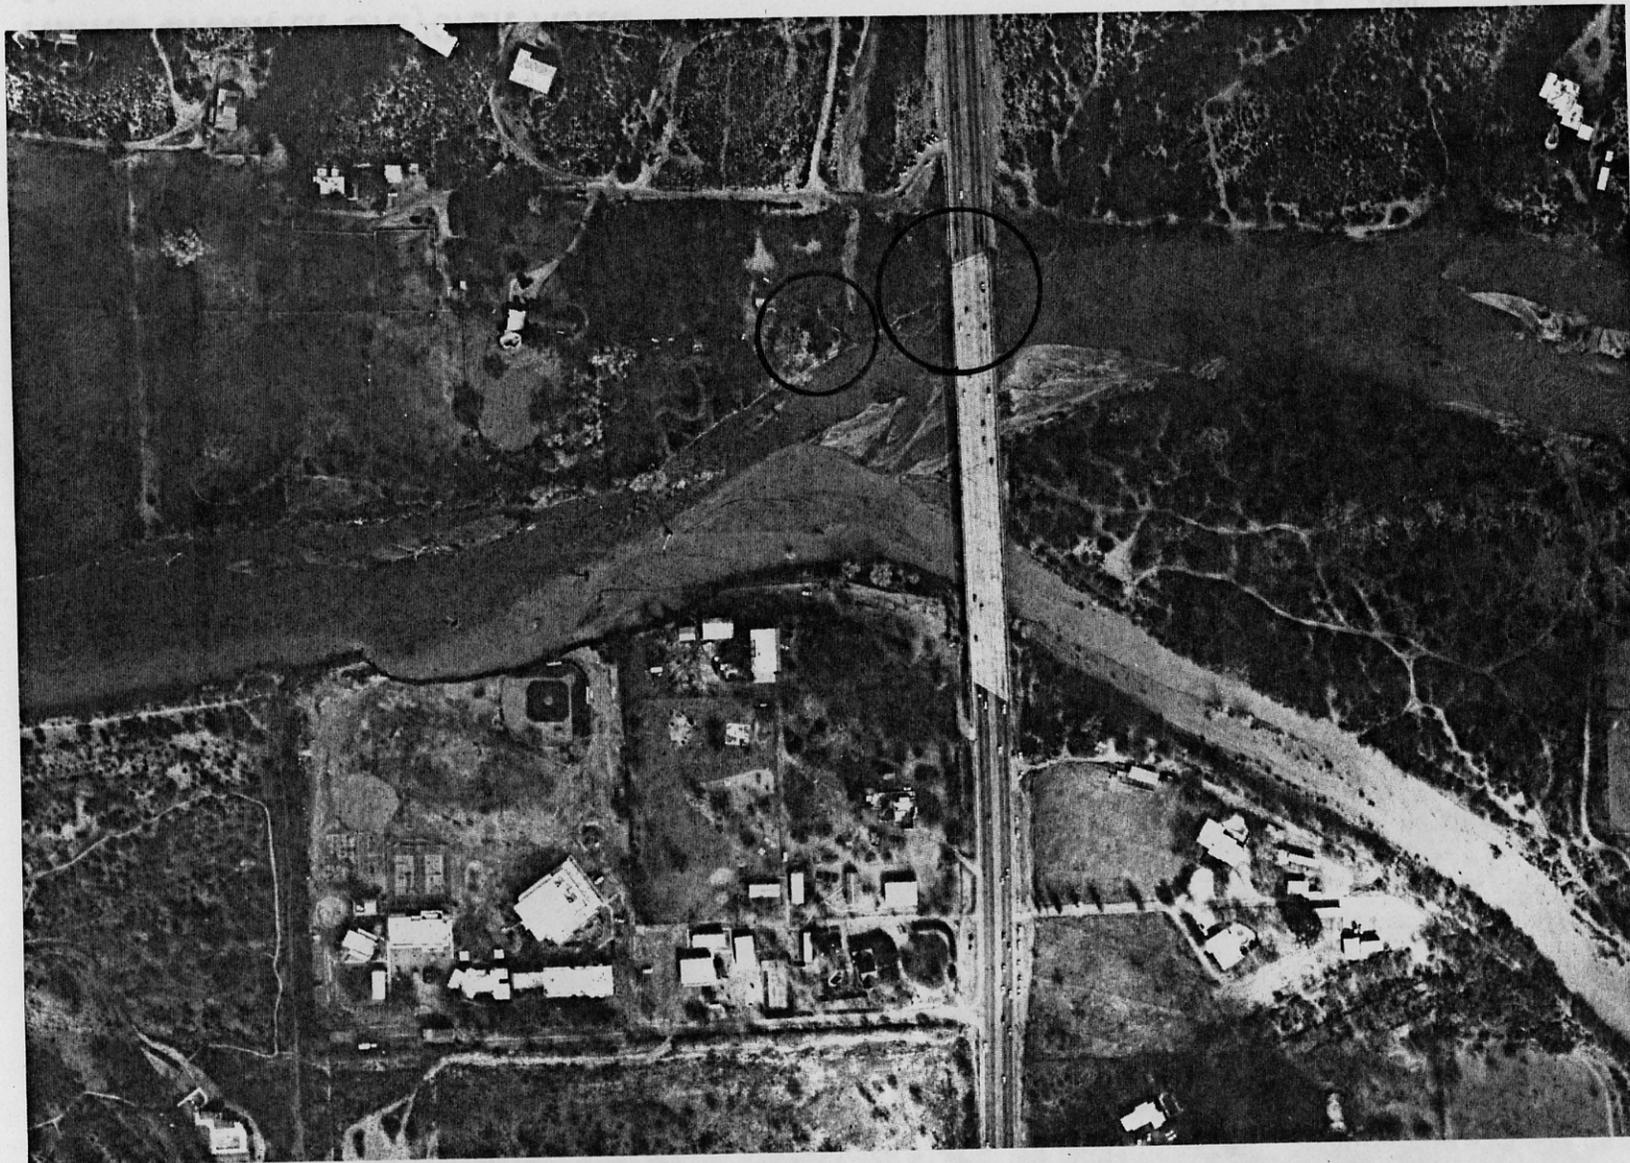
FIGURE 5.1

Severe erosion (up to 140 feet) of the north bank of Rillito Creek under the Craycroft Road bridge caused the bridge caissons to be exposed (Figures 5.1 and 5.2). Emergency repairs were needed to prevent undermining of the north bridge approach and abutment, as additional erosion could result in the bridge being closed for weeks, causing major disruption of travel in the northeast metropolitan area.

Located 300 feet downstream (west) of the Craycroft Road bridge on the north bank of Rillito Creek, approximately 120 feet of bank eroded adjacent to the Luker residence. The post-flood bank was within six feet of the residence, and the home was in danger of being severely damaged (Figures 5.1 and 5.2).

Rillito Creek at Craycroft Road
March 22, 1990

Rillito Creek at Craycroft Road
January 9, 1993

The SCS acting under the EWP provided interim bank protection similar to that provided by the COE at the Craycroft Bridge. Between January 13th - 14th, about 4000 tons of rock rip-rap with an average diameter of three-to-four feet was placed by SCS to prevent further erosion, at a cost of about \$ 60,000 (Figure 5.3).

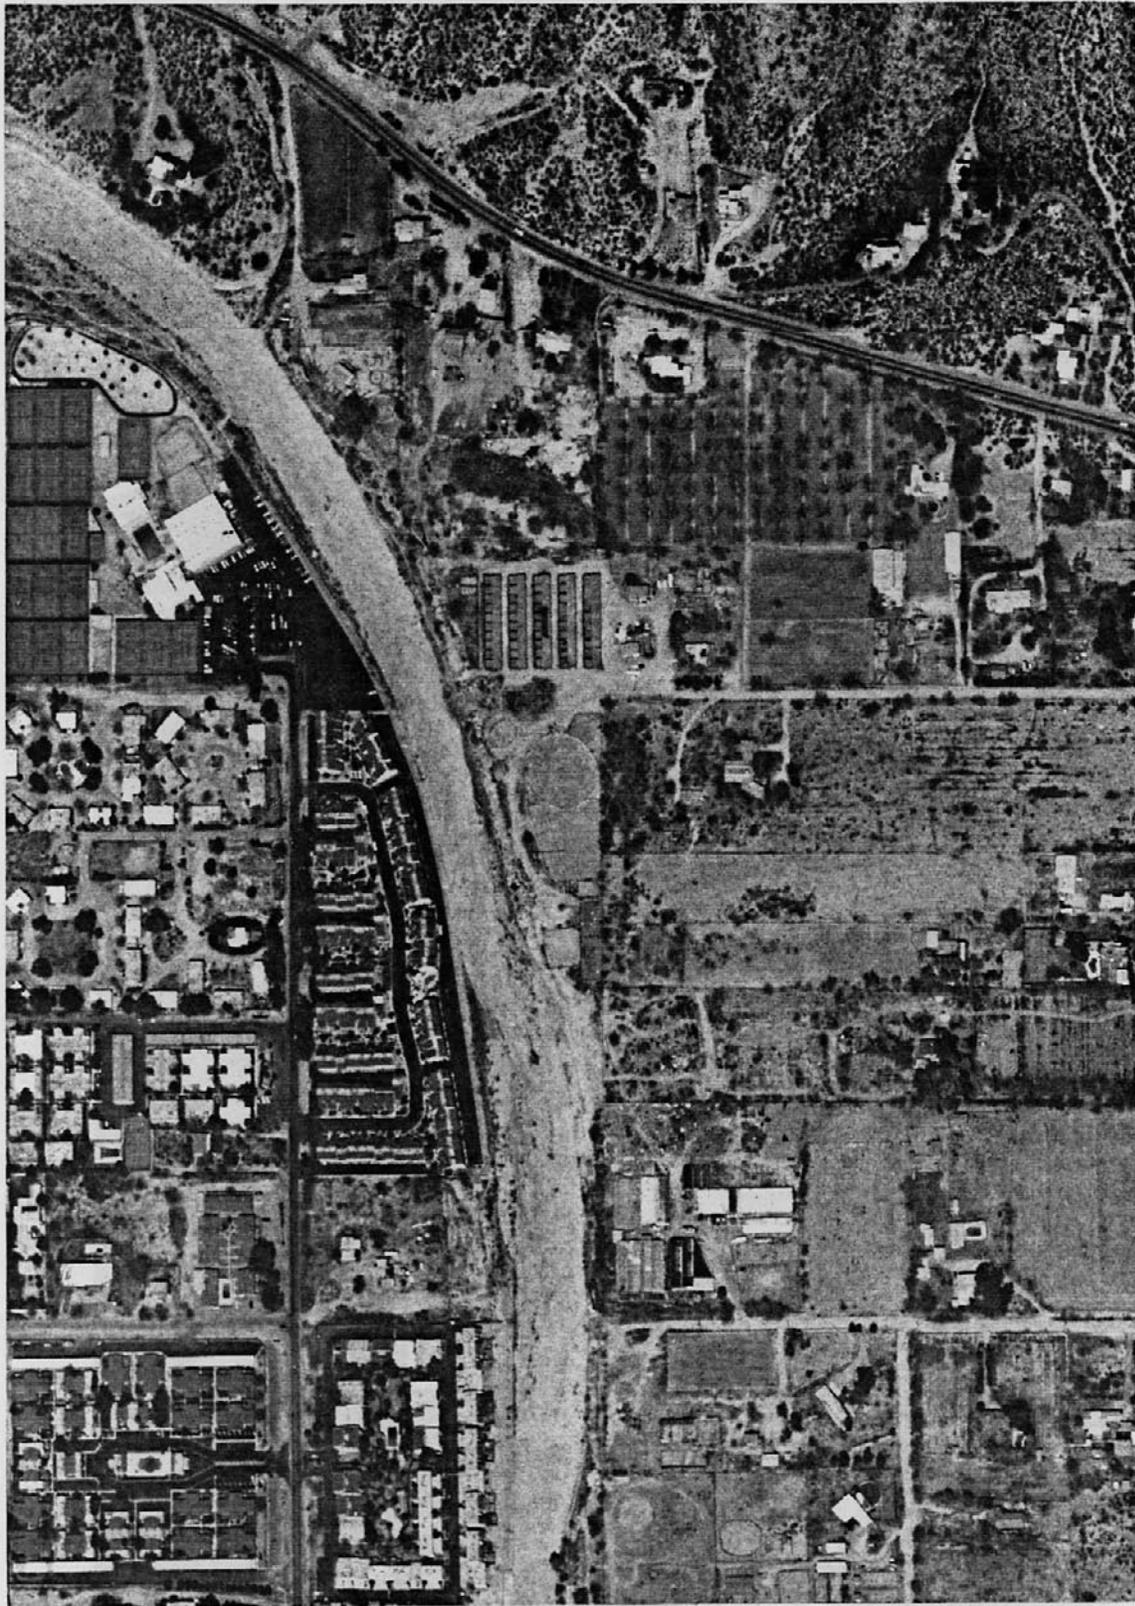
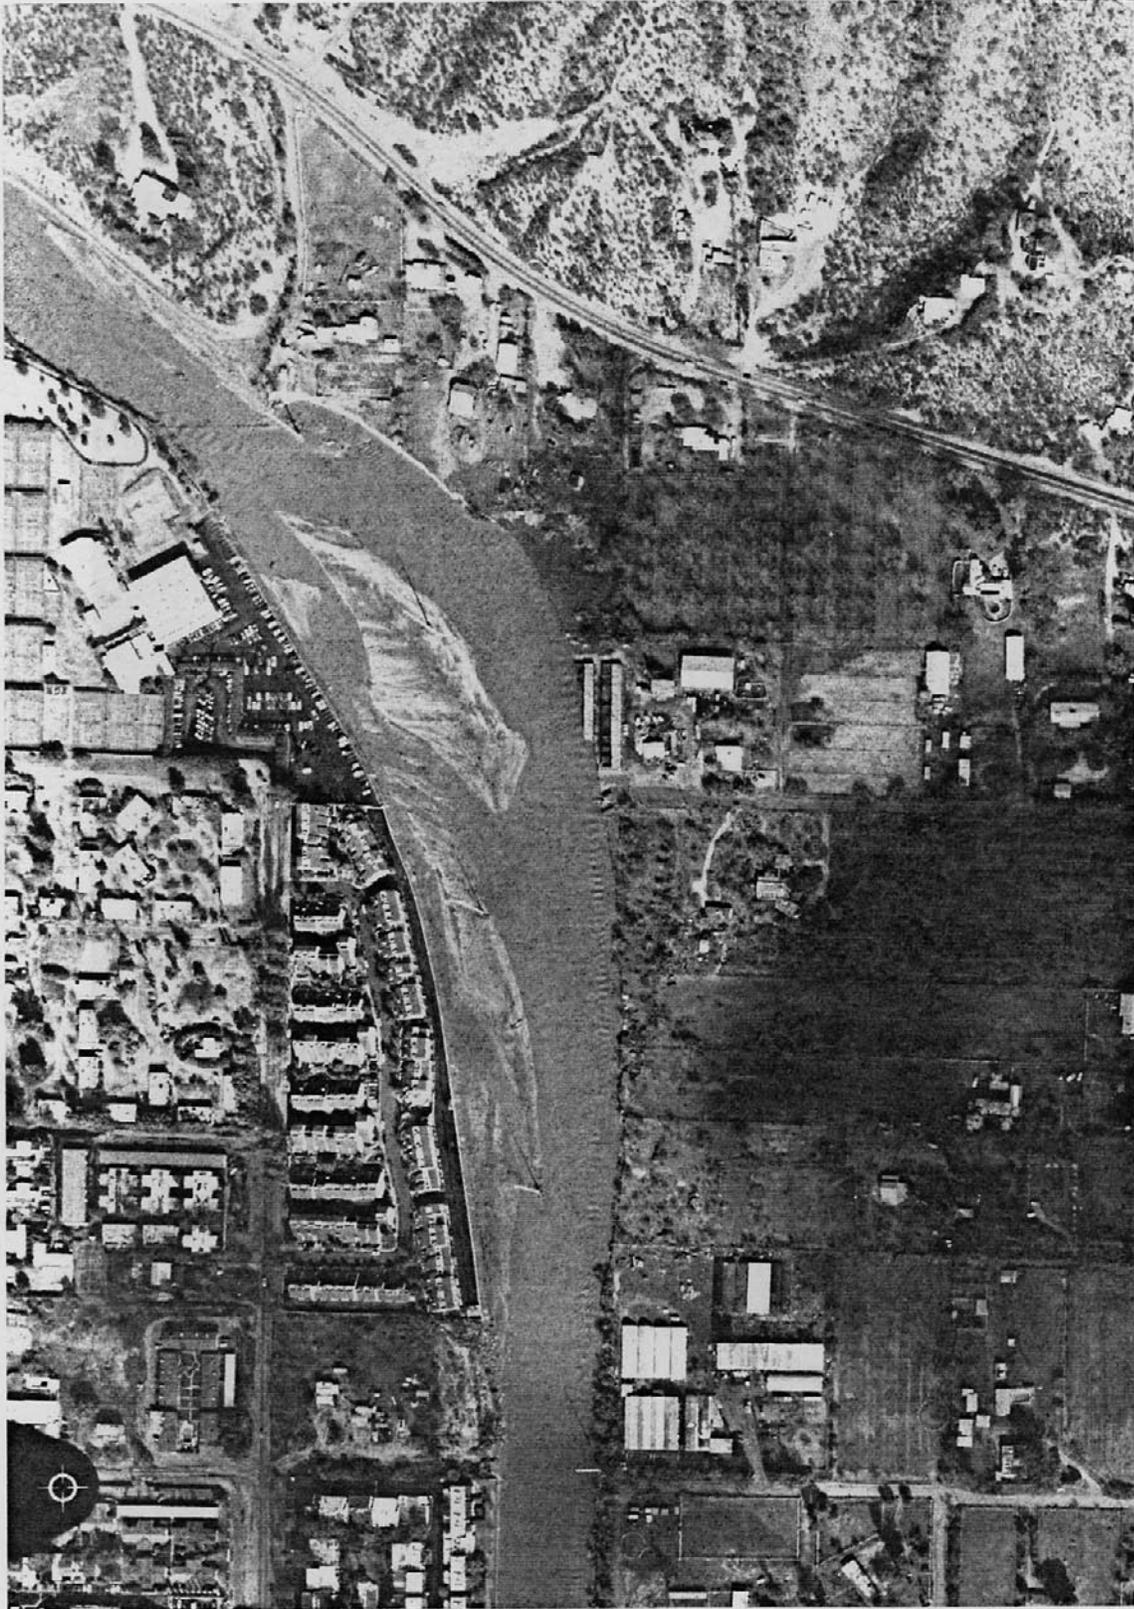
FIGURE 5.4

Up to 300 feet of erosion outward from the channel along the north bank in the bend area caused the channel bottom to widen considerably (Figures 5.4 and 5.5). Several non-habitable buildings, primarily greenhouses and animal housing, fell into Rillito Creek; and the north bank eroded to within 70 feet of a residence at 3100 East River Road. Immediately downstream of the bend, the upstream key-in of the soil-cement bank stabilization along the north bank was in danger of being eroded, threatening the bank stabilization.

Rillito Creek at Country Club Road "Bend Area"
March 19, 1990

Rillito Creek at Country Club Road "Bend Area"
January 9, 1993

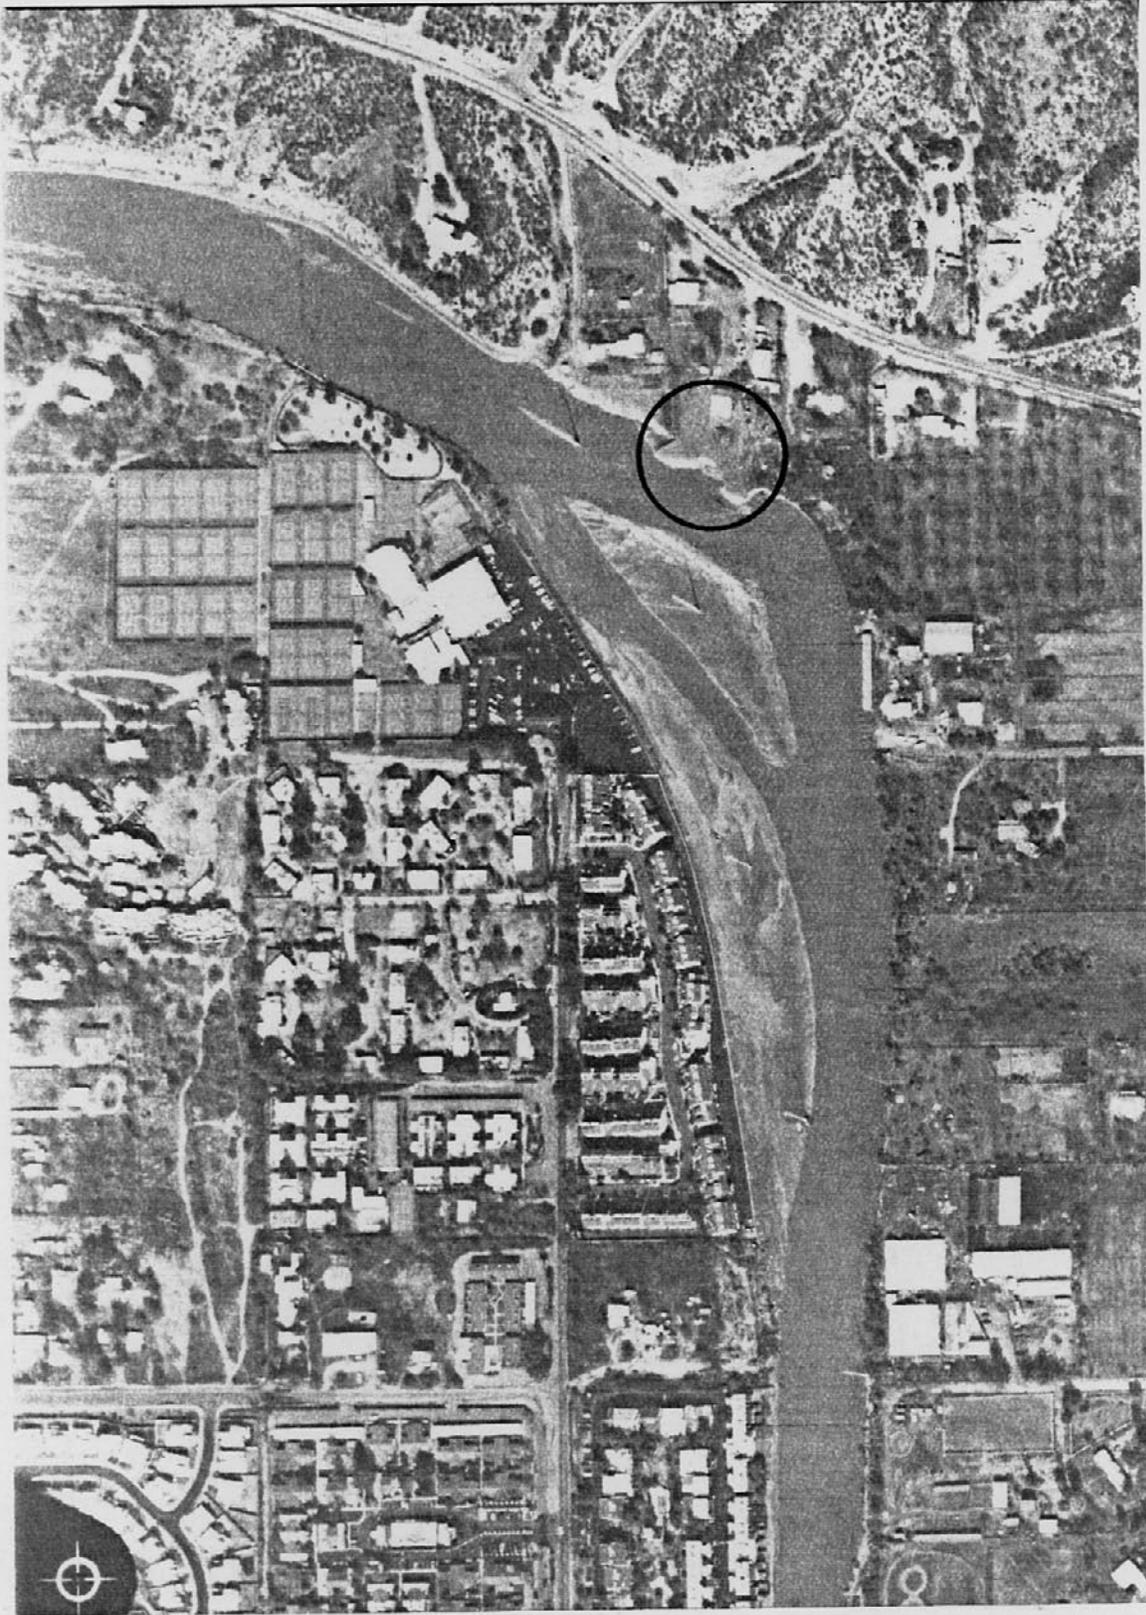
FIGURE 5.6

Rillito Creek at Country Club Road "Bend Area"
January 20, 1993

The COE arranged for emergency action to protect the bank stabilization and a sewer interceptor line located behind the bank stabilization. Rock rip-rap jetties were constructed on the north bank between January 9th - 12th, upstream of the residence at 3100 East River Road to divert flow away from the eroded north bank; the cost to the COE was about \$ 75,000 (Figure 5.6).

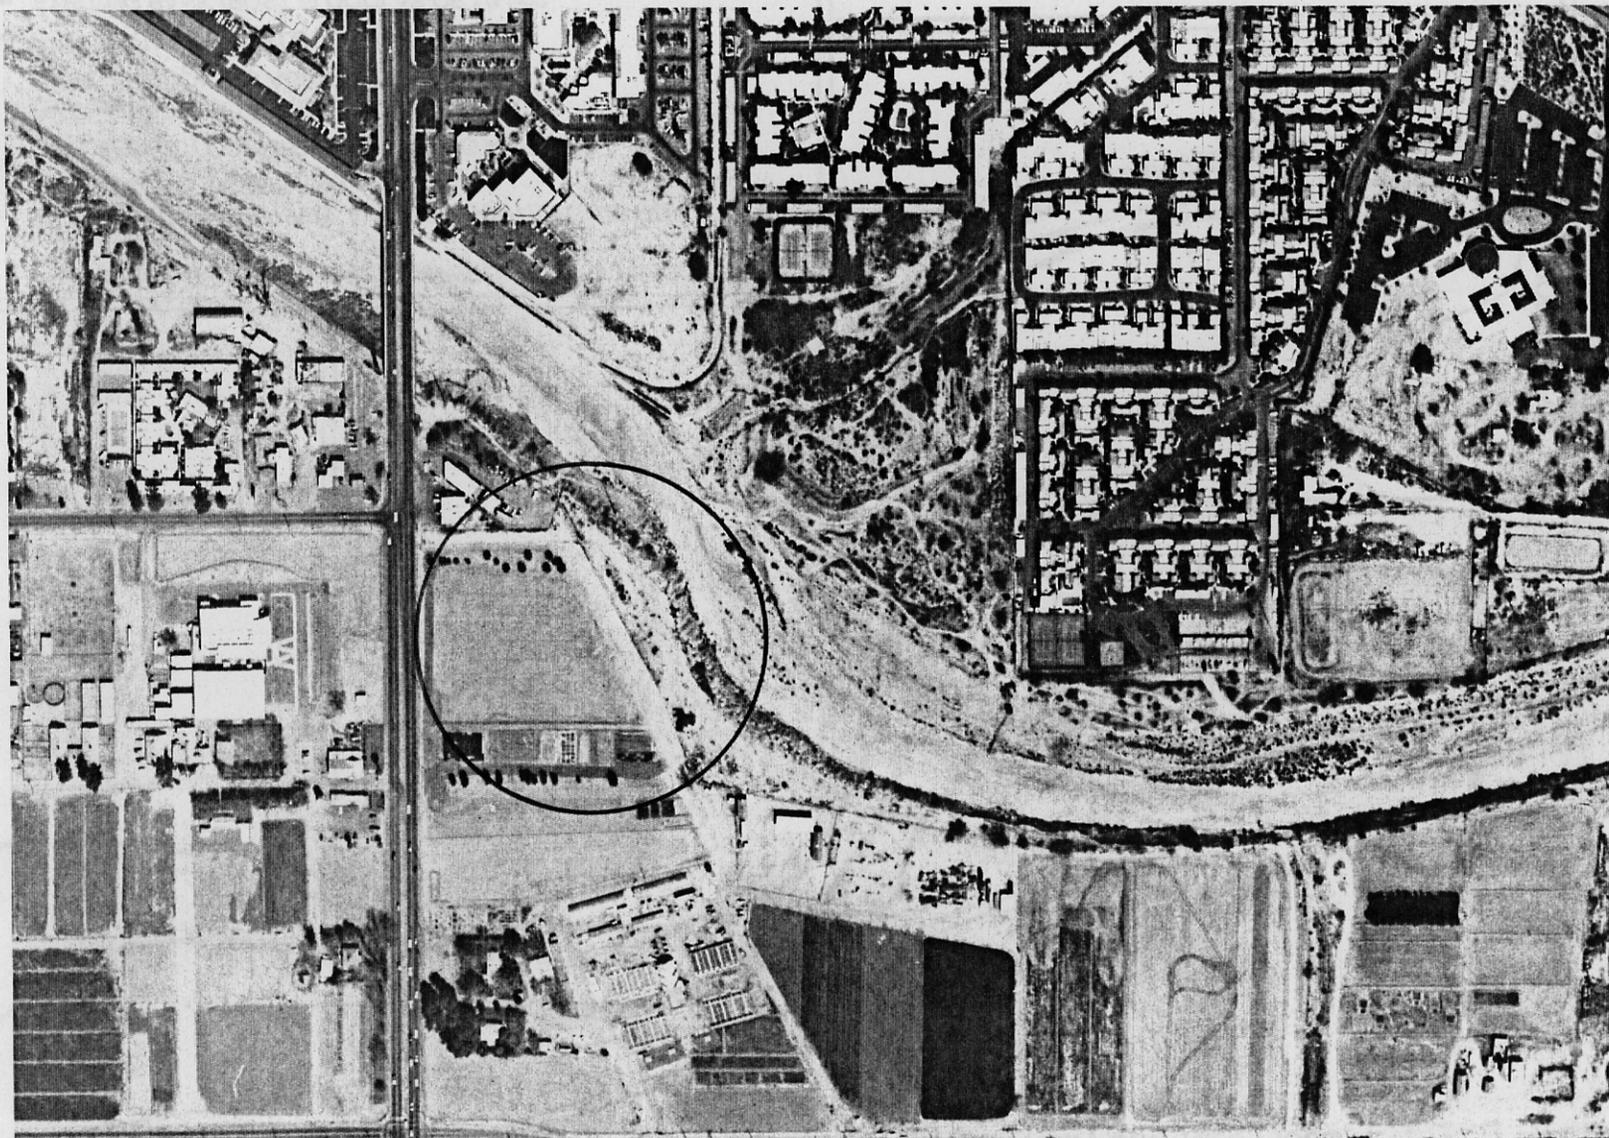
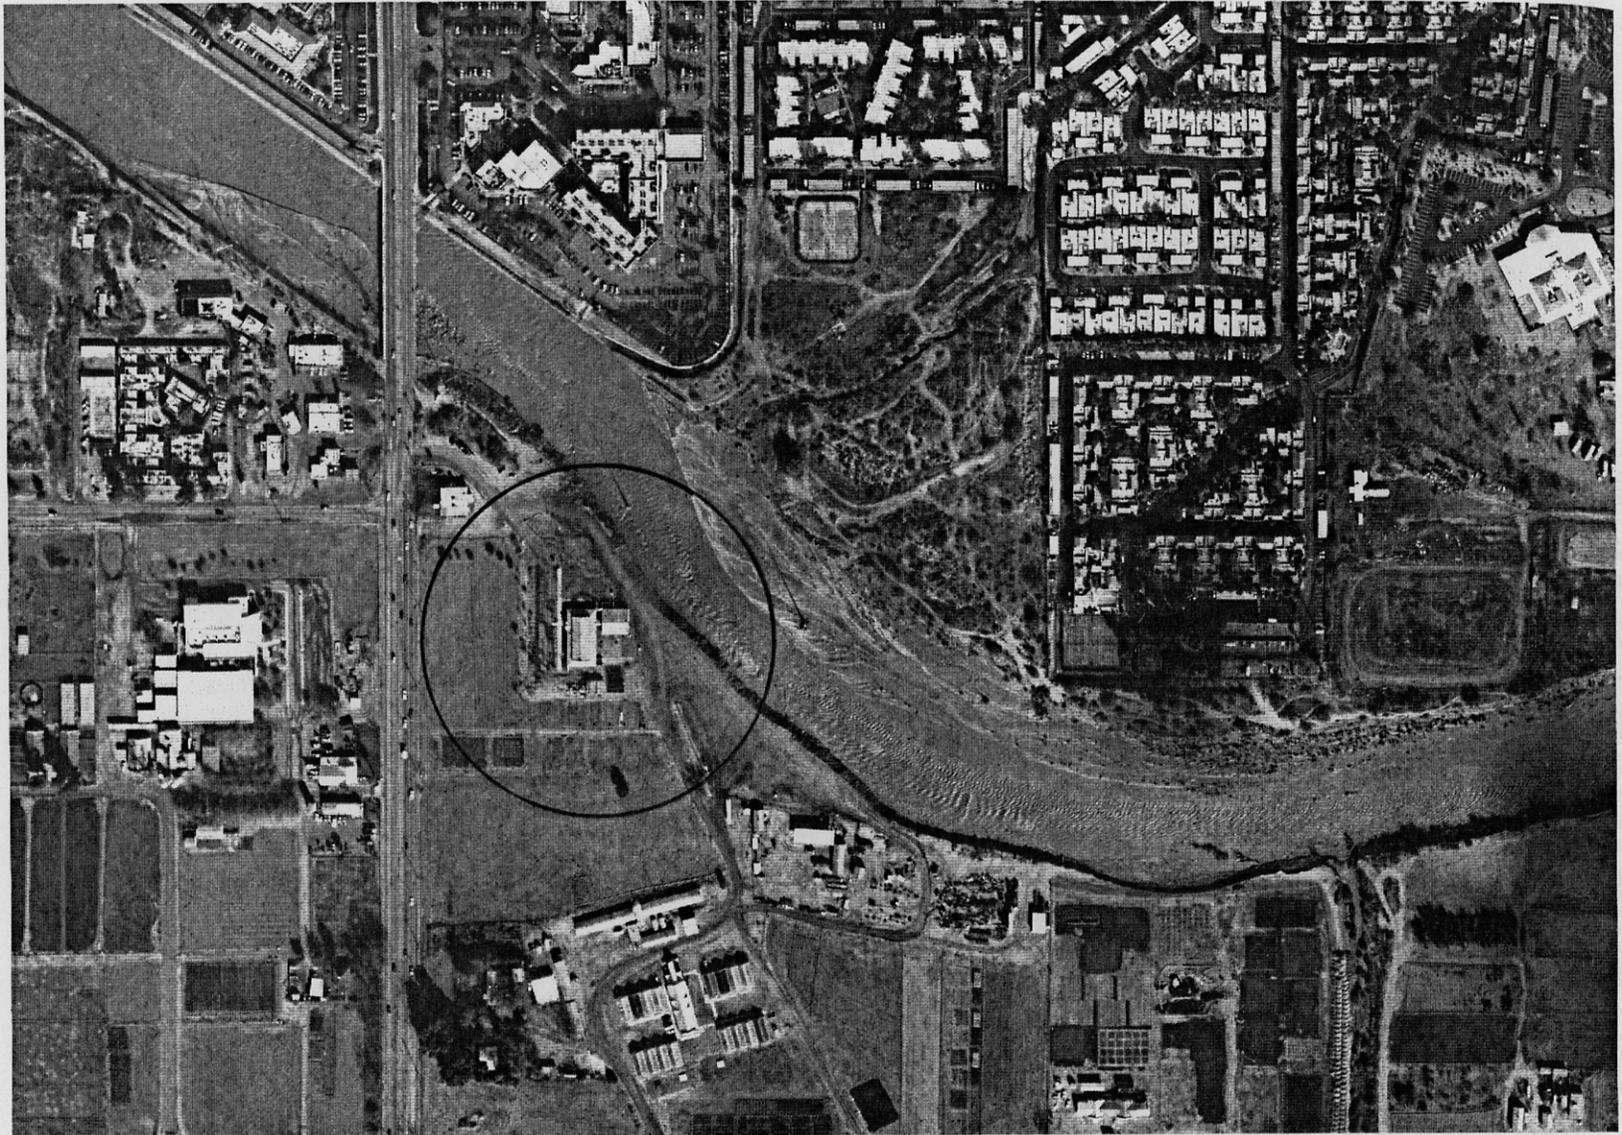
FIGURE 5.8

Beginning the night of January 7th, severe erosion along the south bank of Rillito Creek immediately upstream of Campbell Avenue left the one-year old U of A building within 30 feet of the south bank; on the morning of January 8th, as the bank continued to erode, the building was evacuated. Continued flows in Rillito Creek placed the building in imminent danger (Figures 5.8 and 5.9).

Rillito Creek at Campbell Avenue
March 19, 1990

Rillito Creek at Campbell Avenue
January 9, 1993

Starting at noon, PCDOT & FCD's Operations Division personnel began dumping heavy rock and concrete slabs to protect the remaining bank and building. The cost to PCDOT & FCD for emergency repairs was \$22,200, reimbursable by FEMA. At 2:30 that afternoon, the Campbell Avenue bridge was reopened. Long-term protection for this area will ultimately be provided by the SCS under the EWP.

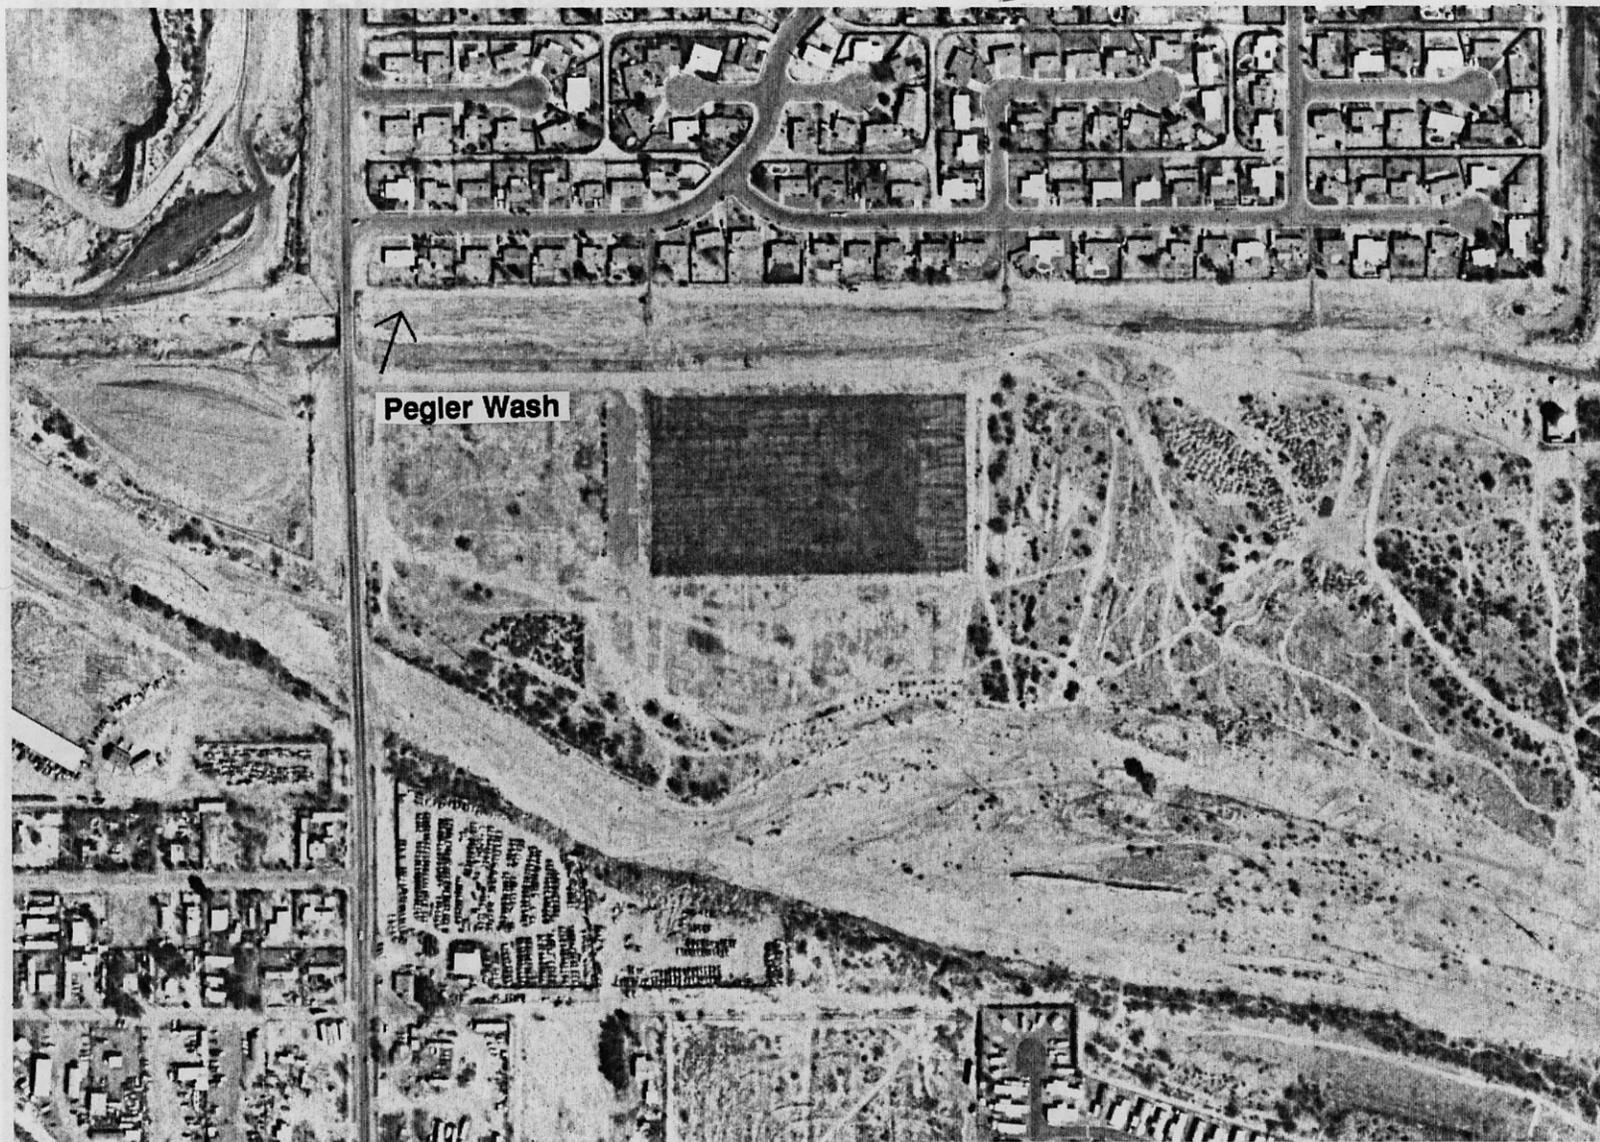
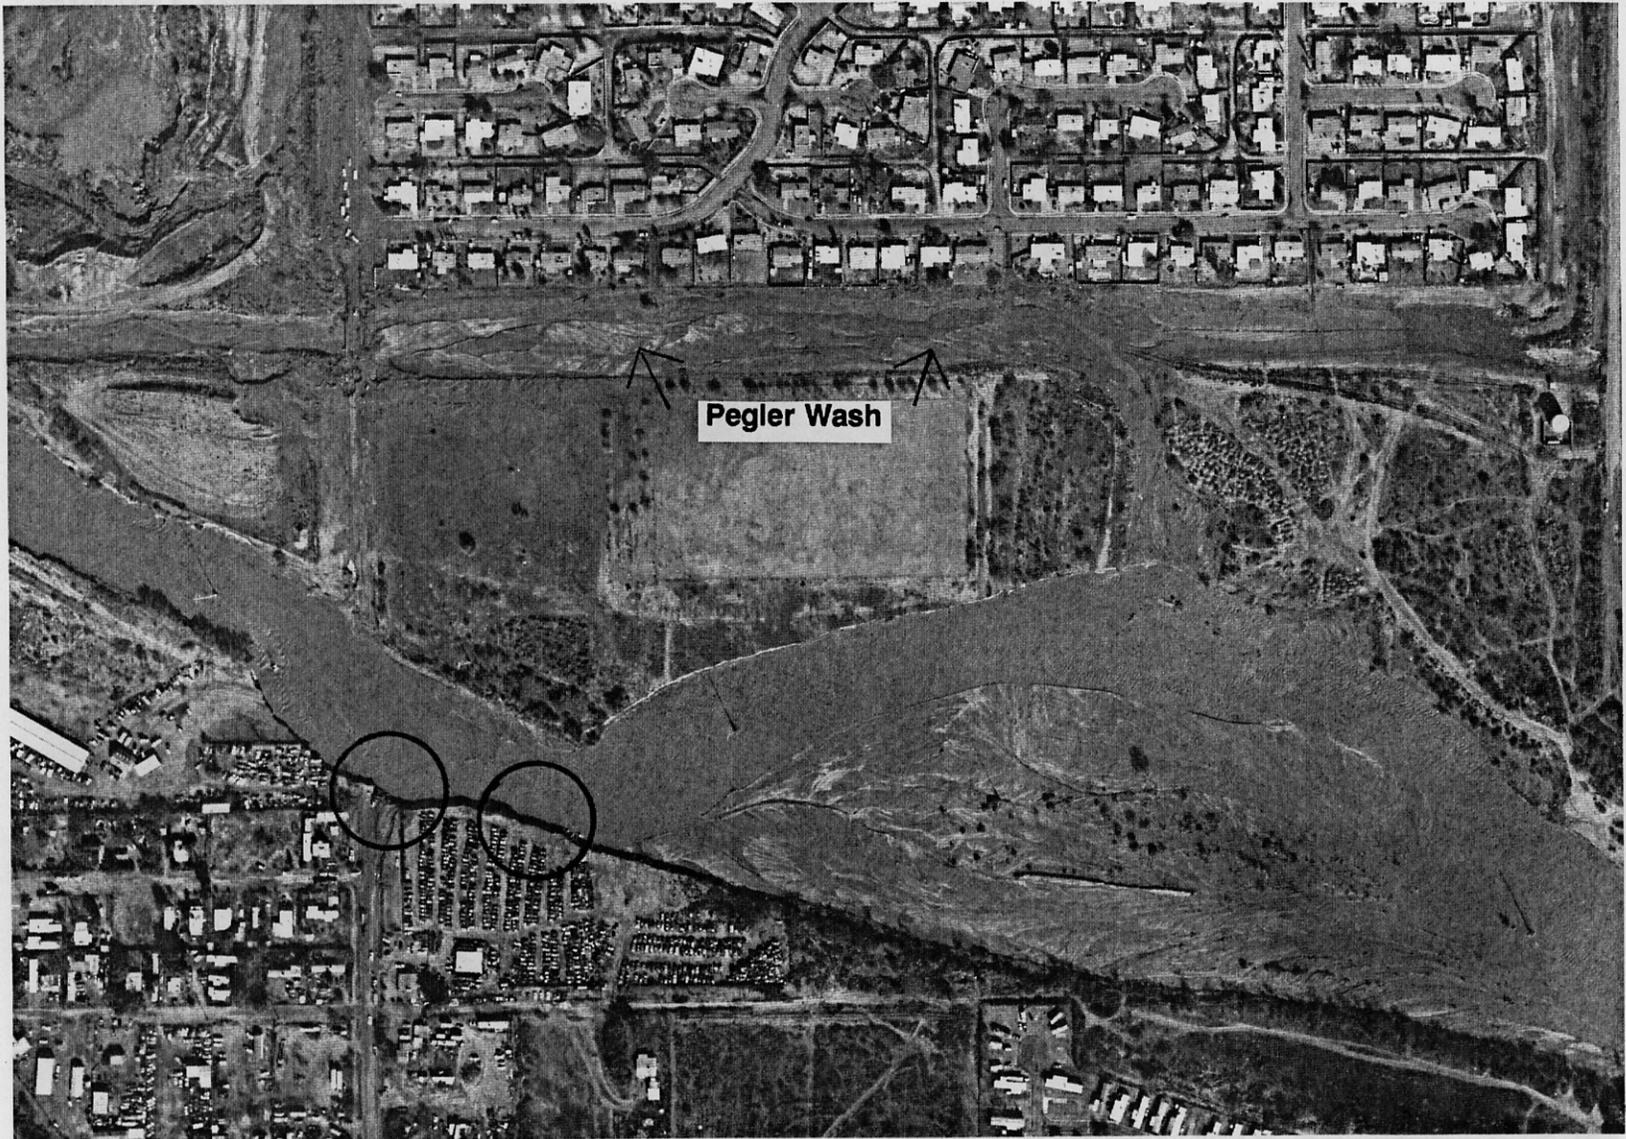
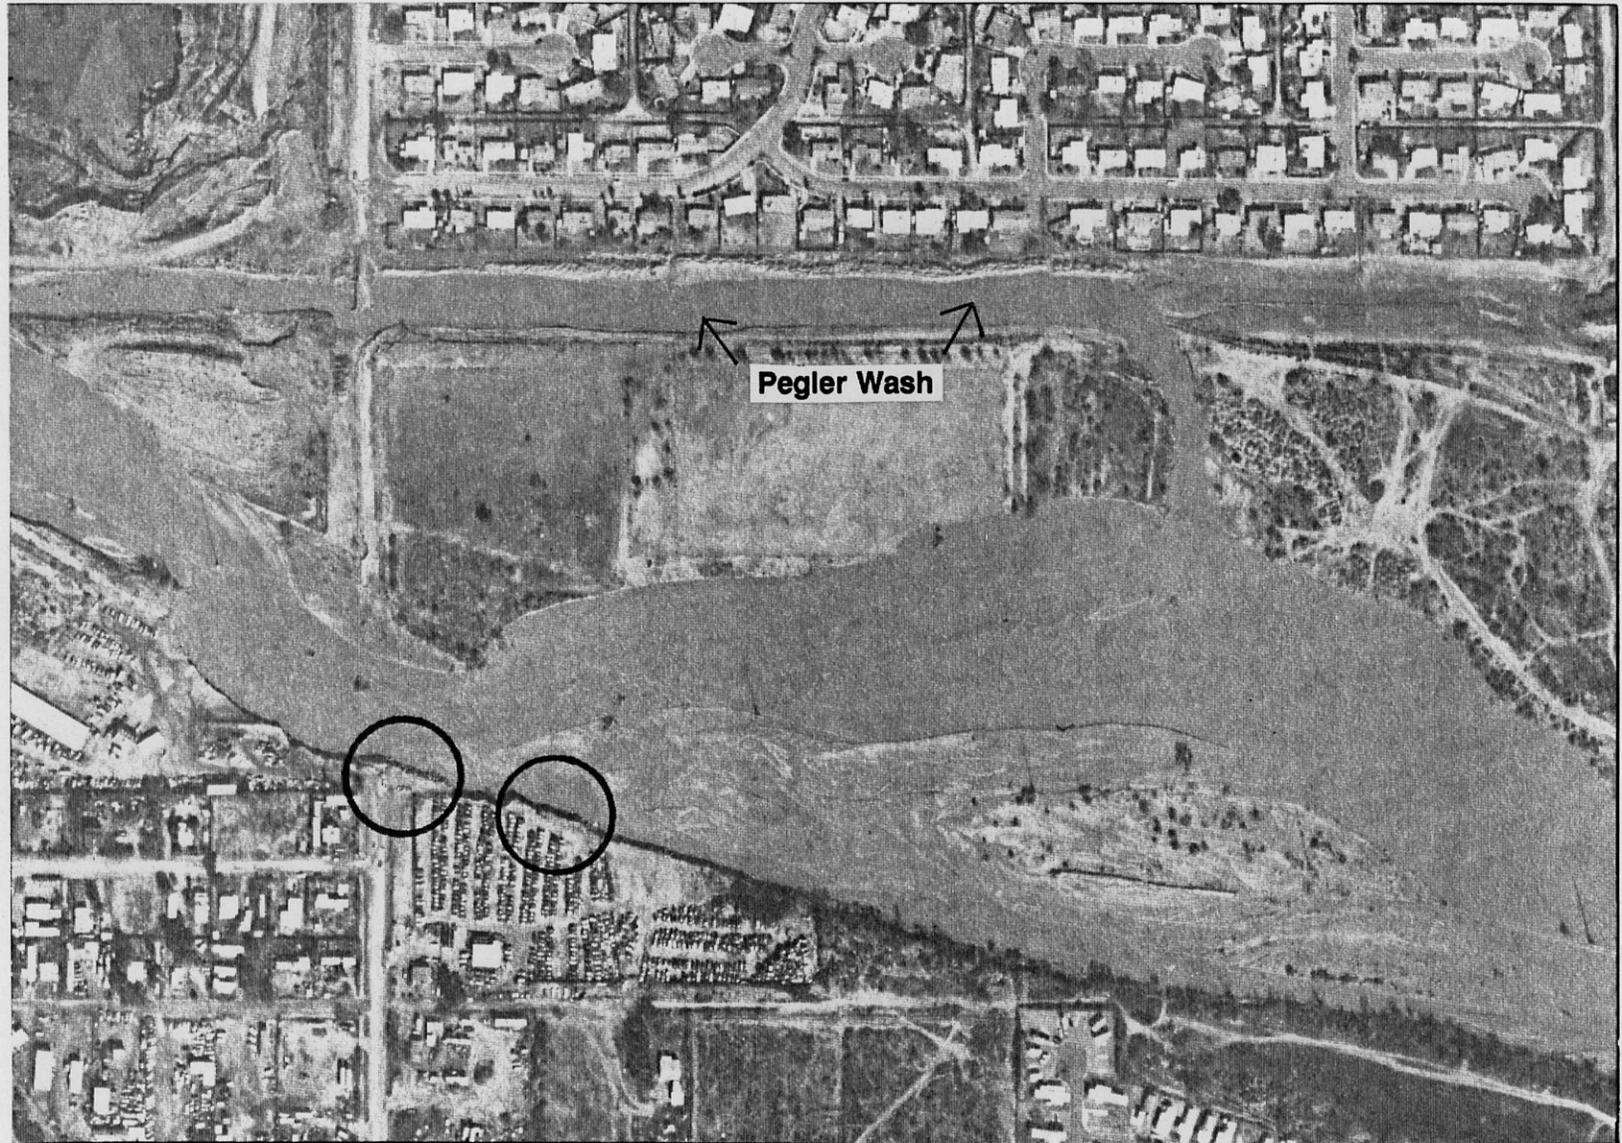
FIGURE 5.10

Rillito Creek / Pegler Wash
at Camino de la Tierra
March 19, 1990

Rillito Creek / Pegler Wash
at Camino de la Tierra
January 9, 1993

Rillito Creek / Pegler Wash
at Camino de la Tierra
January 20, 1993

In response to severe erosion which had occurred along the south bank adjacent to an auto salvaging business upstream of Camino de la Tierra, PCDOT & FCD's Operations Division personnel had a contractor dump four-to-six foot diameter rock rip-rap to protect the remaining bank (Figures 5.10 - 5.12). The cost of this emergency repair work was about \$ 125,000, to be reimbursed by FEMA. Long-term plans call for erosion control bank stabilization on both the north and south banks in the vicinity of Camino de la Tierra, under the SCS's EWP; construction is scheduled to begin in August 1993 (Figure 5.13).
