JANUARY 1993 FLOODS PIMA COUNTY, ARIZONA

Summary Report July 1993

Pima County Department of Transportation
and Flood Control District

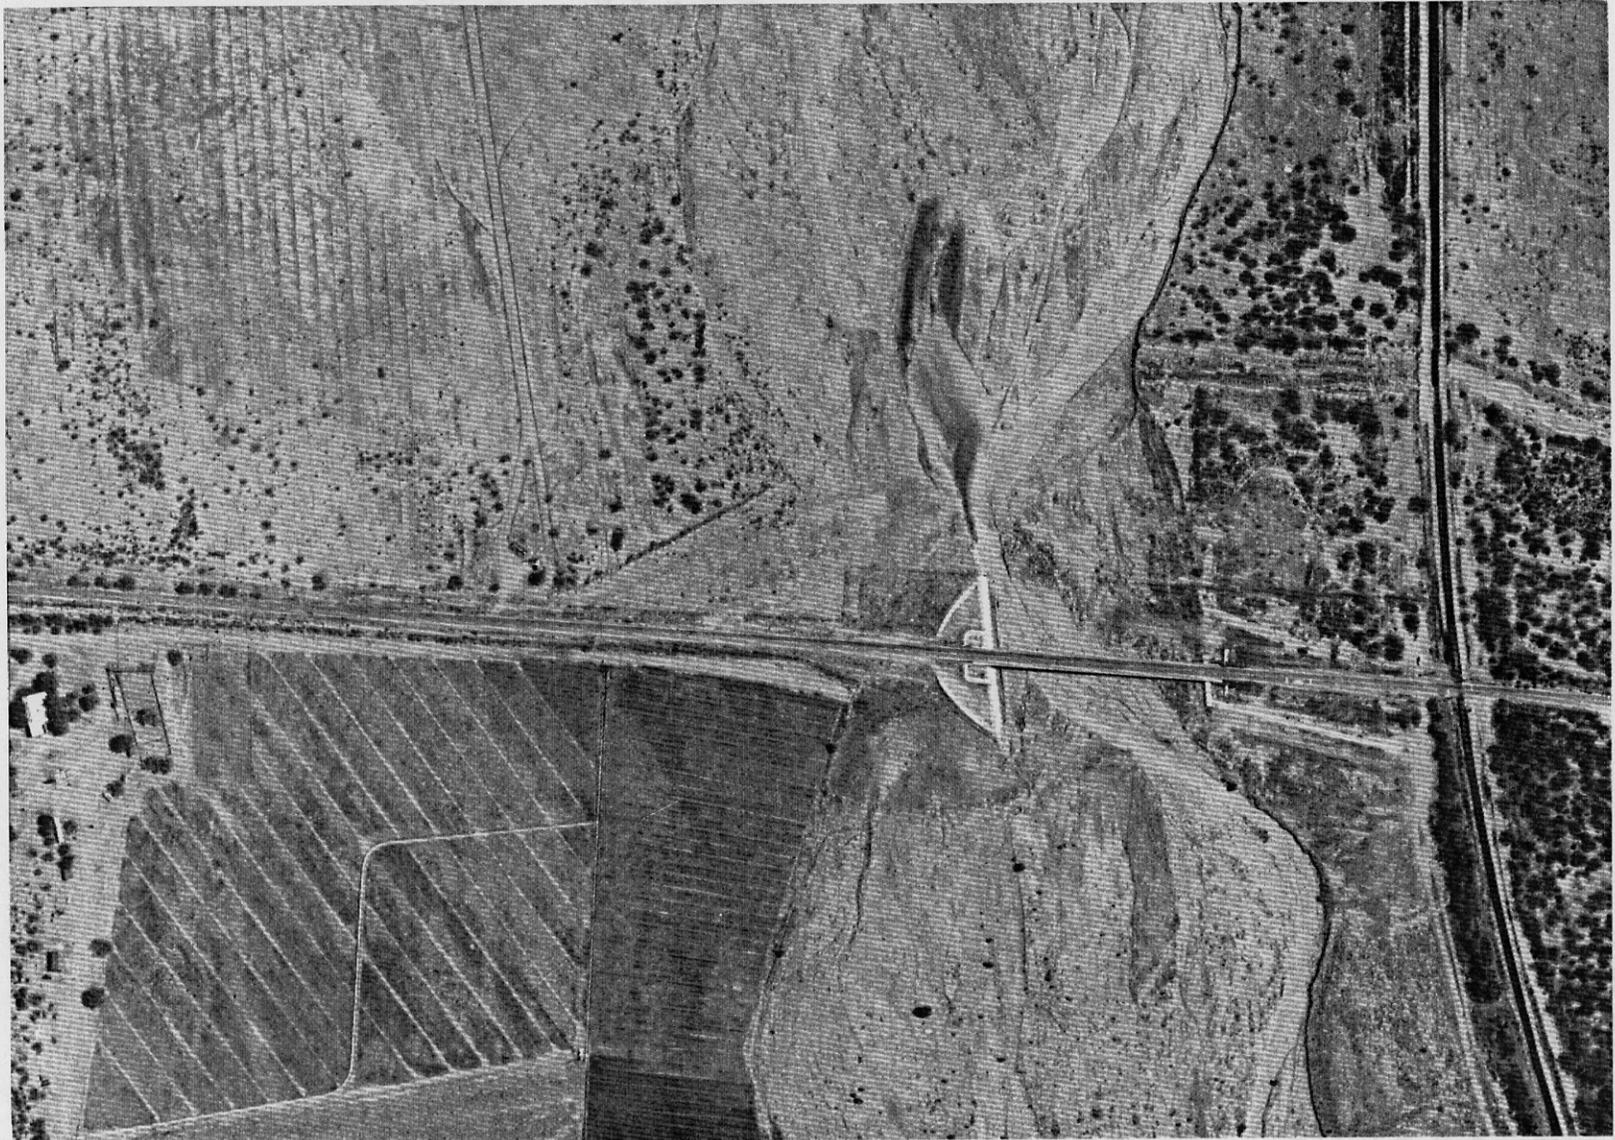
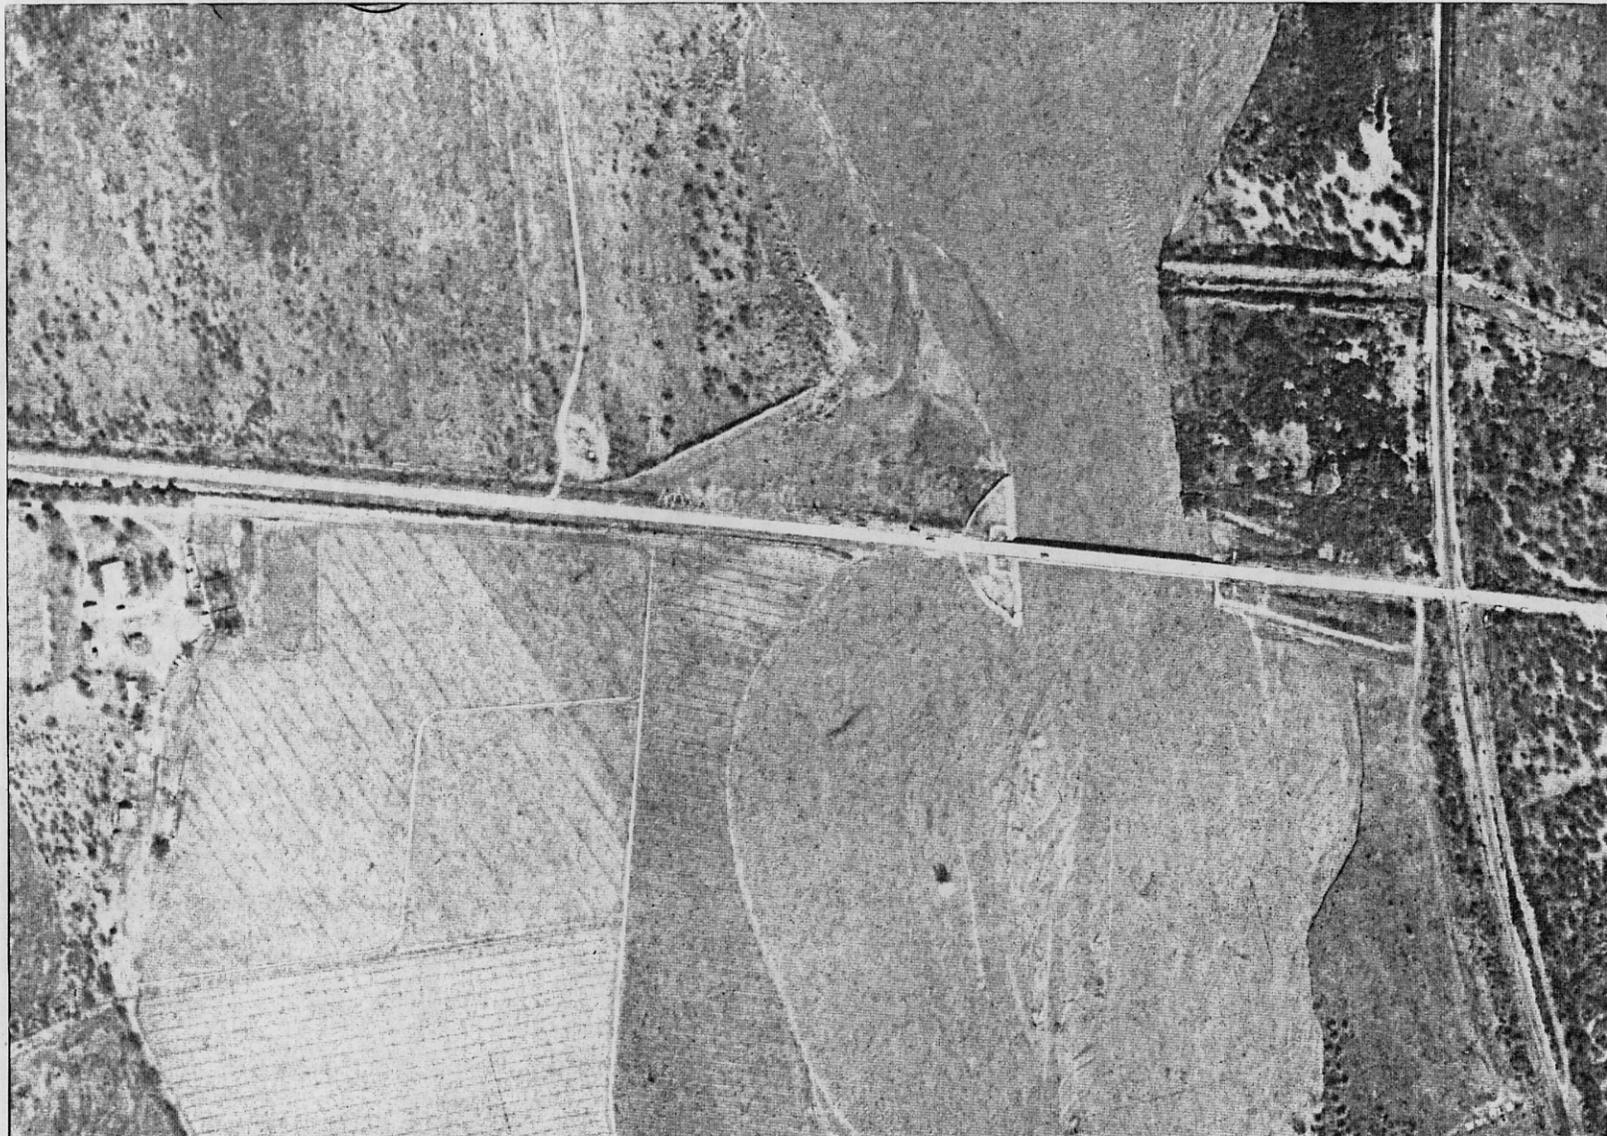
FIGURE 6.1

Bank erosion occurred along the natural channel banks throughout the upper reach, eroding some agricultural land and damaging transportation infrastructure. Specifically, two bridge crossings were damaged (Elephant Head and Sahuarita Roads, Figures 6.1 - 6.4), however the recently constructed Continental Road bridge was essentially unscathed.

Santa Cruz River at Elephant Head Road
April 20, 1990

Santa Cruz River at Elephant Head Road
January 20, 1993

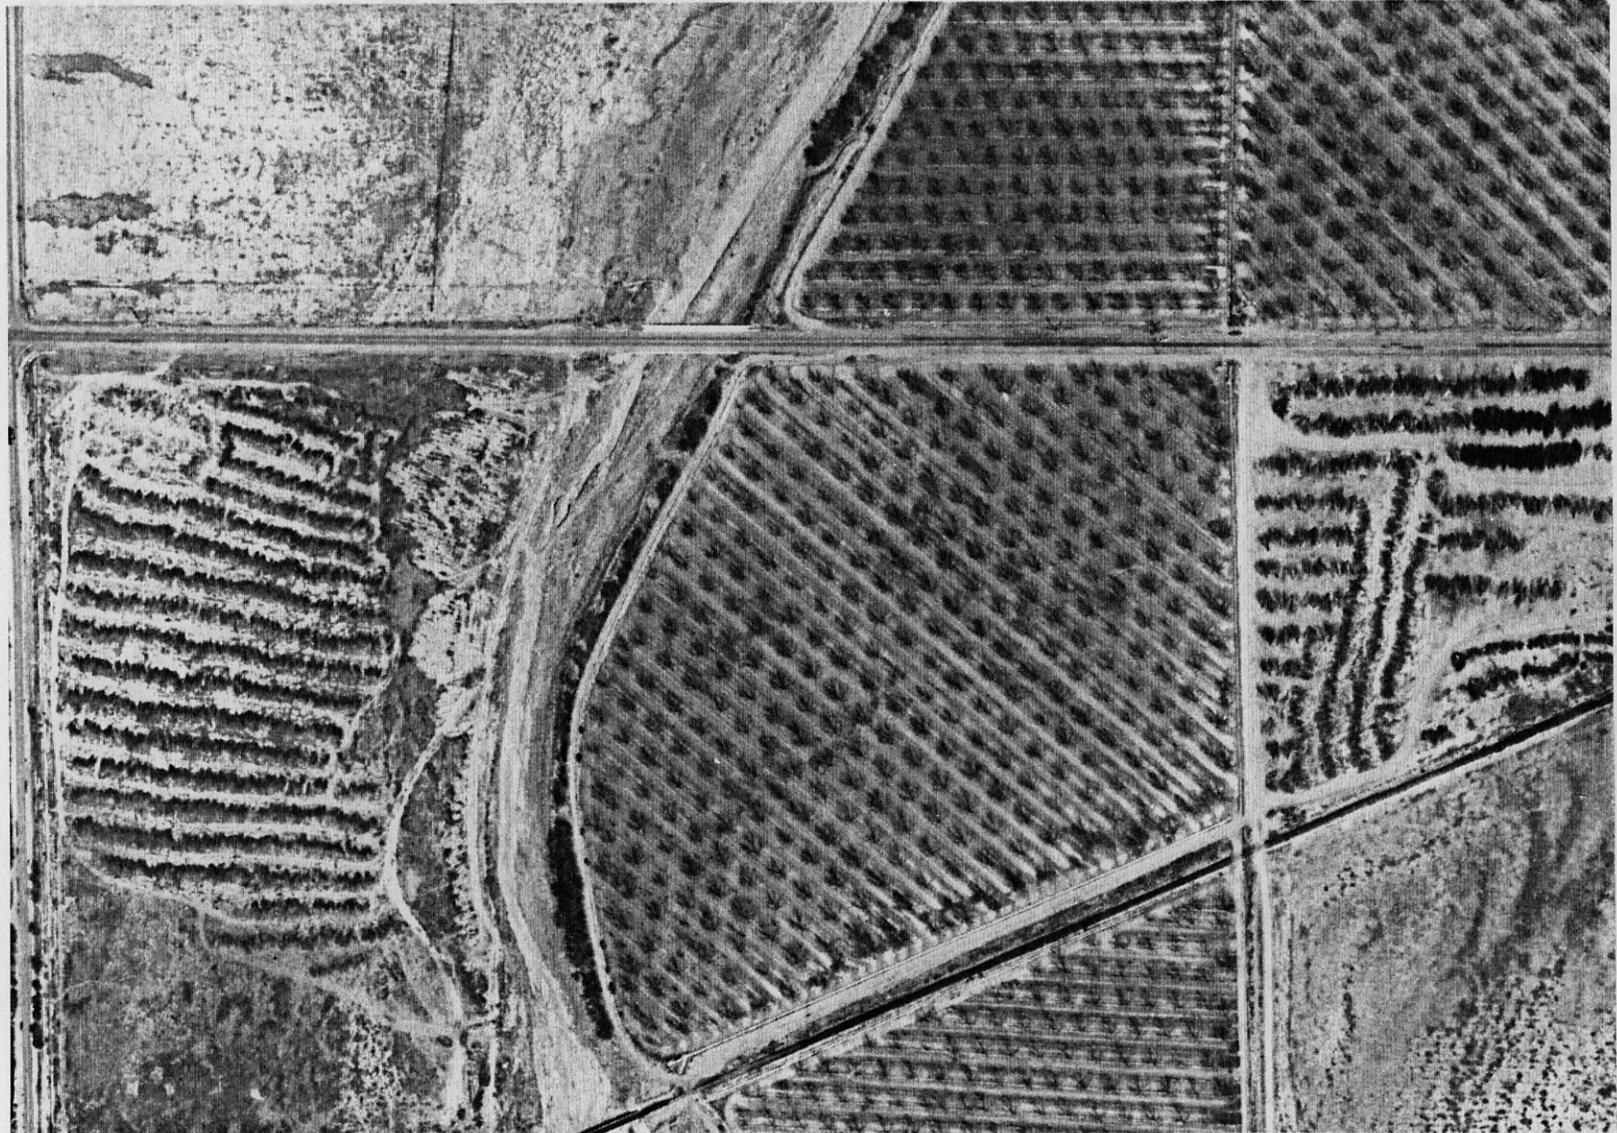
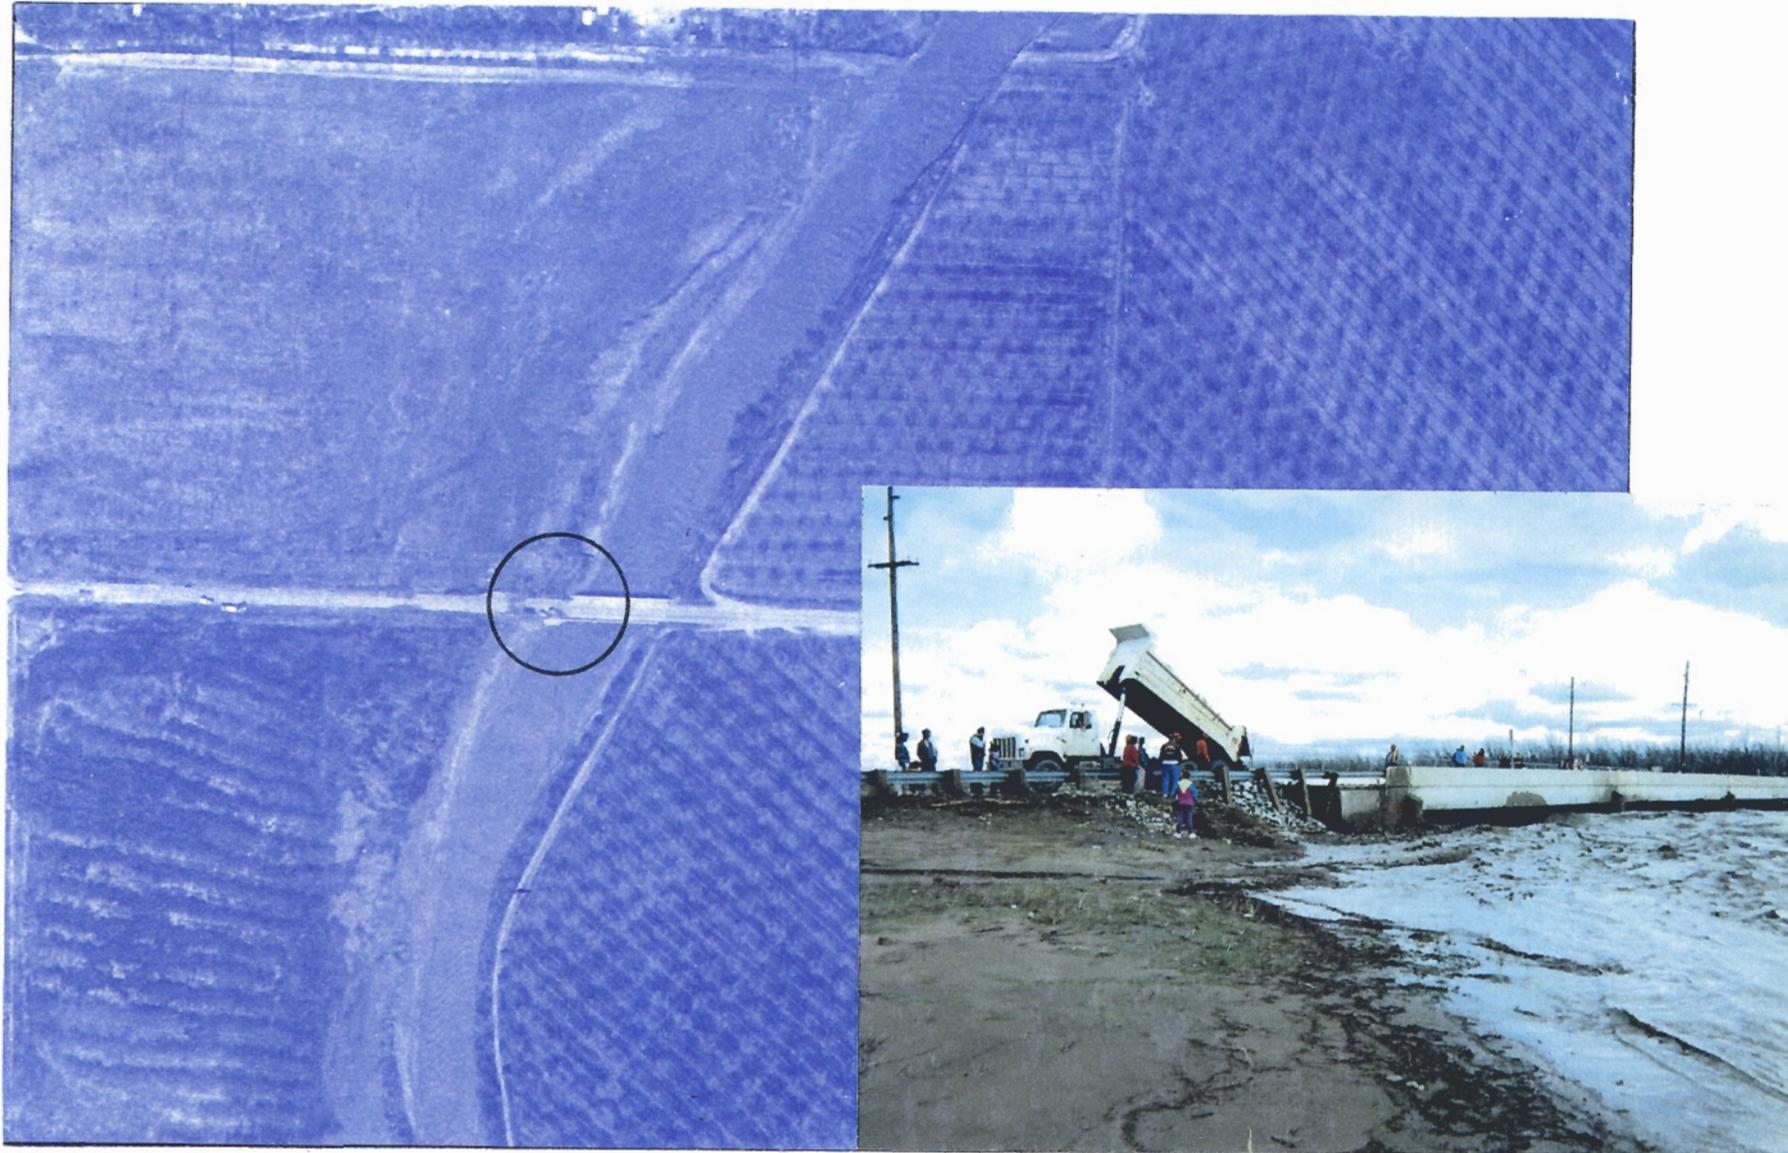
FIGURE 6.3

Santa Cruz River at Sahuarita Road
March 19, 1990

Santa Cruz River at Sahuarita Road
January 20, 1993

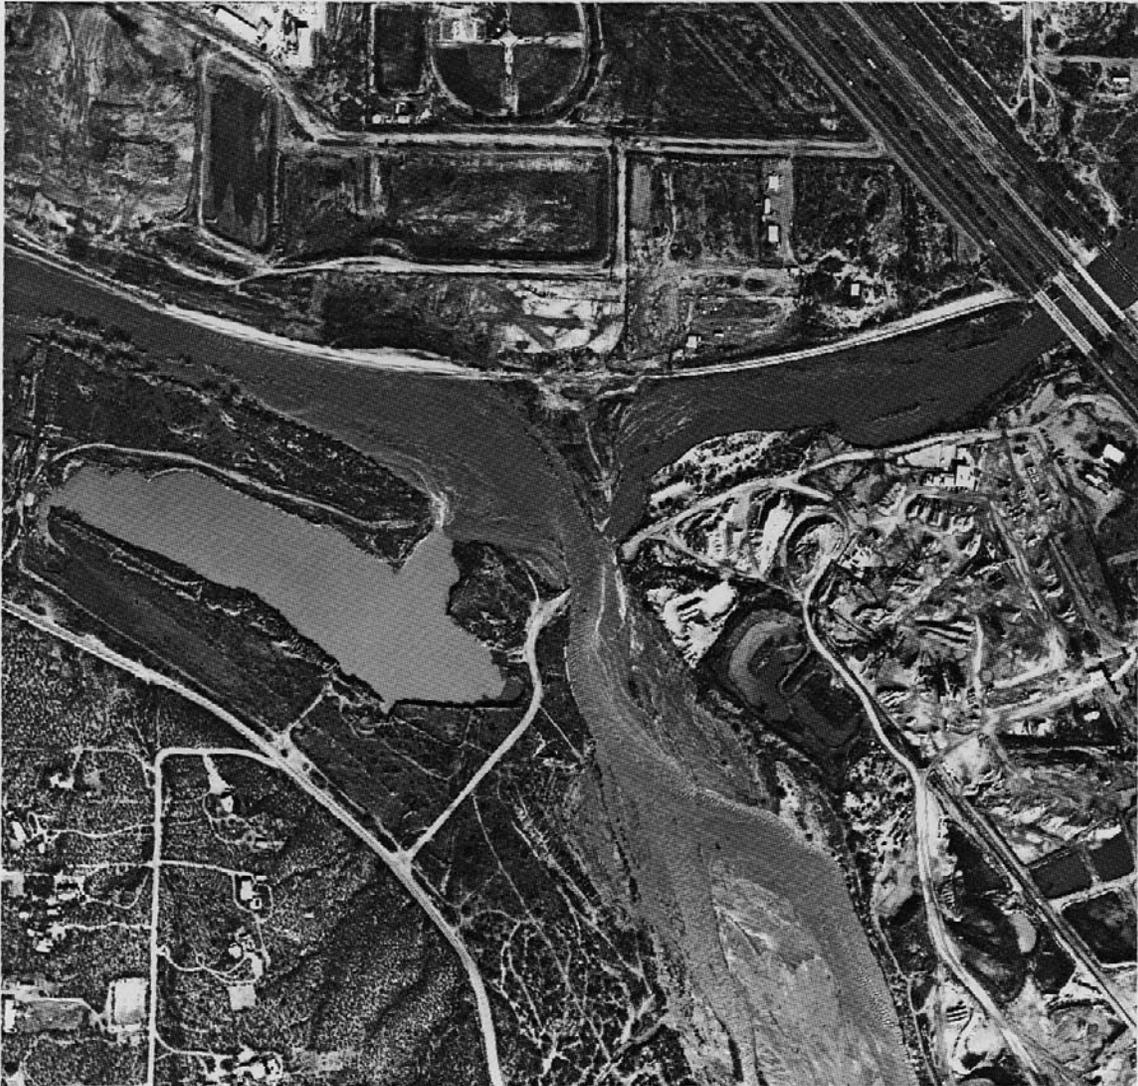
FIGURE 6.6

Upstream of the Rillito confluence, flow was contained within the main channel banks of the Santa Cruz River. Bank erosion occurred at the outside of unprotected bend areas downstream of Grant Road and El Camino del Cerro Road, however structures were generally undamaged. Flow was mostly contained within the main channel from the Rillito confluence to Ina Road, with minor overbank flooding of sand and gravel pits (Figure 6.6).

Santa Cruz River at CDO Wash Confluence
January 9, 1993

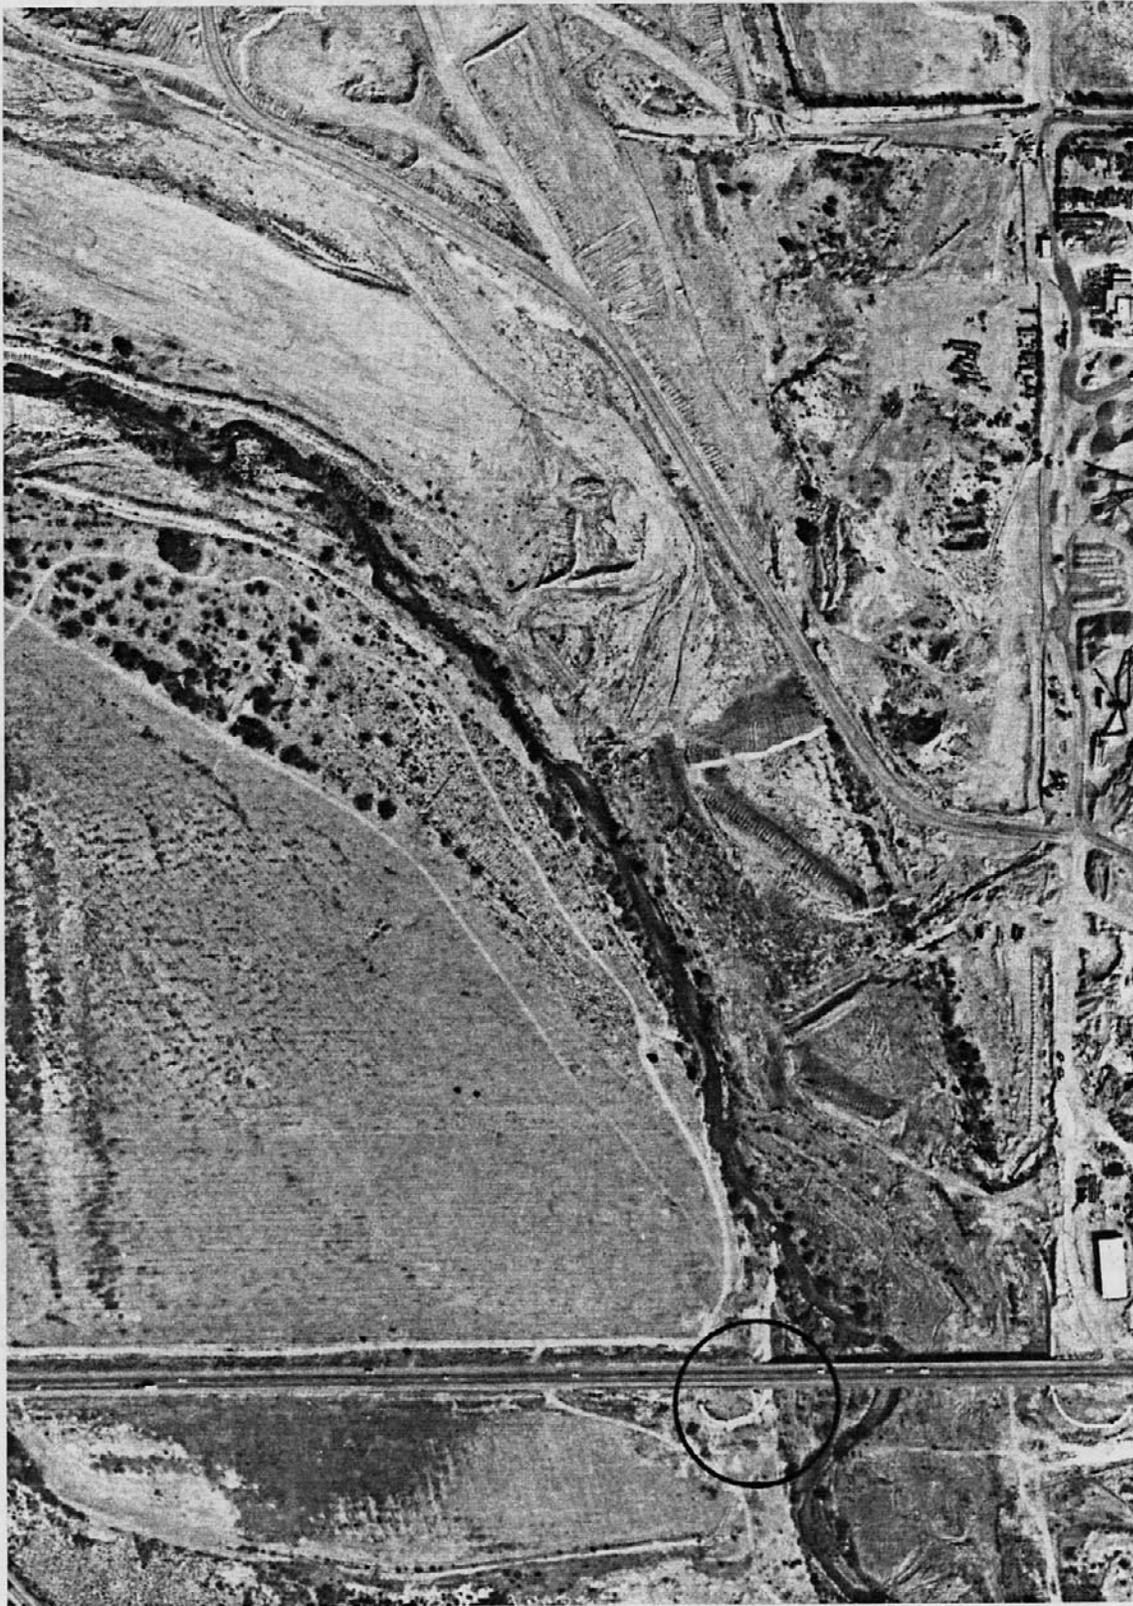
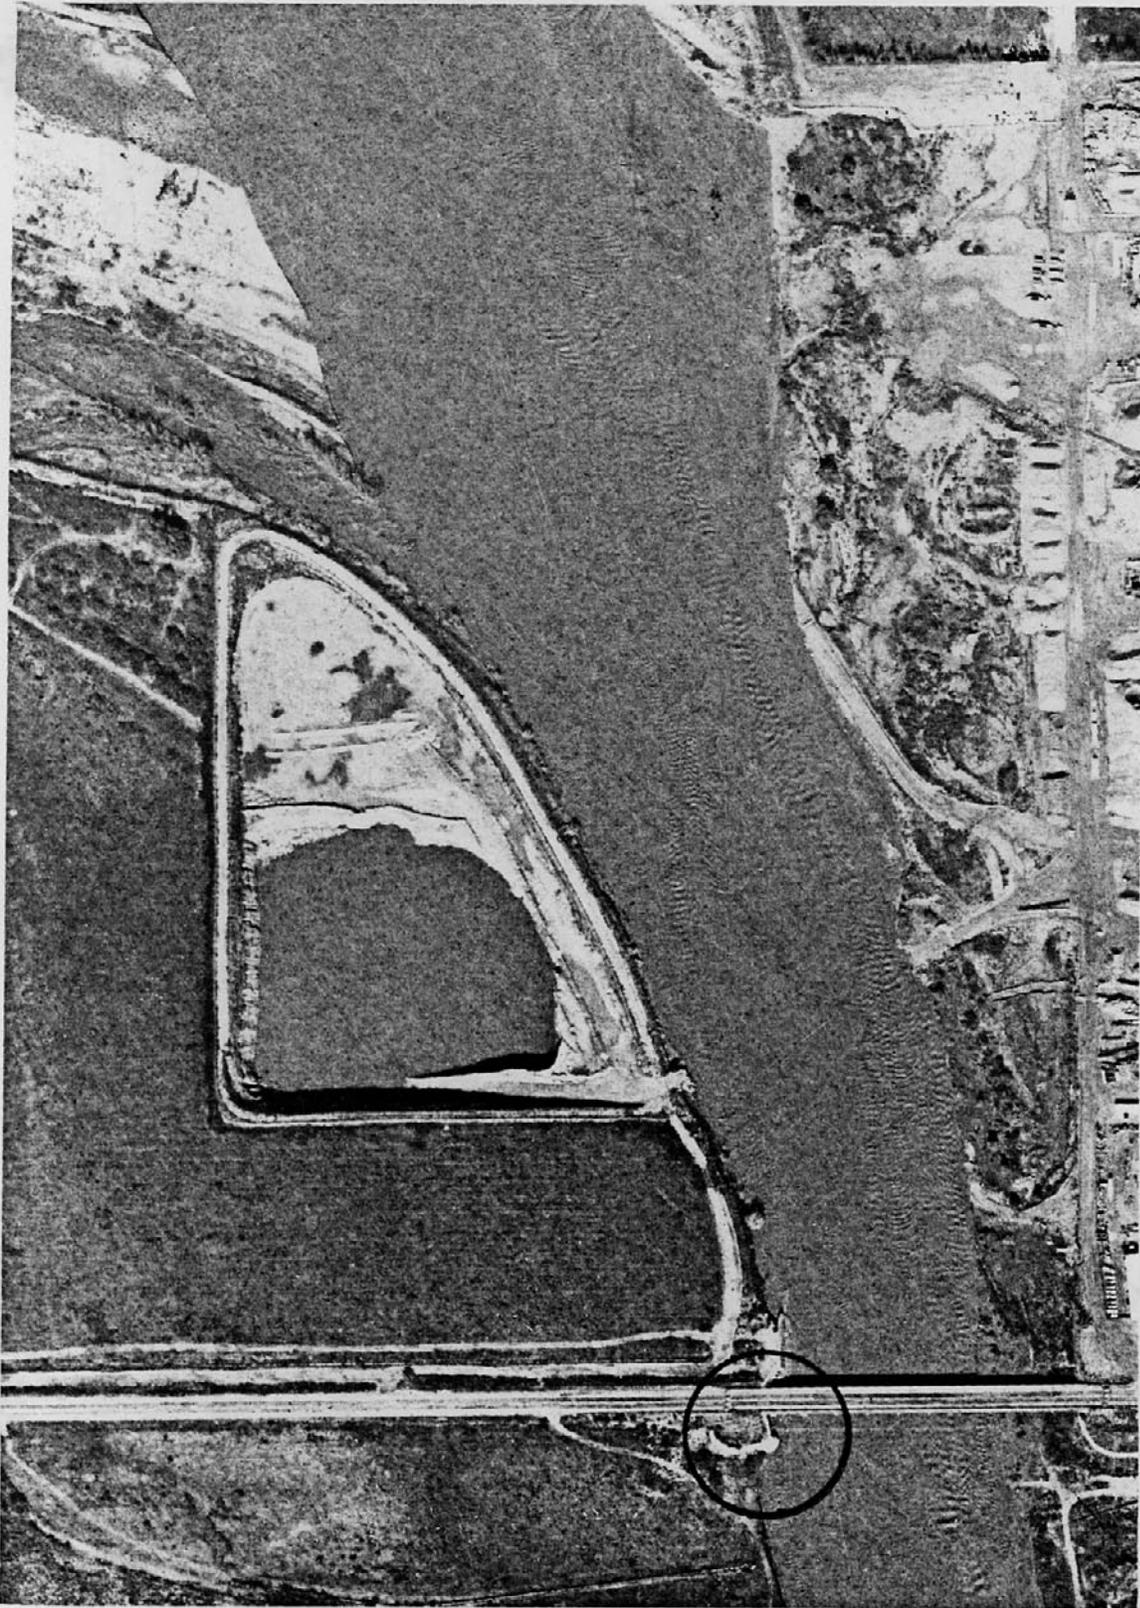
FIGURE 6.7

Seepage and overbank flow into large sand and gravel pits located between Ina and Cortaro Roads contributed to the shifting to the east of the main channel of the Santa Cruz River. Overbank flooding occurred primarily to the east with some to the west. Bank erosion caused extensive damage to the west approach at the Ina Road bridge (Figures 6.7 and 6.8), and the upstream soil-cement key-in along the east bank at Cortaro Road (Figures 6.9 and 6.10).

Santa Cruz River at Ina Road
March 19, 1990

Santa Cruz River at Ina Road
January 20, 1993

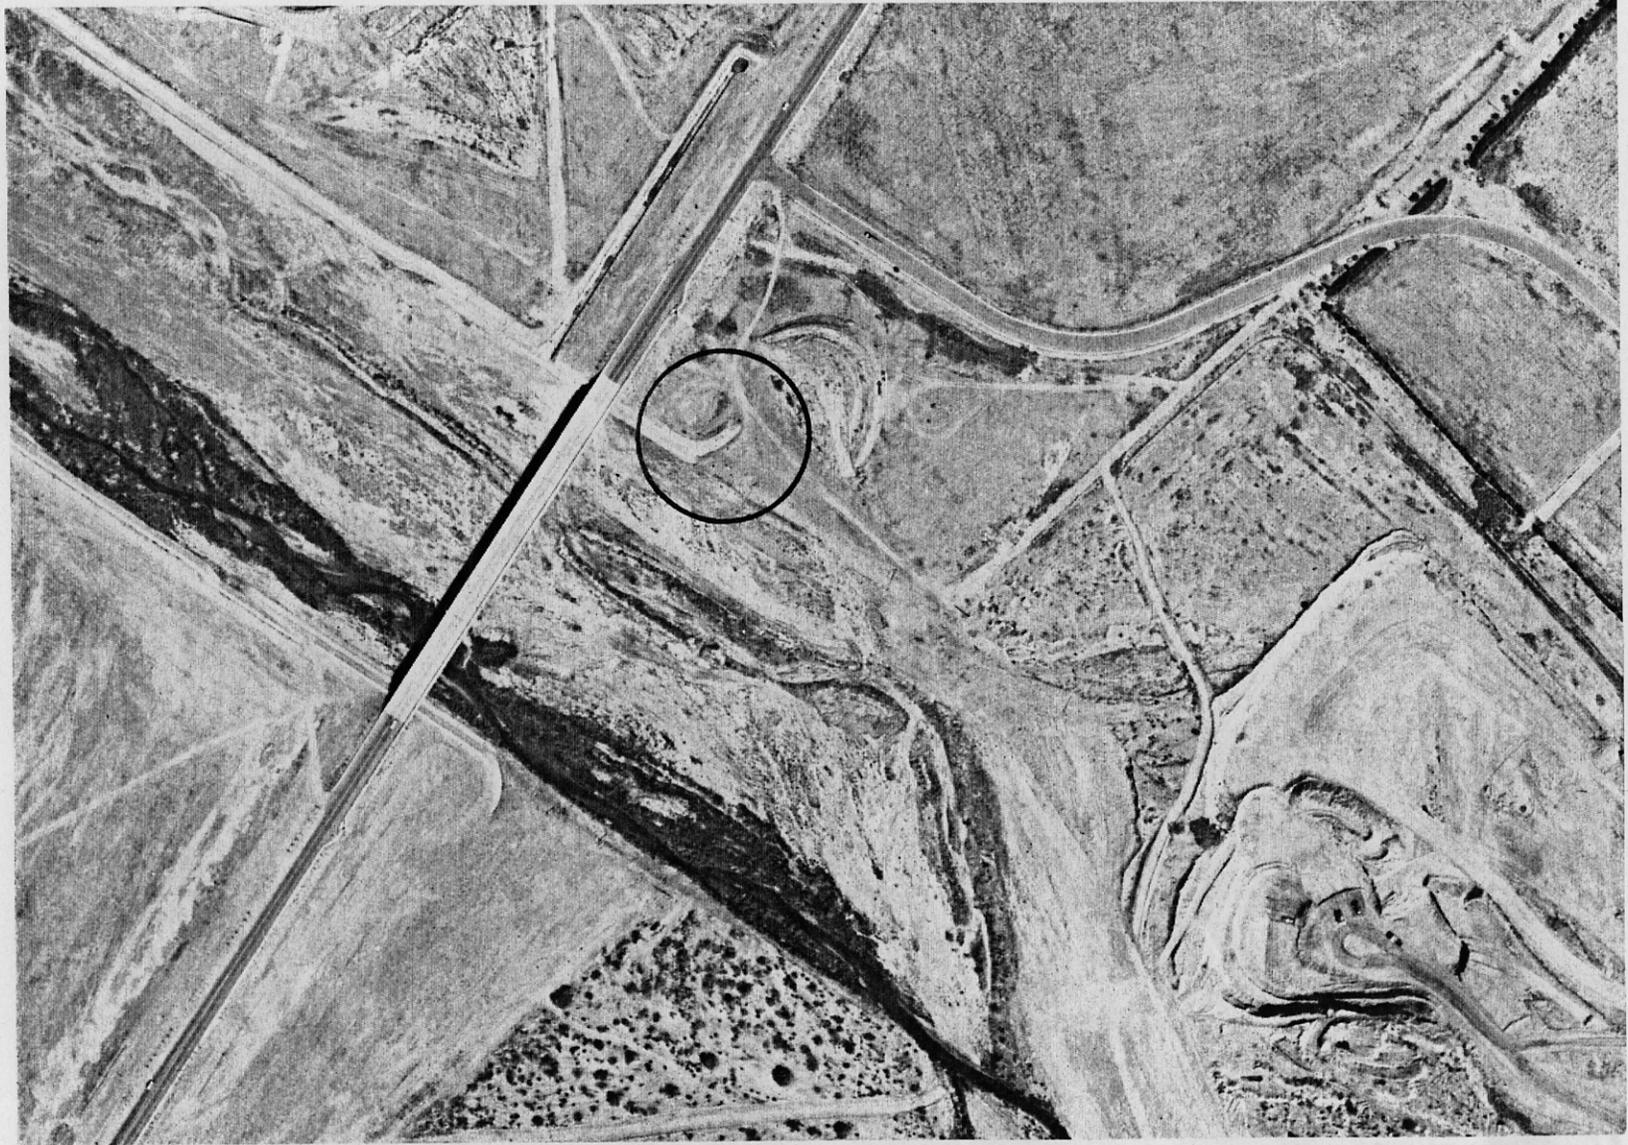
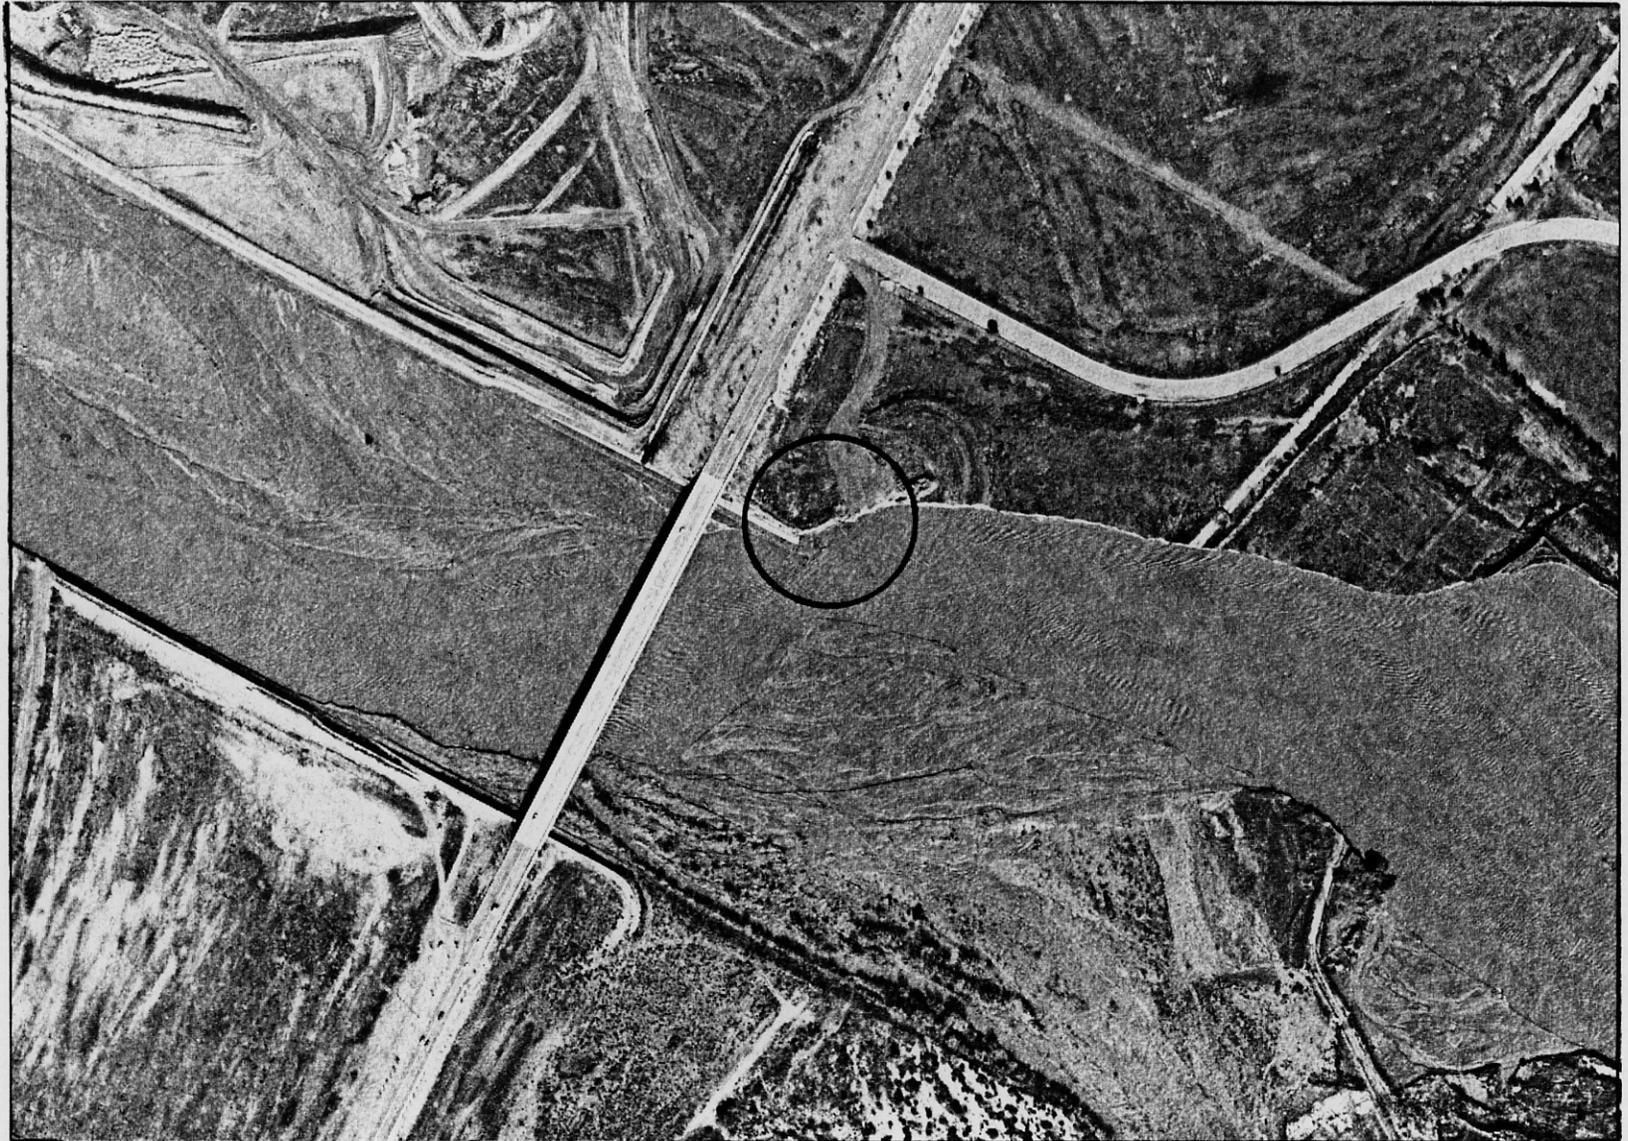
FIGURE 6.9

Santa Cruz River at Cortaro Road
March 19, 1990

Santa Cruz River at Cortaro Road
January 20, 1993

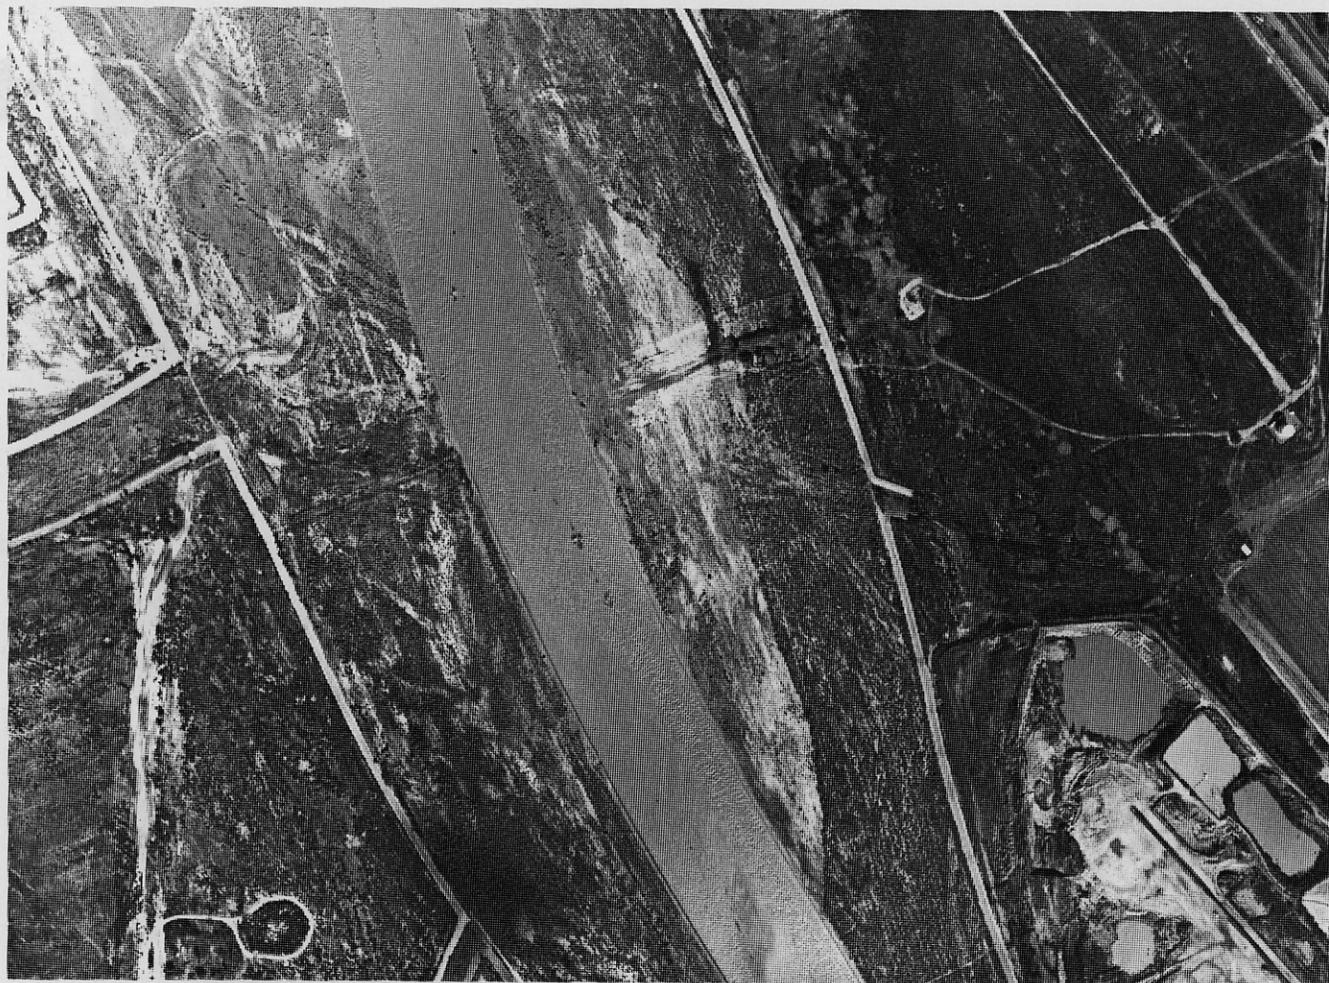
FIGURE 6.11

Except for the peak discharge, flow downstream of Cortaro Road through Continental Ranch was generally contained within the low-flow soil cement bank stabilization. The peak discharge overtopped the low-flow bank protection but was well-contained within the 100-year bank stabilization (Figure 6.11). Some of the bank stabilization was damaged just downstream of Cortaro Road.

Santa Cruz River at Continental Ranch
January 9, 1993

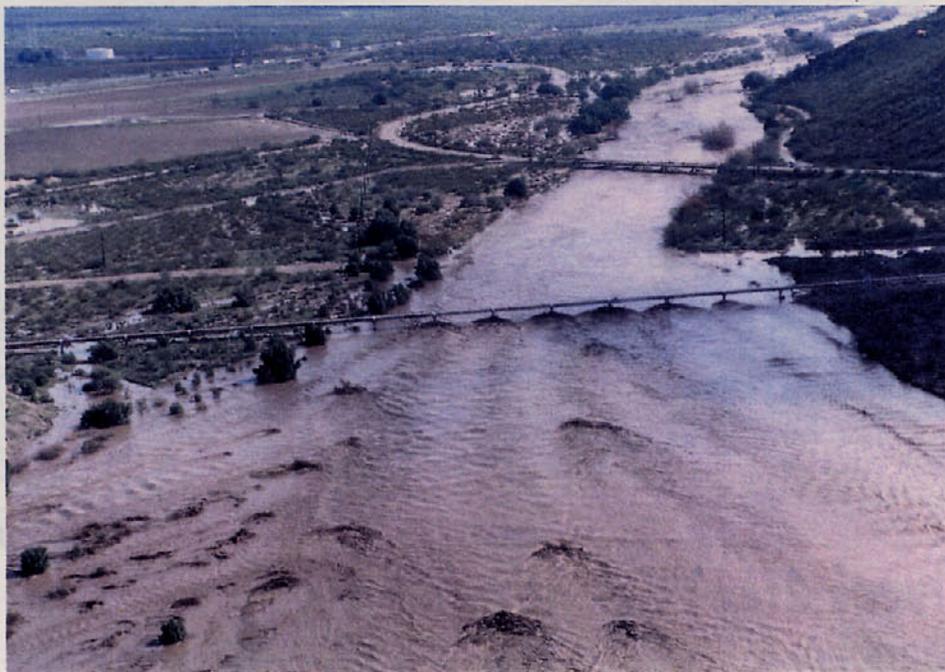
FIGURE 6.21b

6.21b) Avra Valley Road—looking to the southeast, upstream along the Santa Cruz River. Notice the flow breaking out of bank downstream of Avra Valley Road. January 19, 1993.

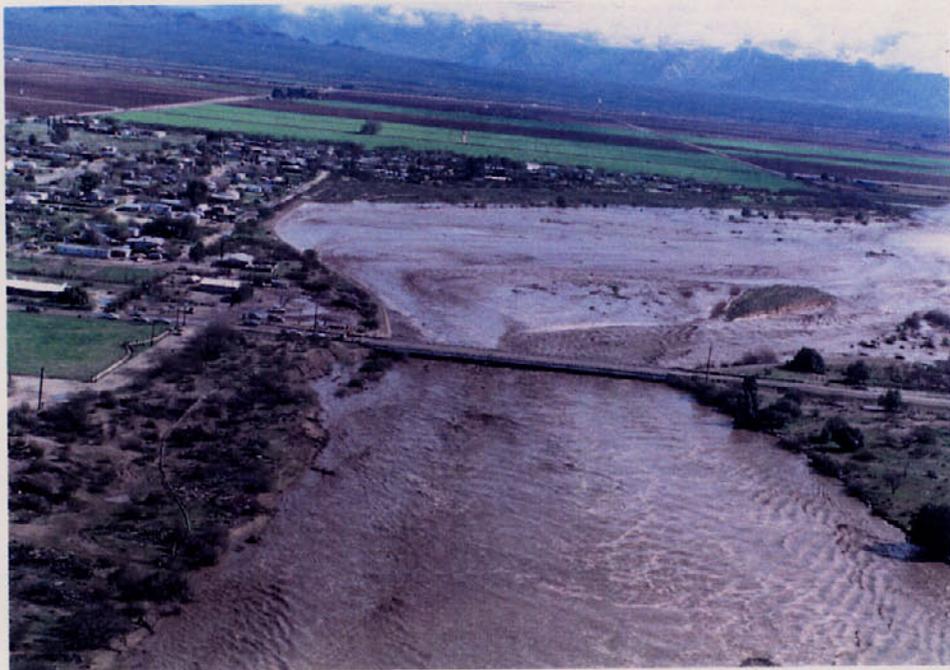
FIGURE 6.22a

6.22a) Sanders Road—looking to the east, upstream along the Santa Cruz River. Notice the soil-cement bank stabilization protecting the Honca Heights subdivision. January 19, 1993.

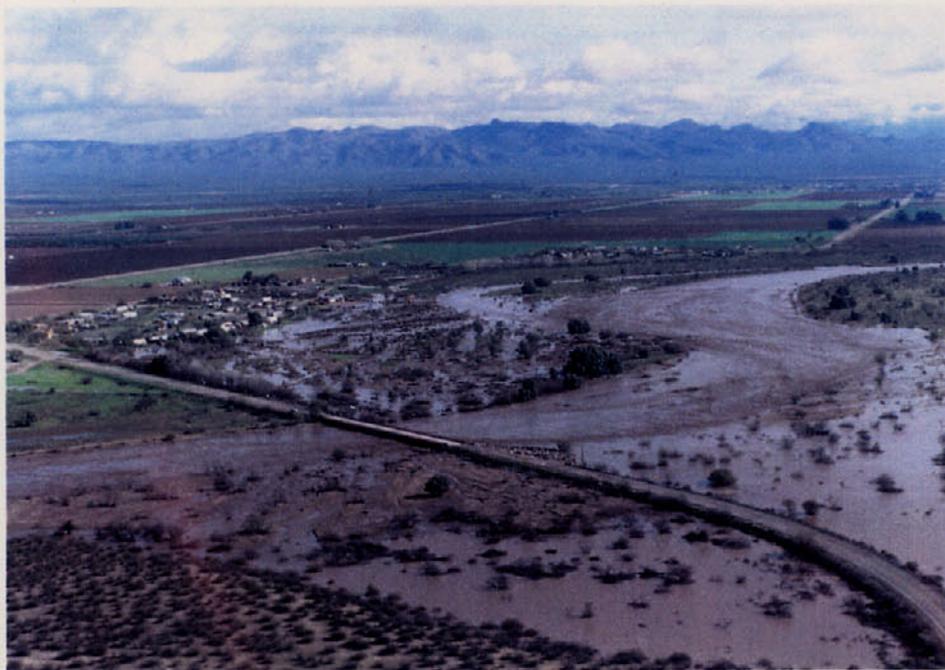
FIGURE 6.22b

6.22b) Trico-Marana Road—looking to the southeast, upstream along the Santa Cruz River. Soil-cement bank stabilization protecting the Berry Acres subdivision. January 19, 1993.
