JANUARY 1993 FLOODS PIMA COUNTY, ARIZONA

Summary Report July 1993

Pima County Department of Transportation
and Flood Control District

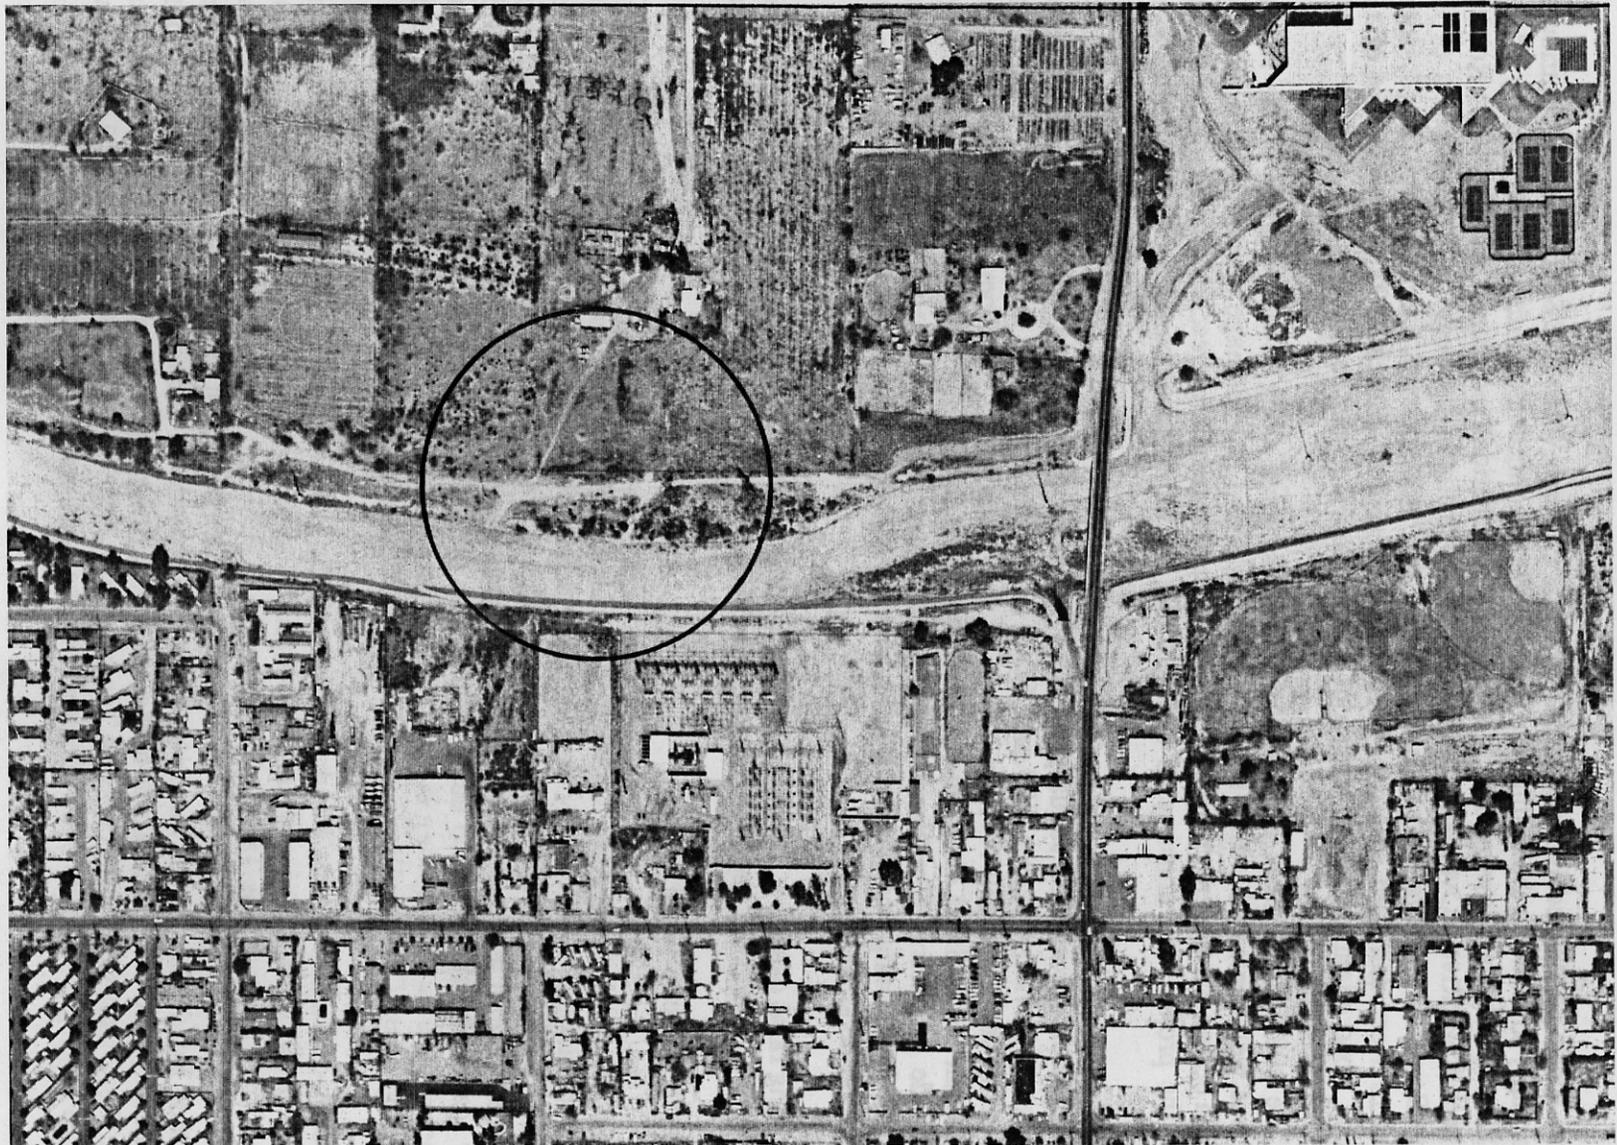
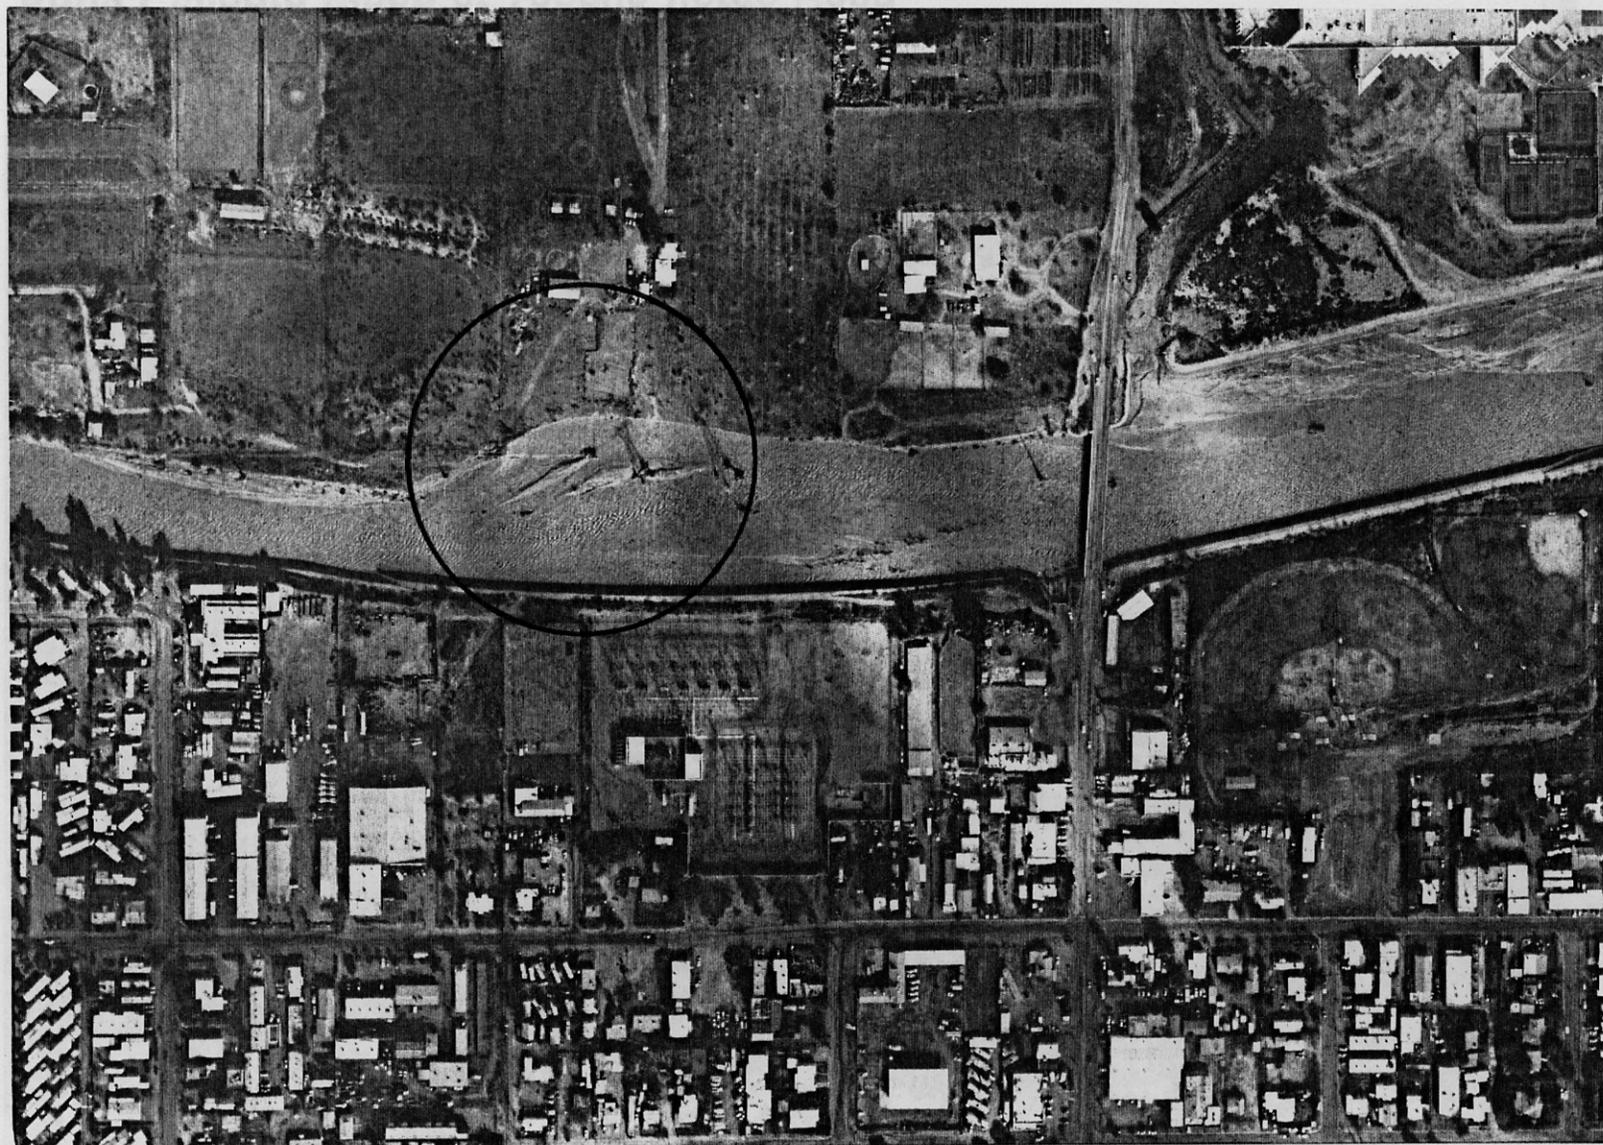
FIGURE 6.23

Severe erosion occurred on January 7th and 8th from Swan Road to Alvernon Way, downstream of Dodge boulevard (Figures 6.23 and 6.24), along the north bank at the Country Club bend, upstream of the Campbell Avenue bridge on the south bank, and from La Cholla Boulevard downstream to the Santa Cruz River. Areas along the south bank upstream and downstream of Camino de la Tierra were heavily eroded. Residences were threatened downstream of the Craycroft Road bridge on the north bank, and opposite the Tucson Racquet Club on the north bank in the bend area.

Rillito Creek downstream of Dodge Blvd.
March 19, 1990

Rillito Creek downstream of Dodge Blvd.
January 9, 1993

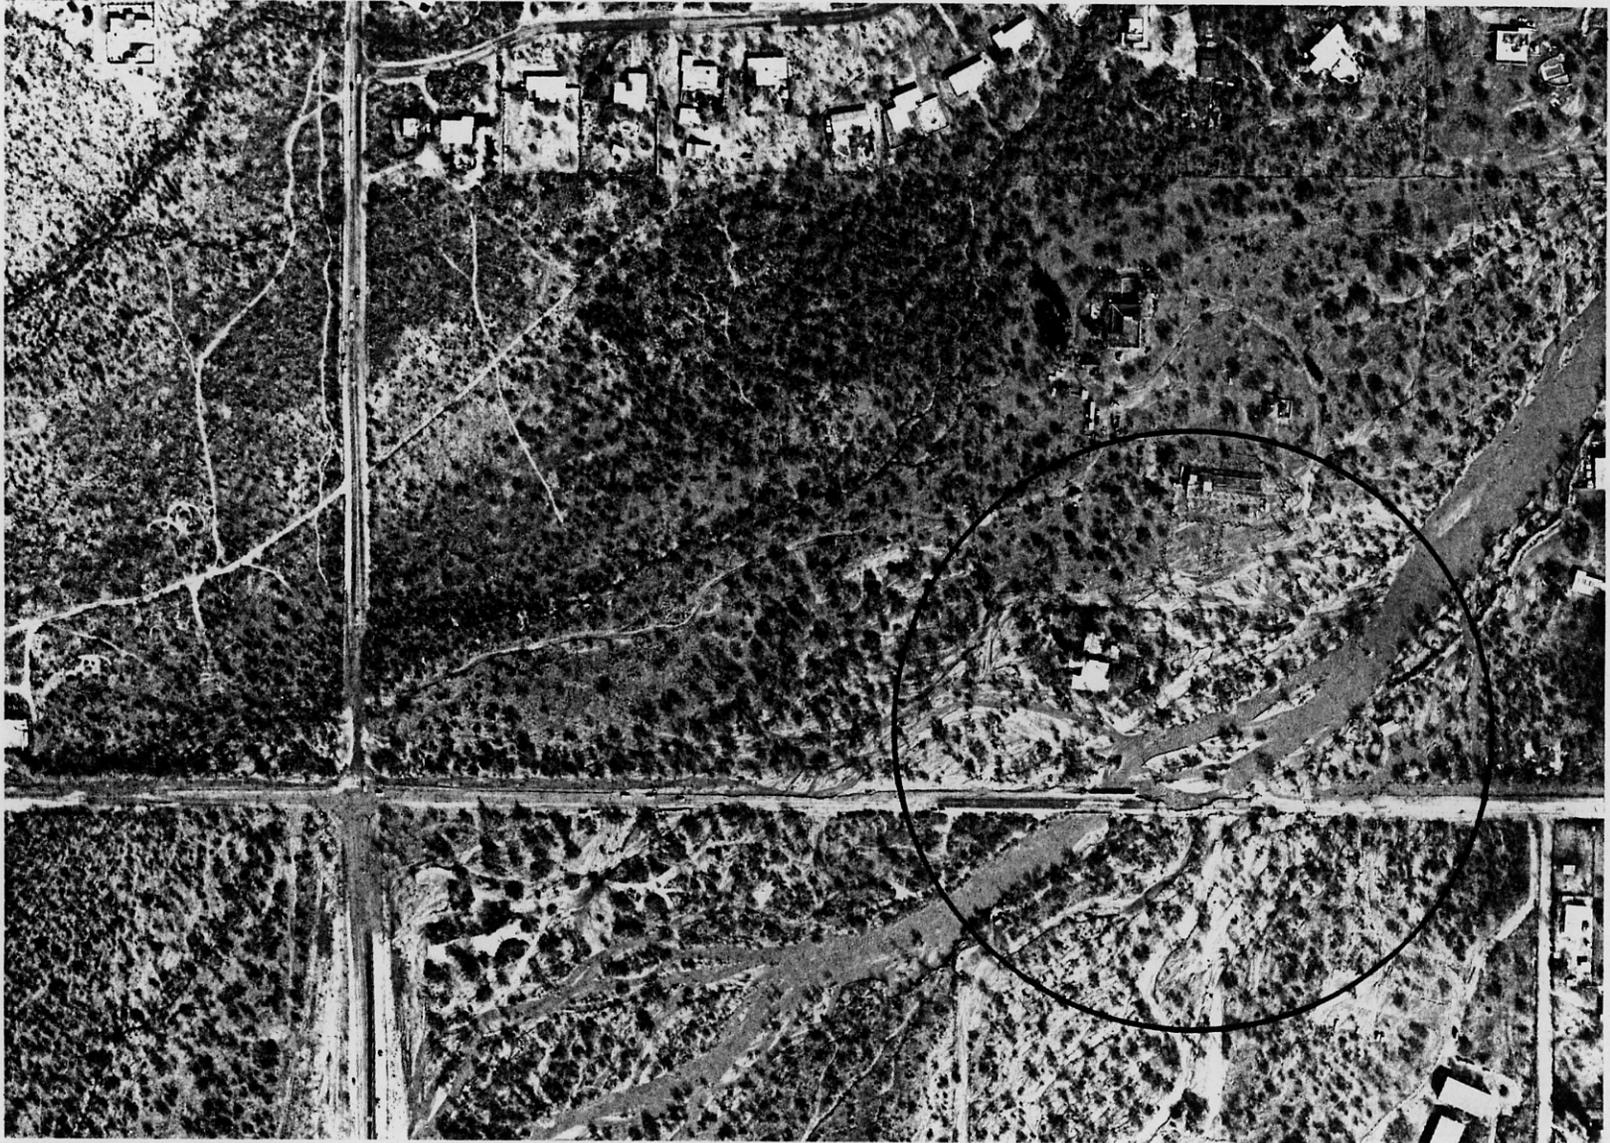
FIGURE 6.26

Upstream of Tanque Verde Road, all roadway dip crossings were heavily damaged and one (Soldier Trail) remained closed until mid-April. Much of the flow breakout downstream of Fort Lowell Road impacted the Tanque Verde Road box culvert, causing widespread inundation along the east approach (Figures 6.25 and 6.26). Flows which broke out to the southeast drained toward Houghton Road, which is elevated above grade to provide all-weather access, then drained south to Tanque Verde Creek. Breakout to the southwest flowed west along the north side of Tanque Verde Road then southwest, crossing Tanque Verde Road west of Houghton Road. These flows rejoined the Agua Caliente Wash upstream of the confluence with Tanque Verde Creek.

Agua Caliente Wash at Tanque Verde Road
January 9, 1993

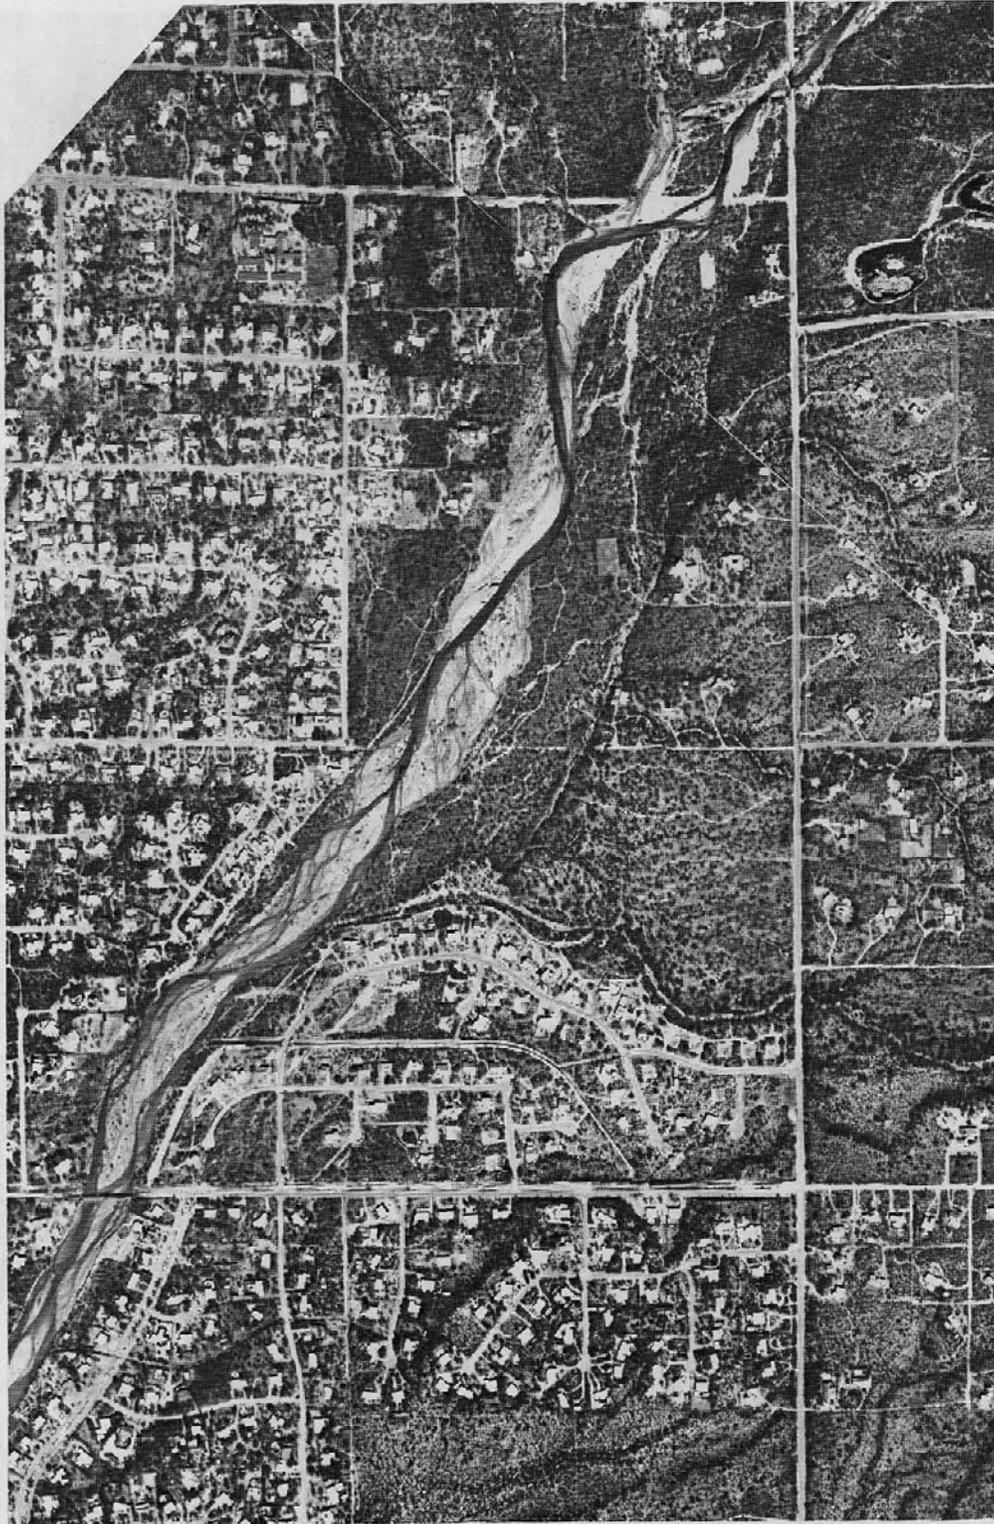
FIGURE 6.28

Considerable erosion occurred along much of the main channel bank and near at-grade roadway crossings; several accessory structures were lost, and many others were threatened. Between Limberlost and Fort Lowell Roads, the main channel almost doubled in width (Figures 6.27 and 6.28). Based on the number of private properties that were damaged and residents who were affected by loss of access, the Agua Caliente Wash area was the residential area most heavily affected by the January 1993 Floods.

Agua Caliente Wash between Limberlost
and Fort Lowell Road
January 20, 1993

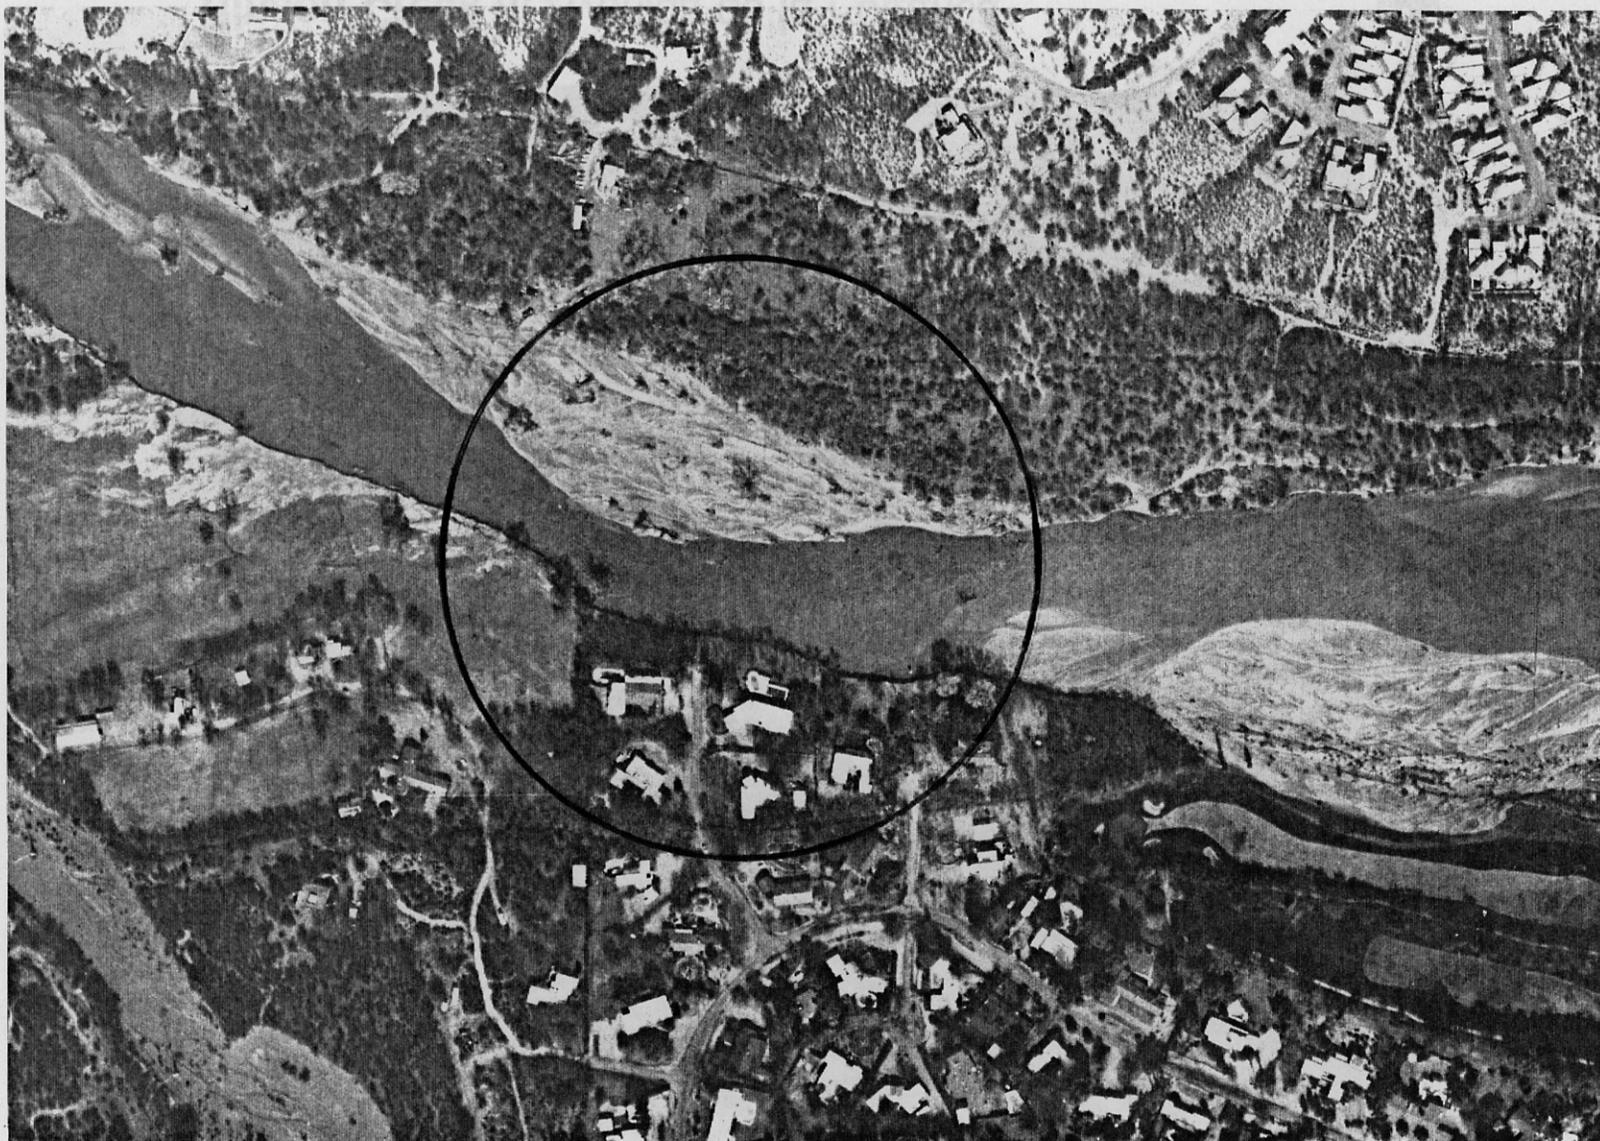
FIGURE 6.30

Except for the reach between Tanque Verde Road and Ventana Canyon Wash, the banks of the Tanque Verde Creek are natural and most eroded. Substantial erosion occurred along the north bank downstream of the Wentworth Wash confluence, and along the south bank at Tucson Country Club Estates. Although no residences were actually damaged at Tucson Country Club Estates, several were threatened, accessory structures were lost, and a sewer line was damaged (Figures 6.29 and 6.30).

Tanque Verde Creek at Tucson Country Club Estates
January 20, 1993

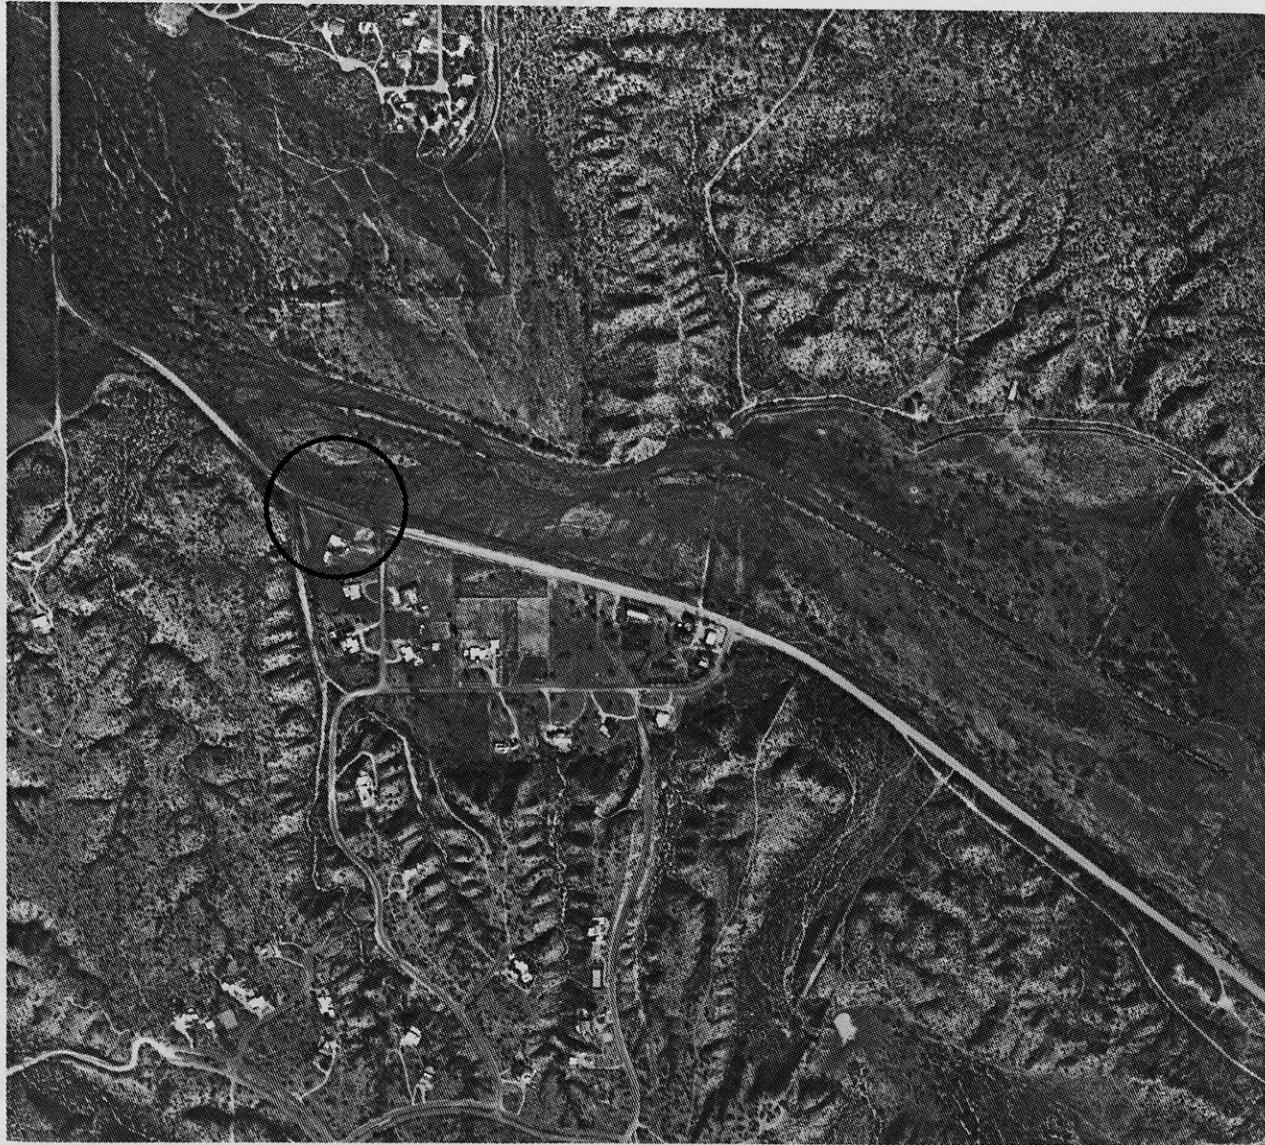
FIGURE 6.32

The main channel of Rincon Creek has limited capacity to convey large discharges; on January 7th and 8th, overbank flow occurred to the south from upstream of Camino Loma Alta to the Old Spanish Trail crossing. Access within the Rincon Valley was limited as both roadway crossings are at-grade and were damaged. Access across several private roads also was lost. Overbank flooding and sediment deposition damaged at least one residence located at the intersection of Old Spanish Trail and Avenida de la Potranca (Figures 6.31 and 6.32).

Rincon Creek at Avenida de la Potranca
January 20, 1993

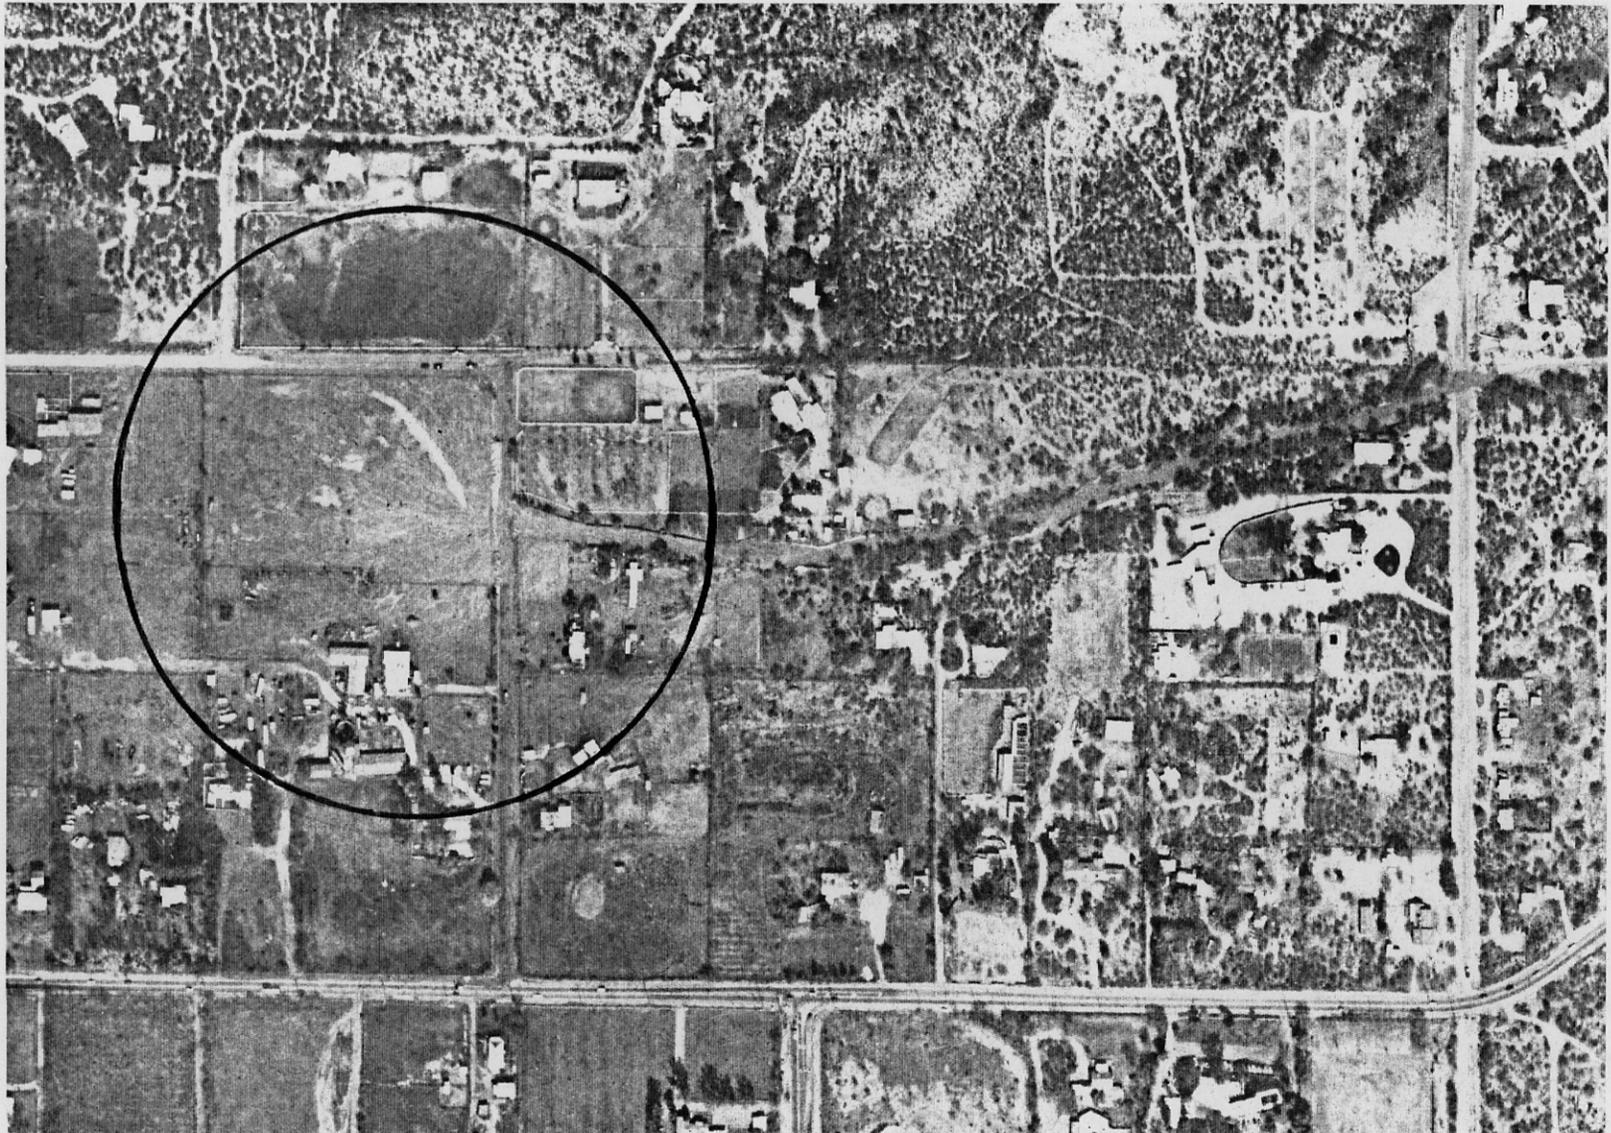
FIGURE 6.34

Downstream of Alvernon Way just north of River Road flow spread out in an alluvial fan, inundating several residences along Sutton Lane and depositing sediment over broad areas (Figures 6.33 and 6.34). The feasibility of providing positive conveyance from Finger Rock Wash to Rillito Creek is being investigated, to remove the threat of flooding from this area.

Finger Rock Wash at Sutton Lane
January 20, 1993

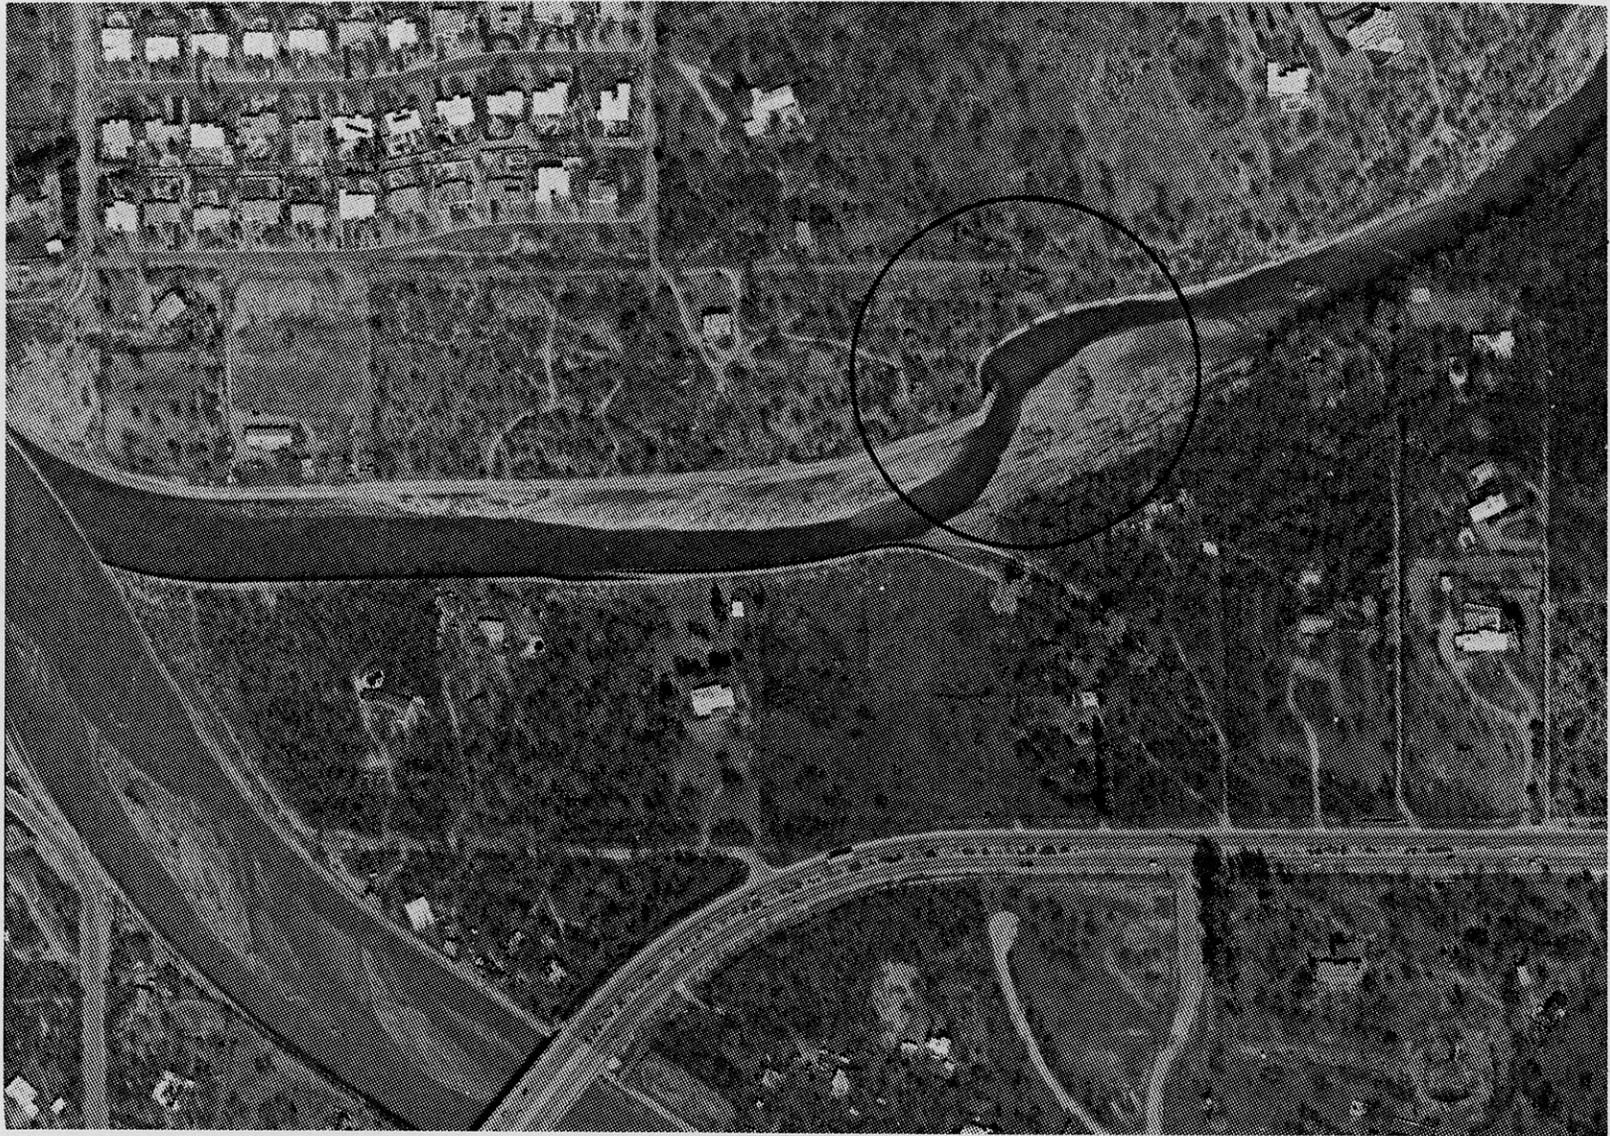
FIGURE 6.36

Upstream of the confluence at Tanque Verde Creek, Sabino Creek was flowing bankfull. Erosion behind the upstream key-in on the north bank soil-cement bank stabilization caused the bank stabilization to fail (Figures 6.35 and 6.36).

Sabino Creek at Webster Avenue
January 20, 1993

Soil-cement bank stabilization extends about 2000 feet upstream of the Tanque Verde Creek confluence, along both banks of Sabino Creek. Floodwaters flowed around the back side of the upstream key-in on the west side, and the uppermost 50-foot section of bank stabilization broke off and fell into the creek (Figure 6.35).

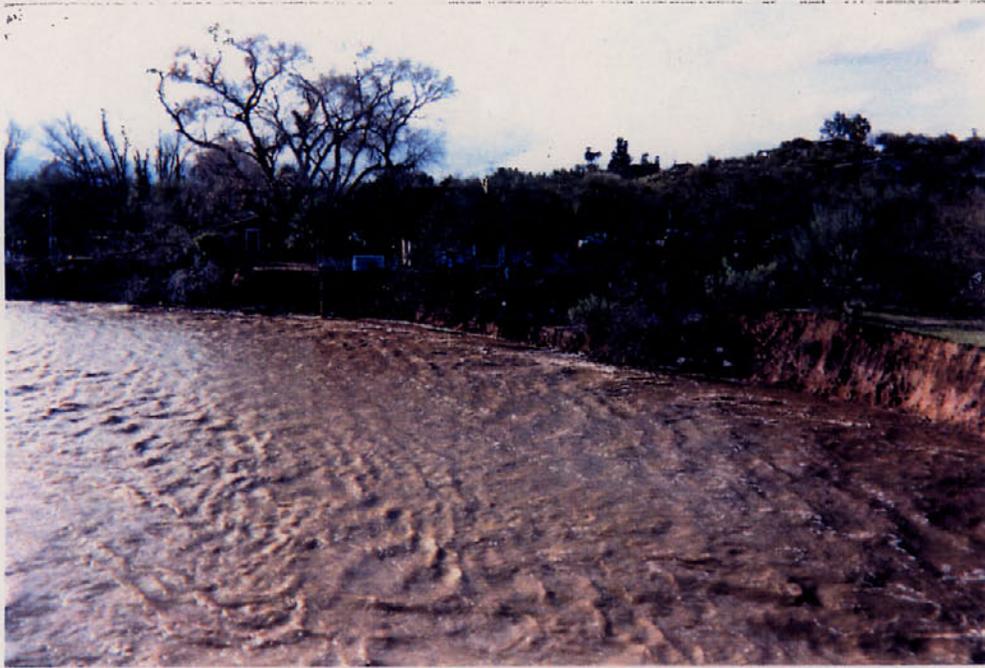
FIGURE 7.2a

7.2a) Bank erosion at the Luker residence, north bank of Rillito Creek downstream of Craycroft Road Bridge—looking northwest. January 11, 1993.

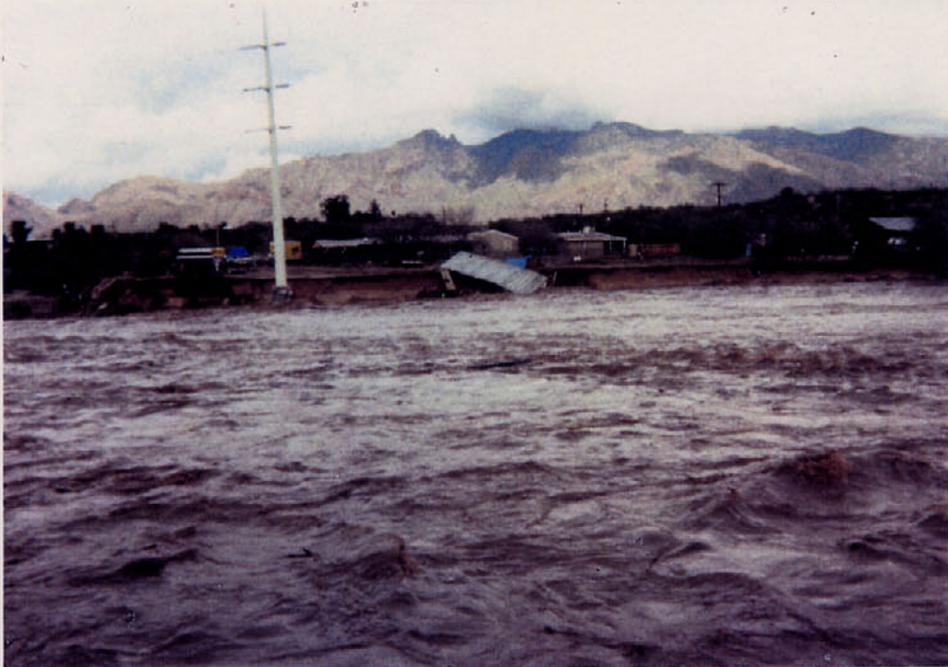
FIGURE 7.2b

7.2b) Rillito Creek at the Country Club Road "bend area"—looking to the northeast from the Tucson Racquet Club parking lot. January 15, 1993.

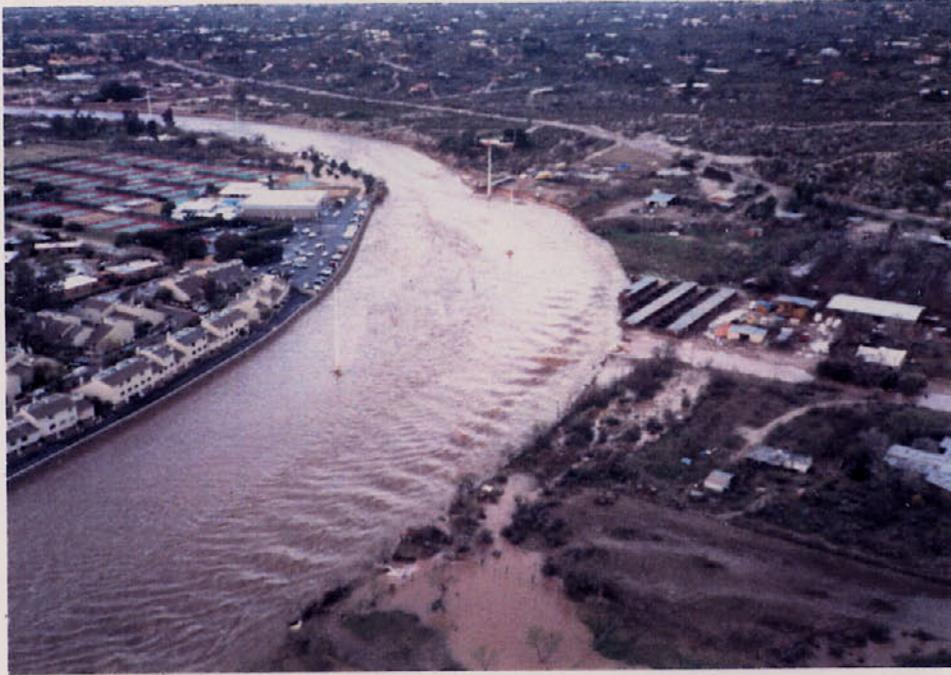
FIGURE 7.3a

7.3a) Rillito Creek at the Country Club Road "bend area"—looking downstream to the northwest. Note erosion at outside of bend. January 8, 1993.

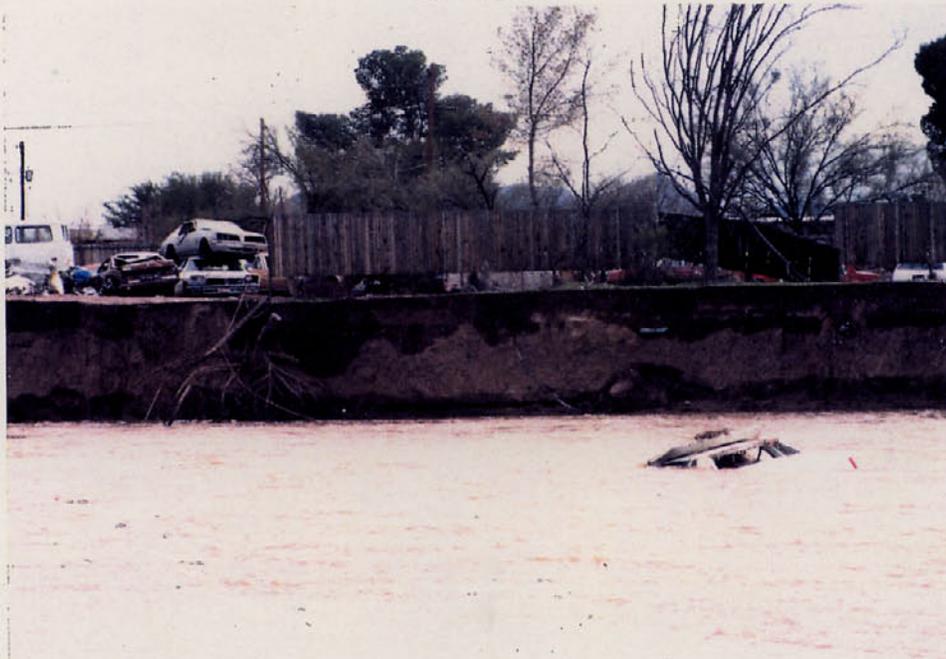
FIGURE 7.3b

7.3b) South bank of Rillito Creek upstream of Camino de la Tierra. January 15, 1993.

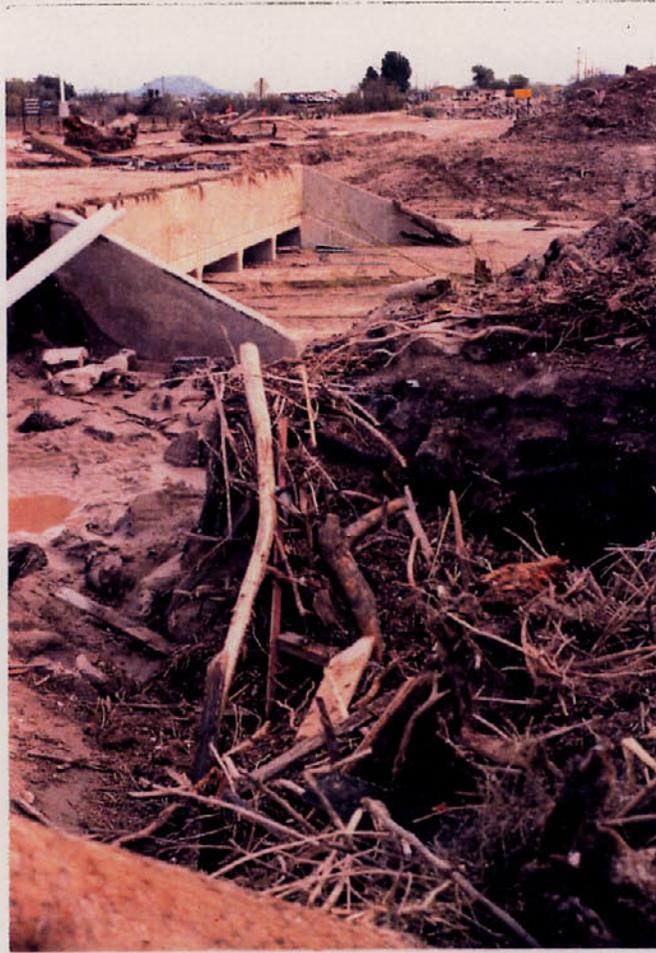
FIGURE 7.4a

7.4a) Pegler Wash box culvert at Camino de la Tierra—looking southeast across Camino de la Tierra. January 15, 1993. Direction of flow →

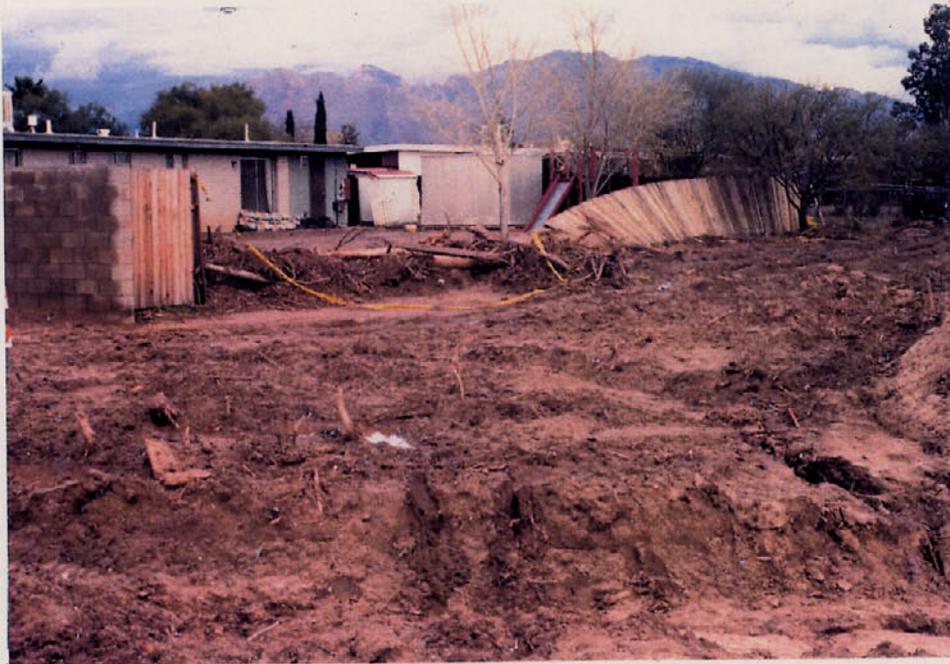
FIGURE 7.4b

7.4b) House located on north bank of Pegler Wash, east of Camino de la Tierra. Note sandbags under sliding door. January 15, 1993.

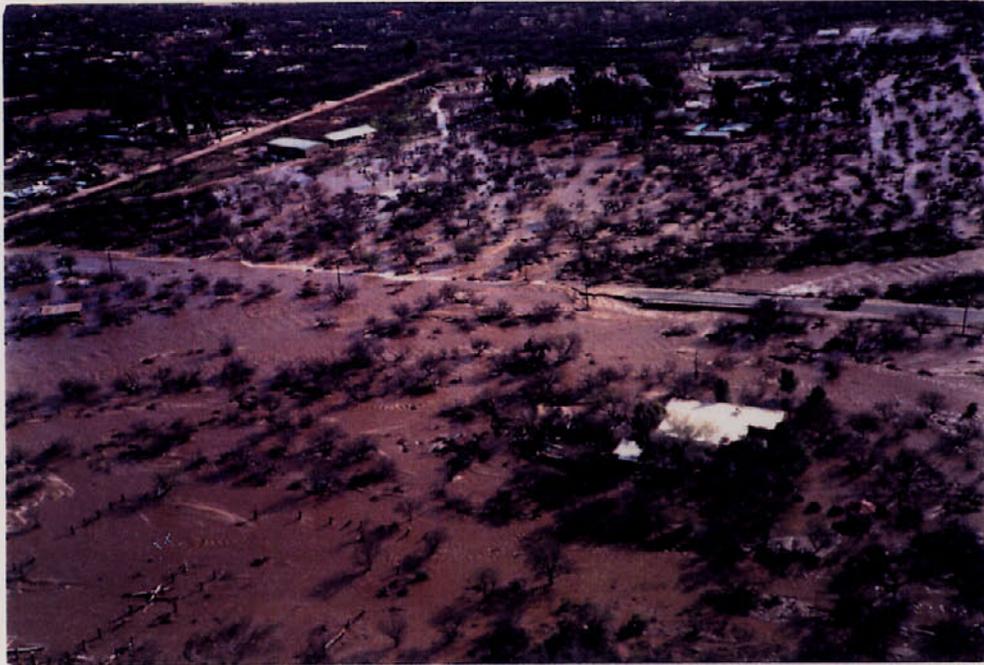
FIGURE 7.5a

7.5a) Agua Caliente Wash at Tanque Verde Road—looking to the southeast. Note flooding at residence on north side of Tanque Verde Road; also note flooding at Amity on south side of road, at top center of photograph. January 8, 1993.

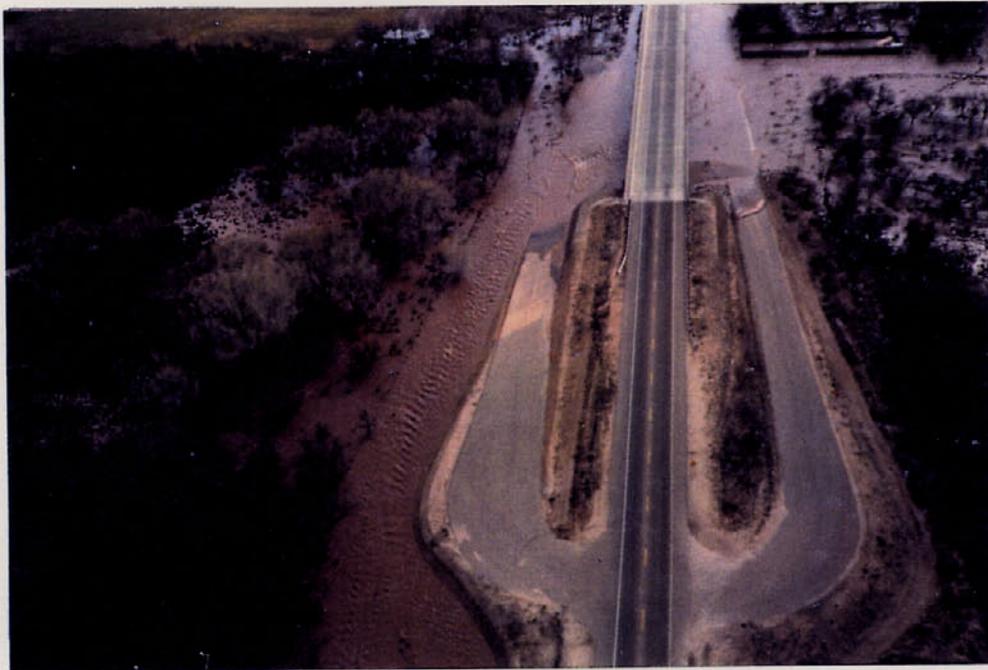
FIGURE 7.5b

7.5b) Looking south along Houghton Road bridge at Tanque Verde Creek crossing.

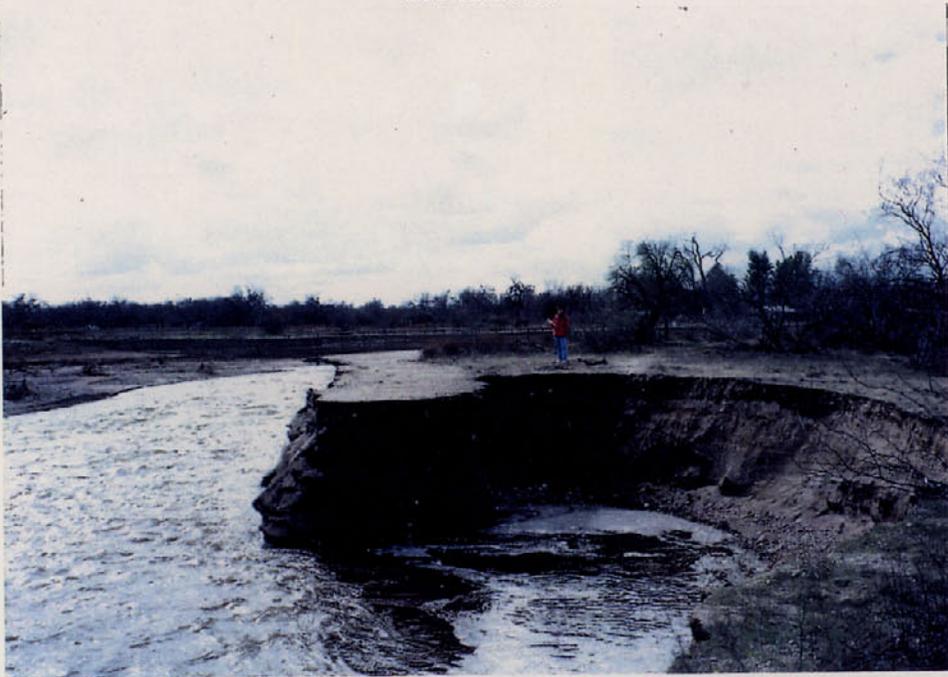
FIGURE 7.6a

7.6a) Erosion behind upstream key-in of bank stabilization along Sabino Creek, north west bank, near Webster Avenue—looking to the southwest. January 9, 1993.
