JANUARY 1993 FLOODS PIMA COUNTY, ARIZONA

Summary Report July 1993

Pima County Department of Transportation
and Flood Control District

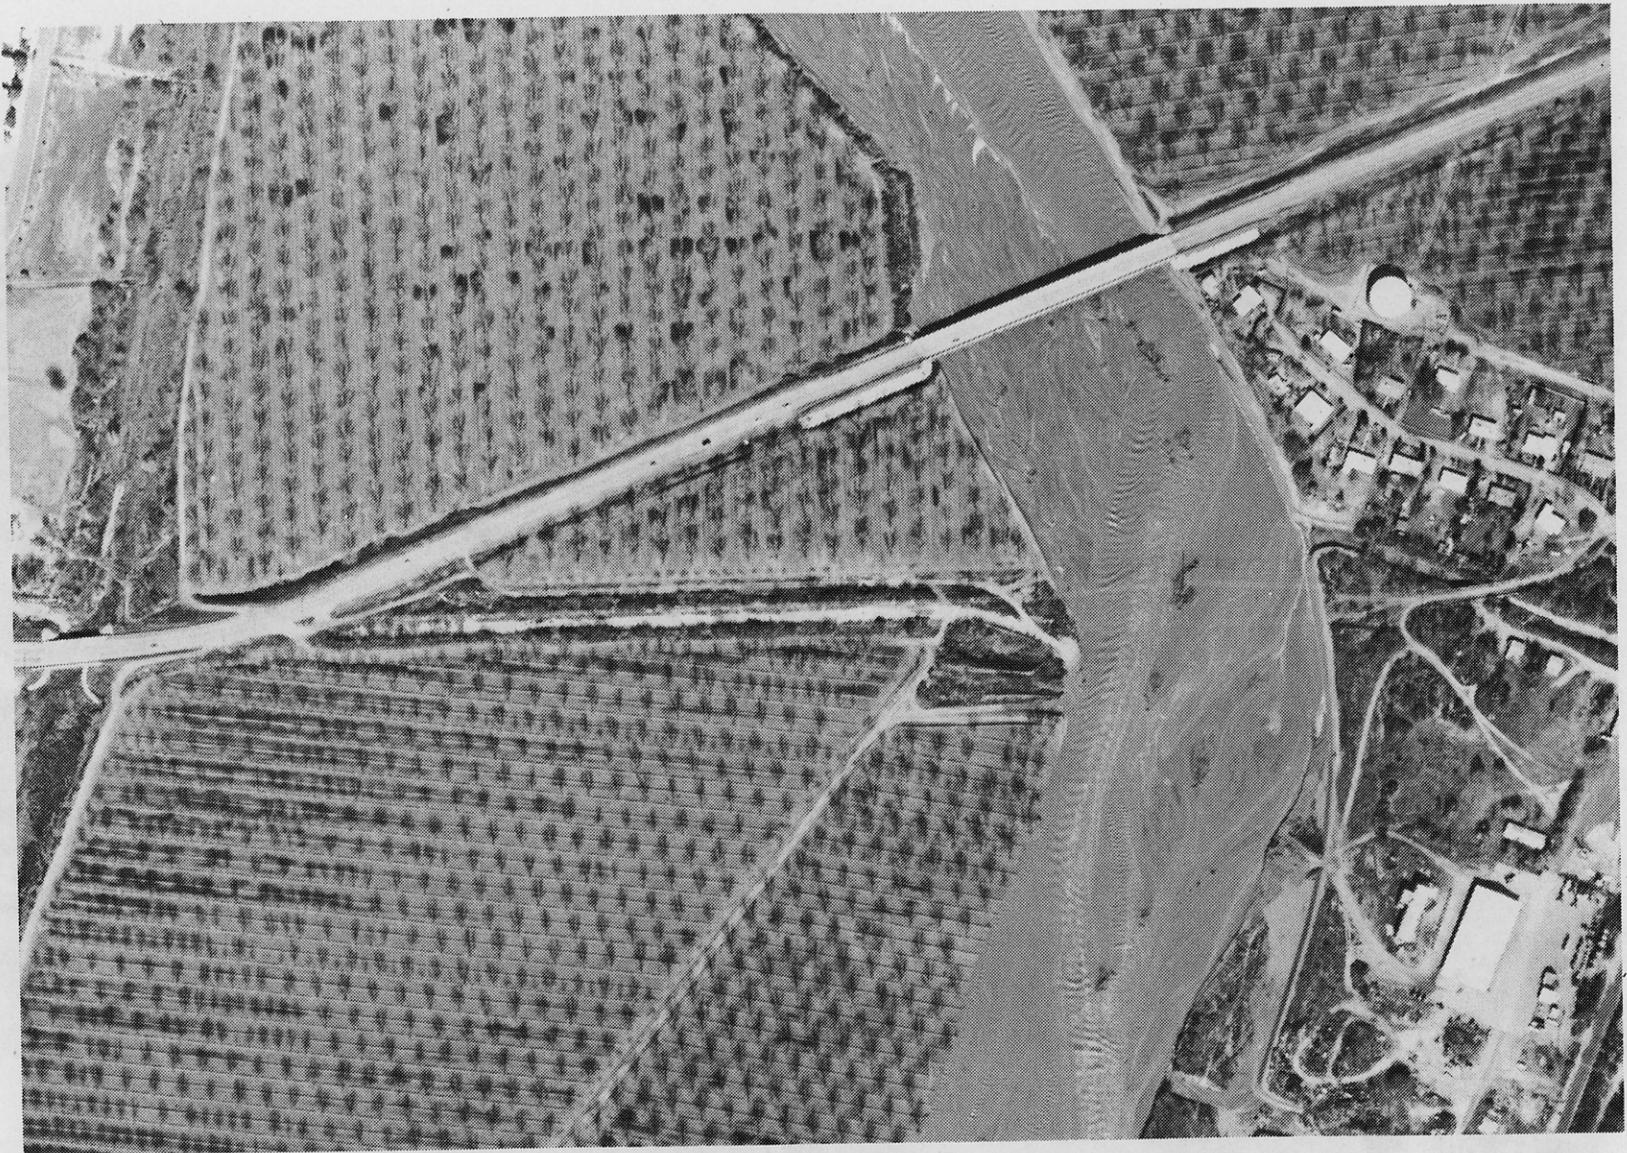
FIGURE 8.2

Santa Cruz River - Structural damage to bridges and roadways; and private property damage due to bank erosion, and overbank flooding and sediment deposition was much greater in the October 1983 Flood than in the January 1993 Floods. Soil-cement bank stabilization which has been constructed along several reaches of the Santa Cruz River through the urbanized area since the October 1983 Flood protected many areas from flood and erosion damage during the January 1993 Floods. October 1983 and January 1993 Flood photographs are shown for comparison purposes in Figures 8.1 - 8.13.

Santa Cruz River at Continental Road
January 20, 1993

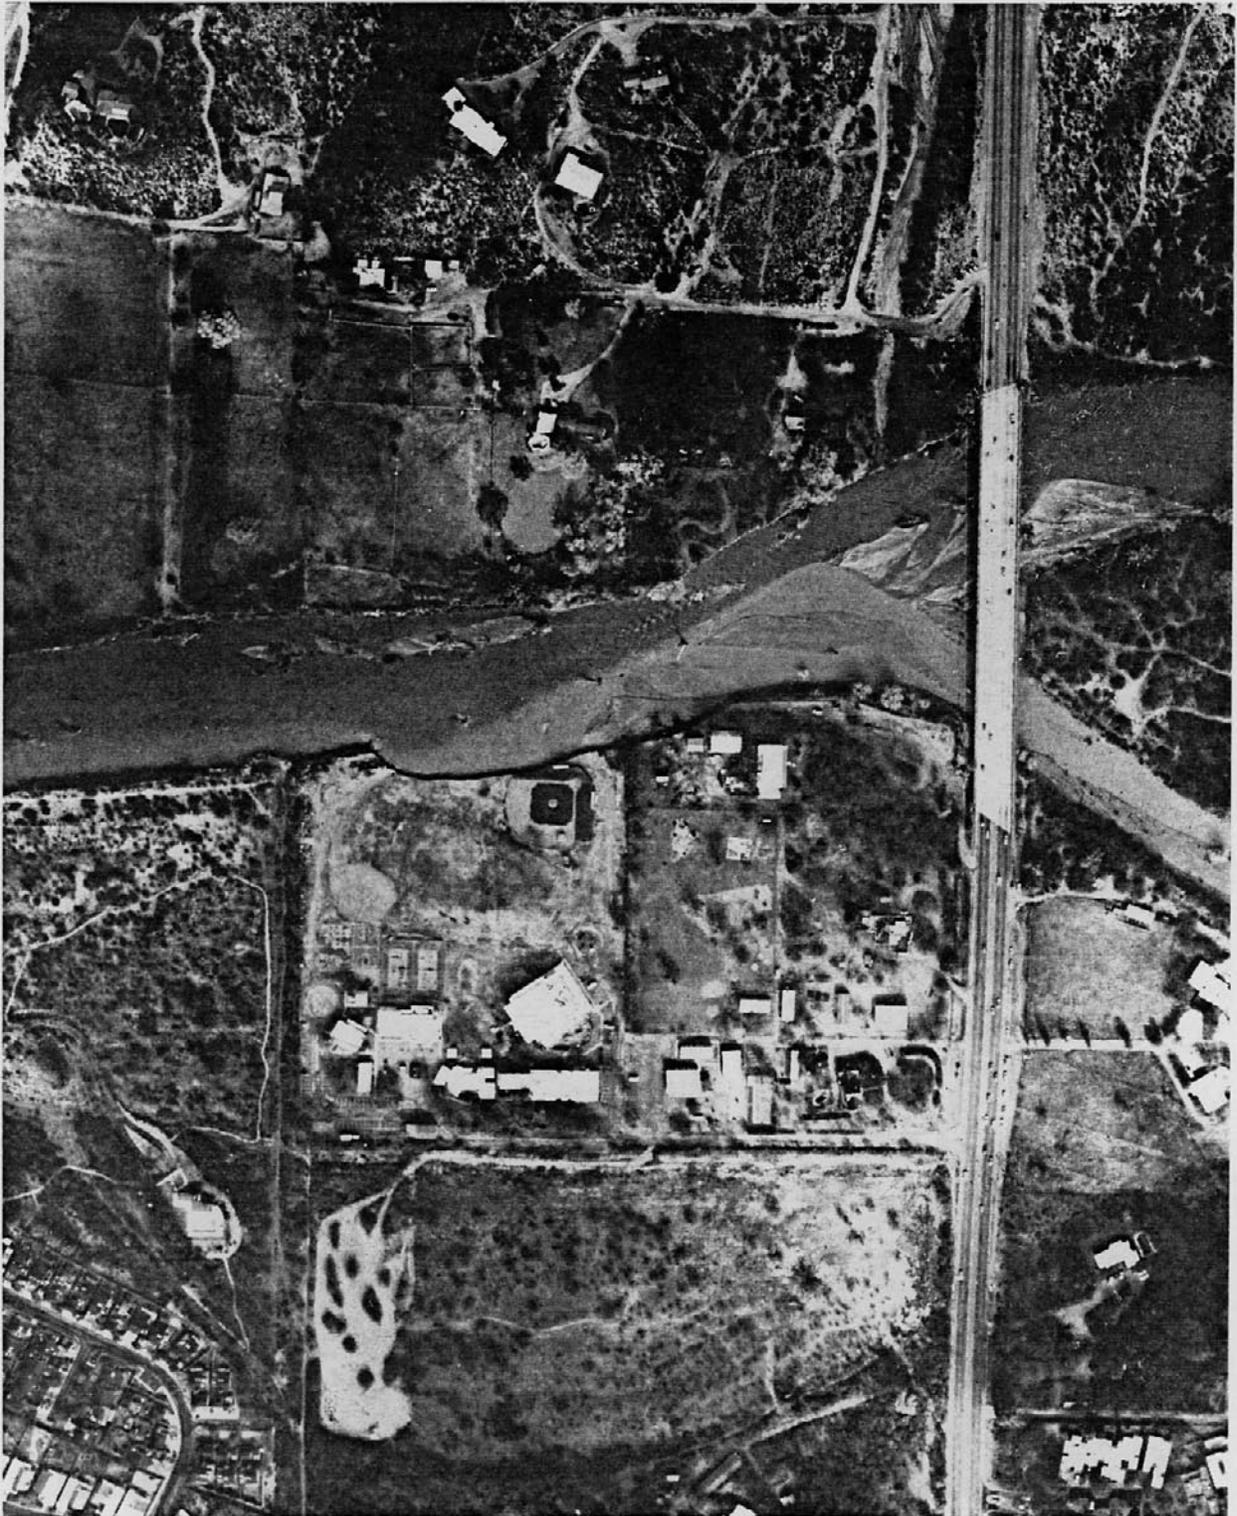
FIGURE 8.15

Rillito Creek - Although damage along the Rillito was extensive in January 1993, in some locations exceeding that which occurred in 1983, overall greater damage was incurred in October 1983, when residential and commercial building were lost at Country Club Road and First Avenue, respectively. Damage to infrastructure, including roads, bridges, and rip-rap bank stabilization was much greater in the October 1983 Flood, and acreage lost to erosion was also higher. See Figures 8.14 - 8.25 for October 1983 and January 1993 Flood photographs.

Rillito Creek at Craycroft Road
January 9, 1993

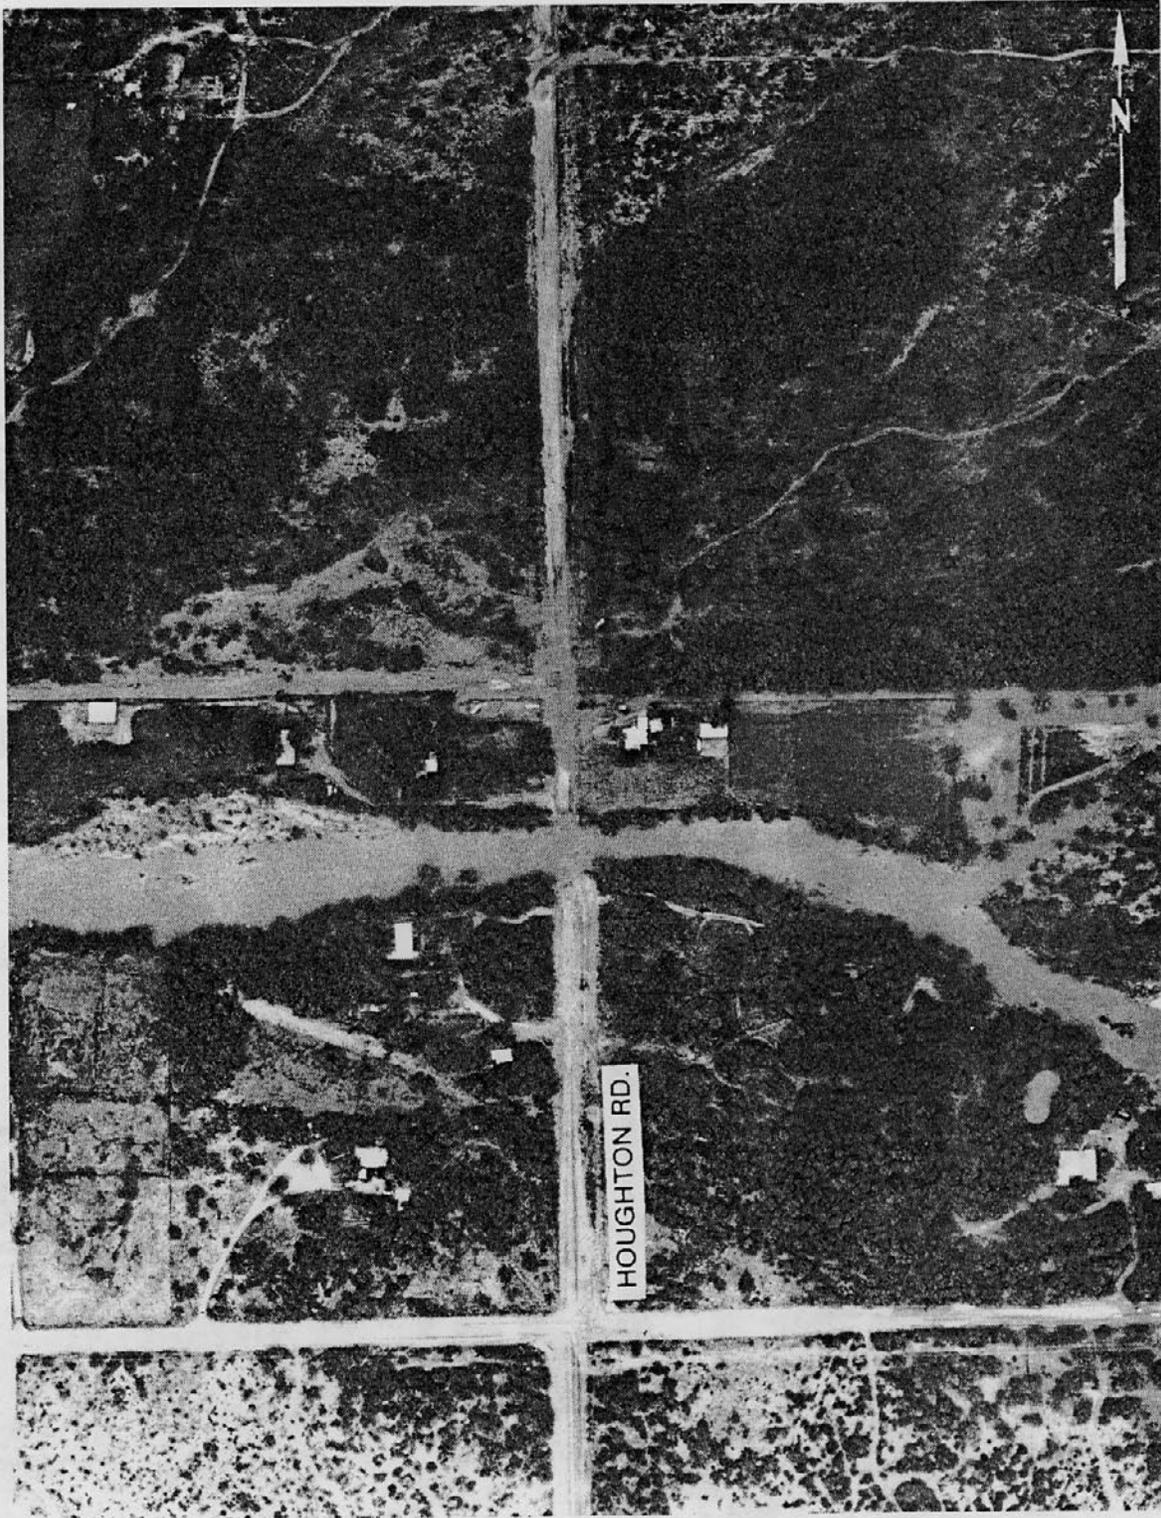
FIGURE 8.26

Tanque Verde Creek at Houghton Road
October 3, 1983

Tanque Verde Creek - Damage to public infrastructure and private property, including structures and eroded acreage, was much greater in 1983 due primarily to the higher peak discharges (Figures 8.26 and 8.27). Also, the reach between Tanque Verde Road and the Ventana Canyon Wash has since been protected by soil-cement bank stabilization.

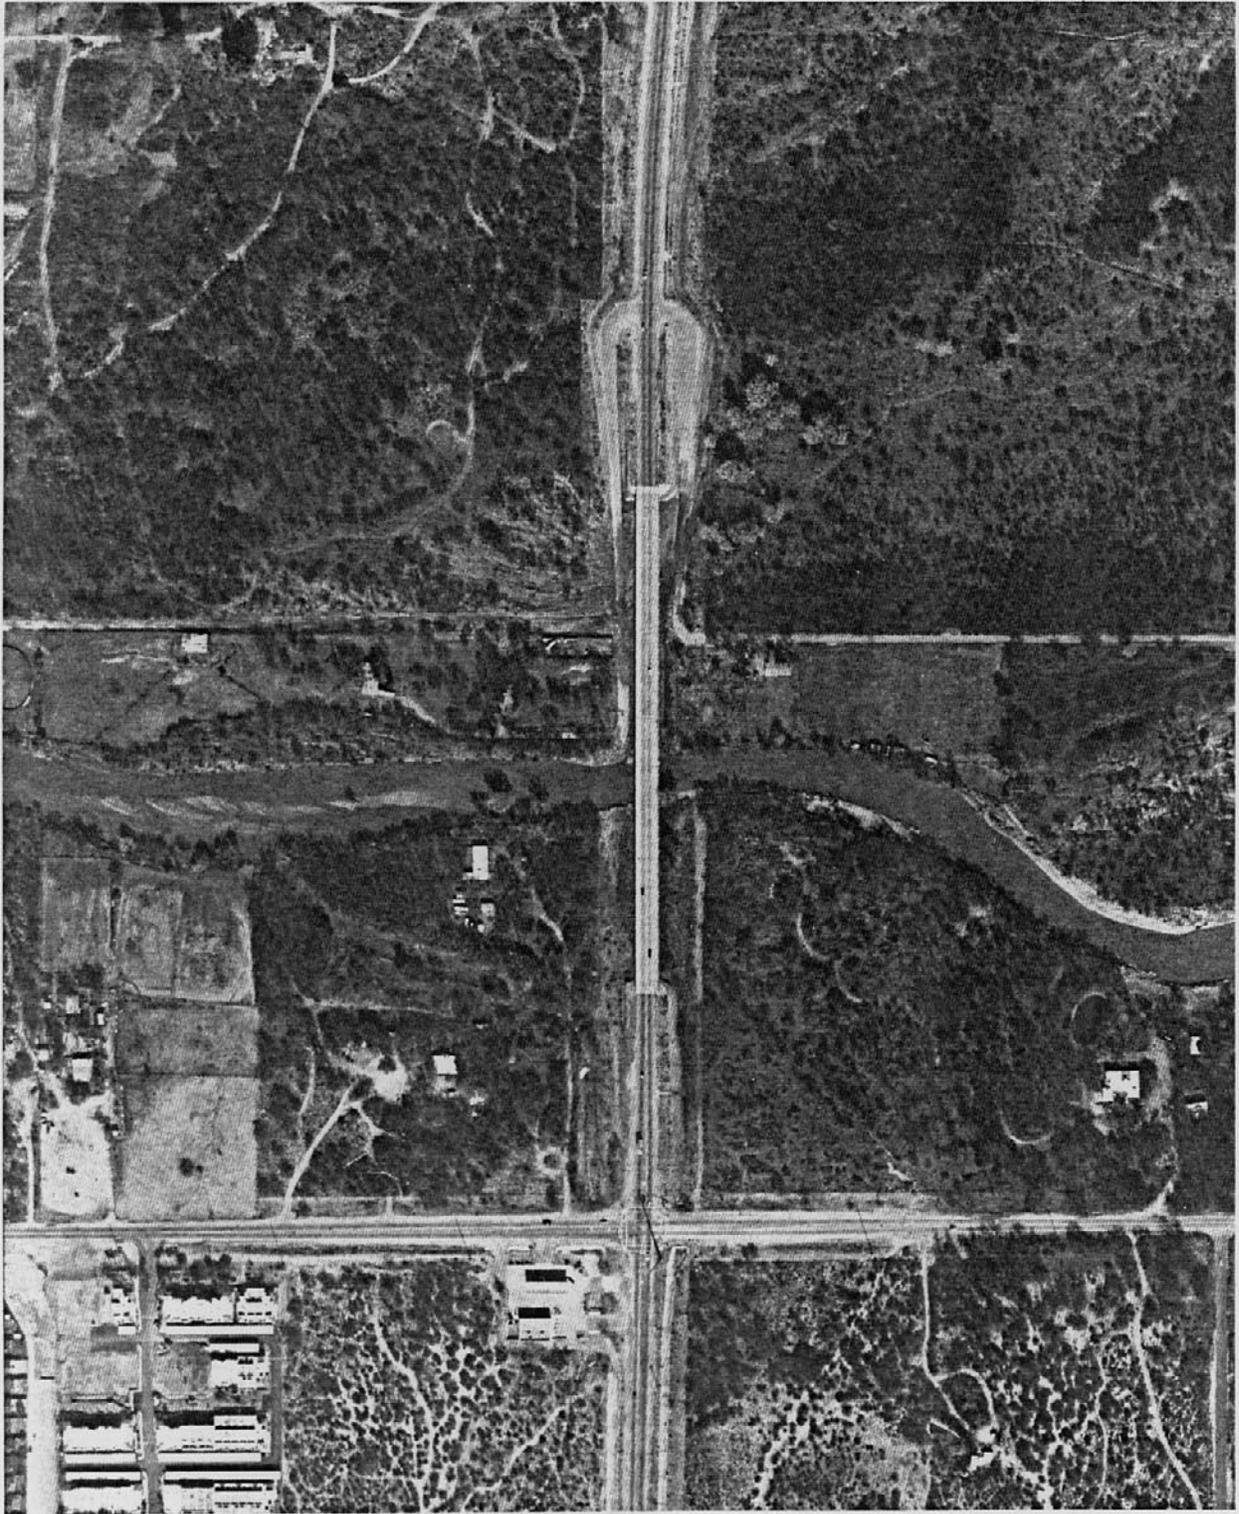
FIGURE 8.27

Tanque Verde Creek at Houghton Road
January 20, 1993

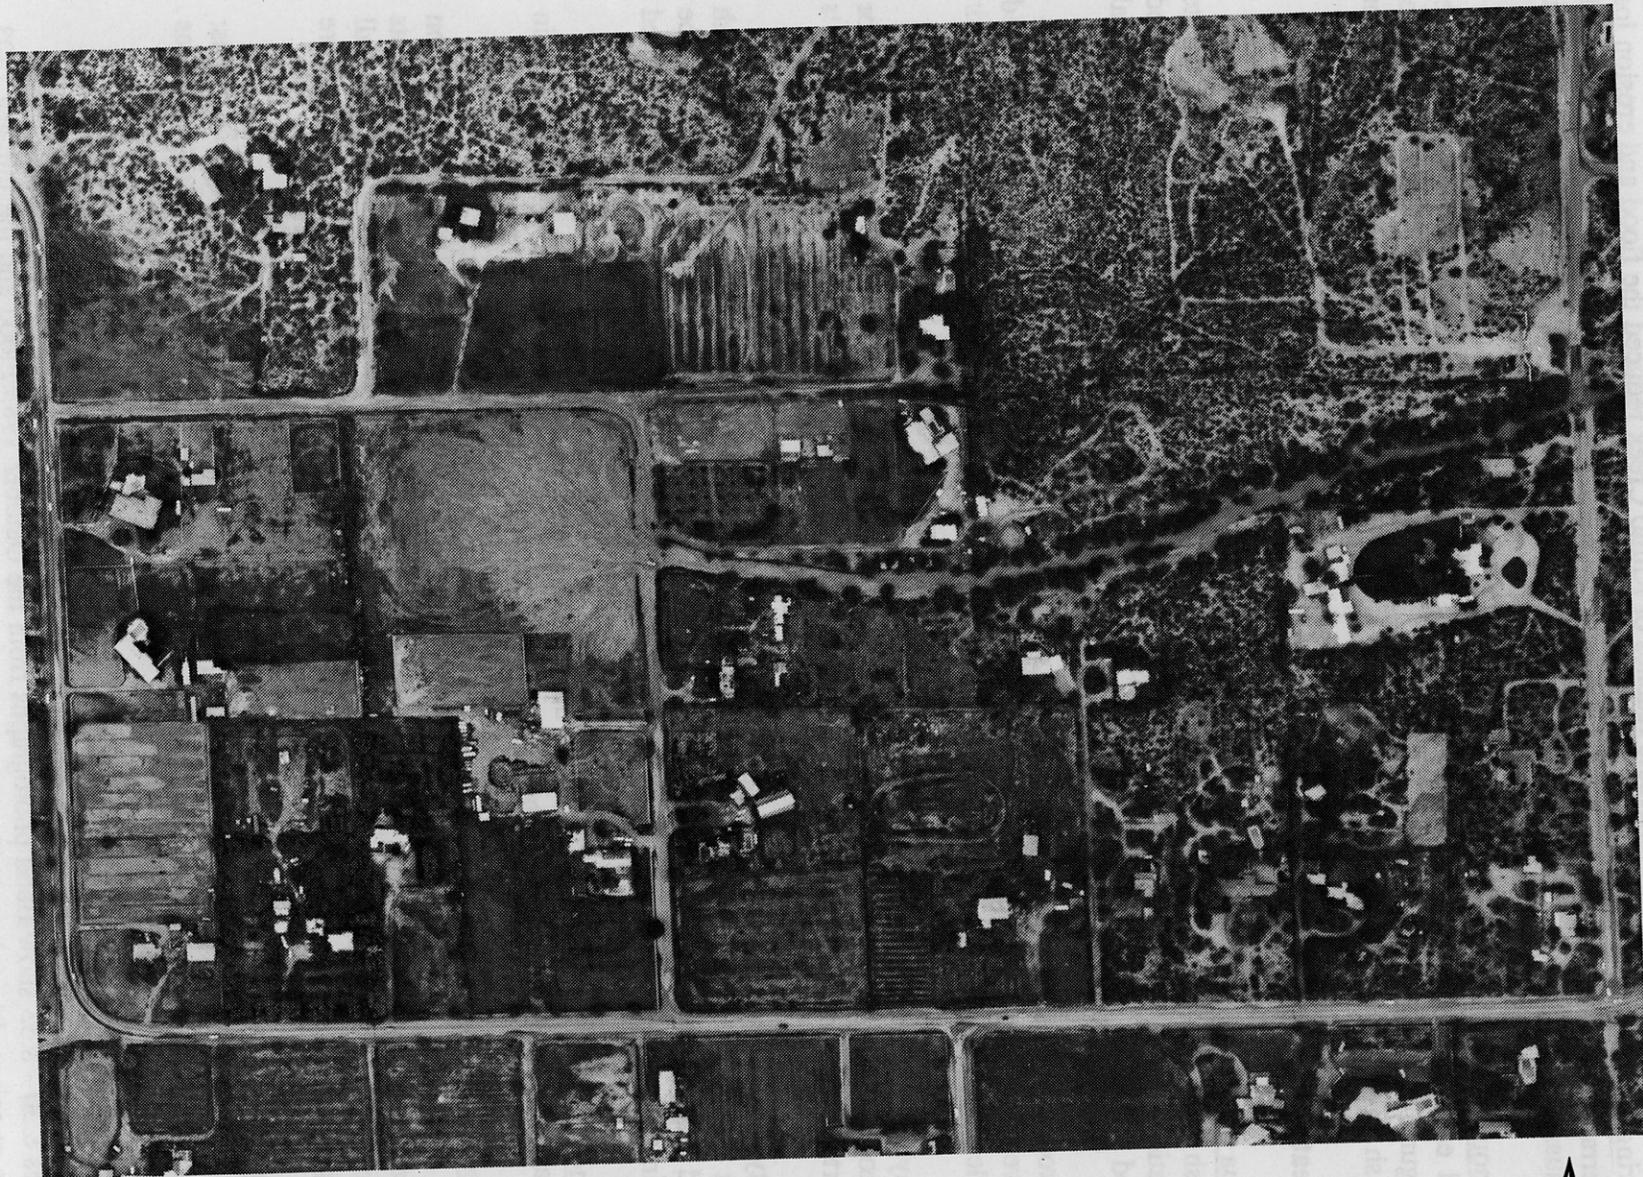
FIGURE 8.28

Finger Rock Wash - Flood and sediment damage to private property in the vicinity of Sutton Lane was much greater in the January 1993 Floods due to the higher discharges. Residents reported essentially no damage in the 1983 Flood (Figures 8.28 and 8.29). Additionally, ball playing fields at the Mehl-Foothills District Park, located near Pontatoc and River Roads, were damaged by erosion.

Finger Rock Wash at Sutton Lane
October 3, 1983

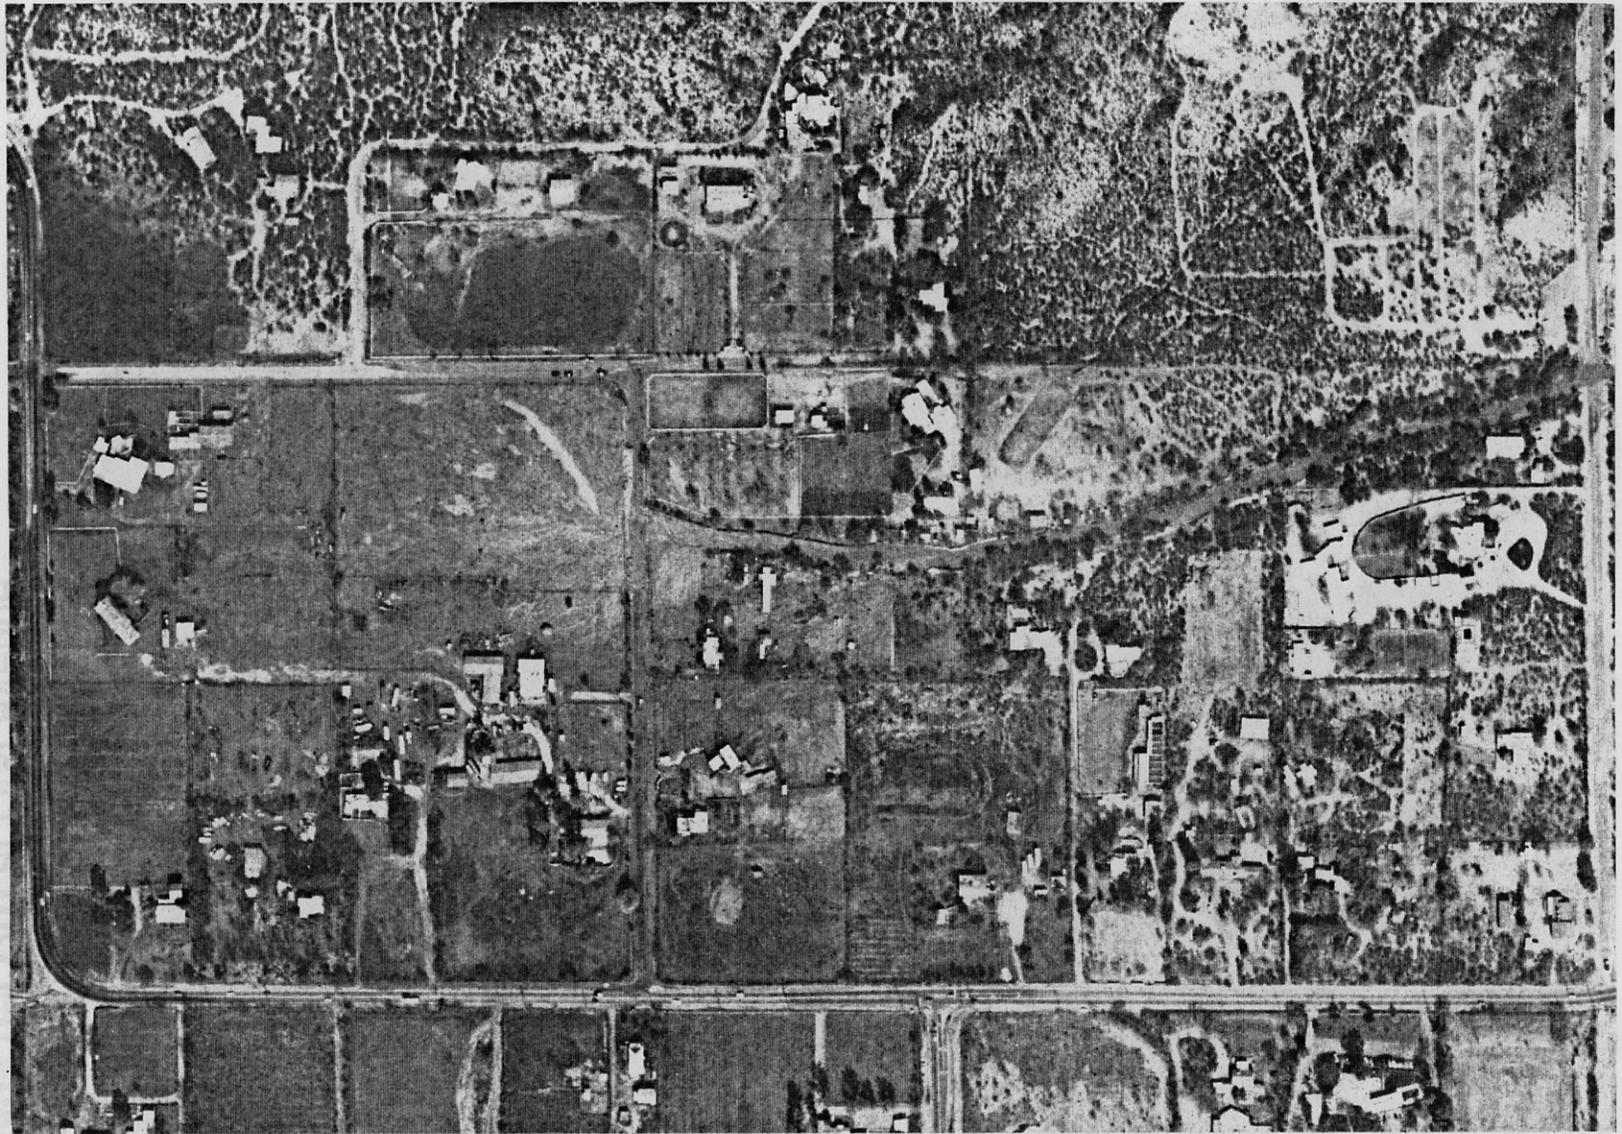
FIGURE 8.29

Finger Rock Wash at Sutton Lane
January 20, 1993

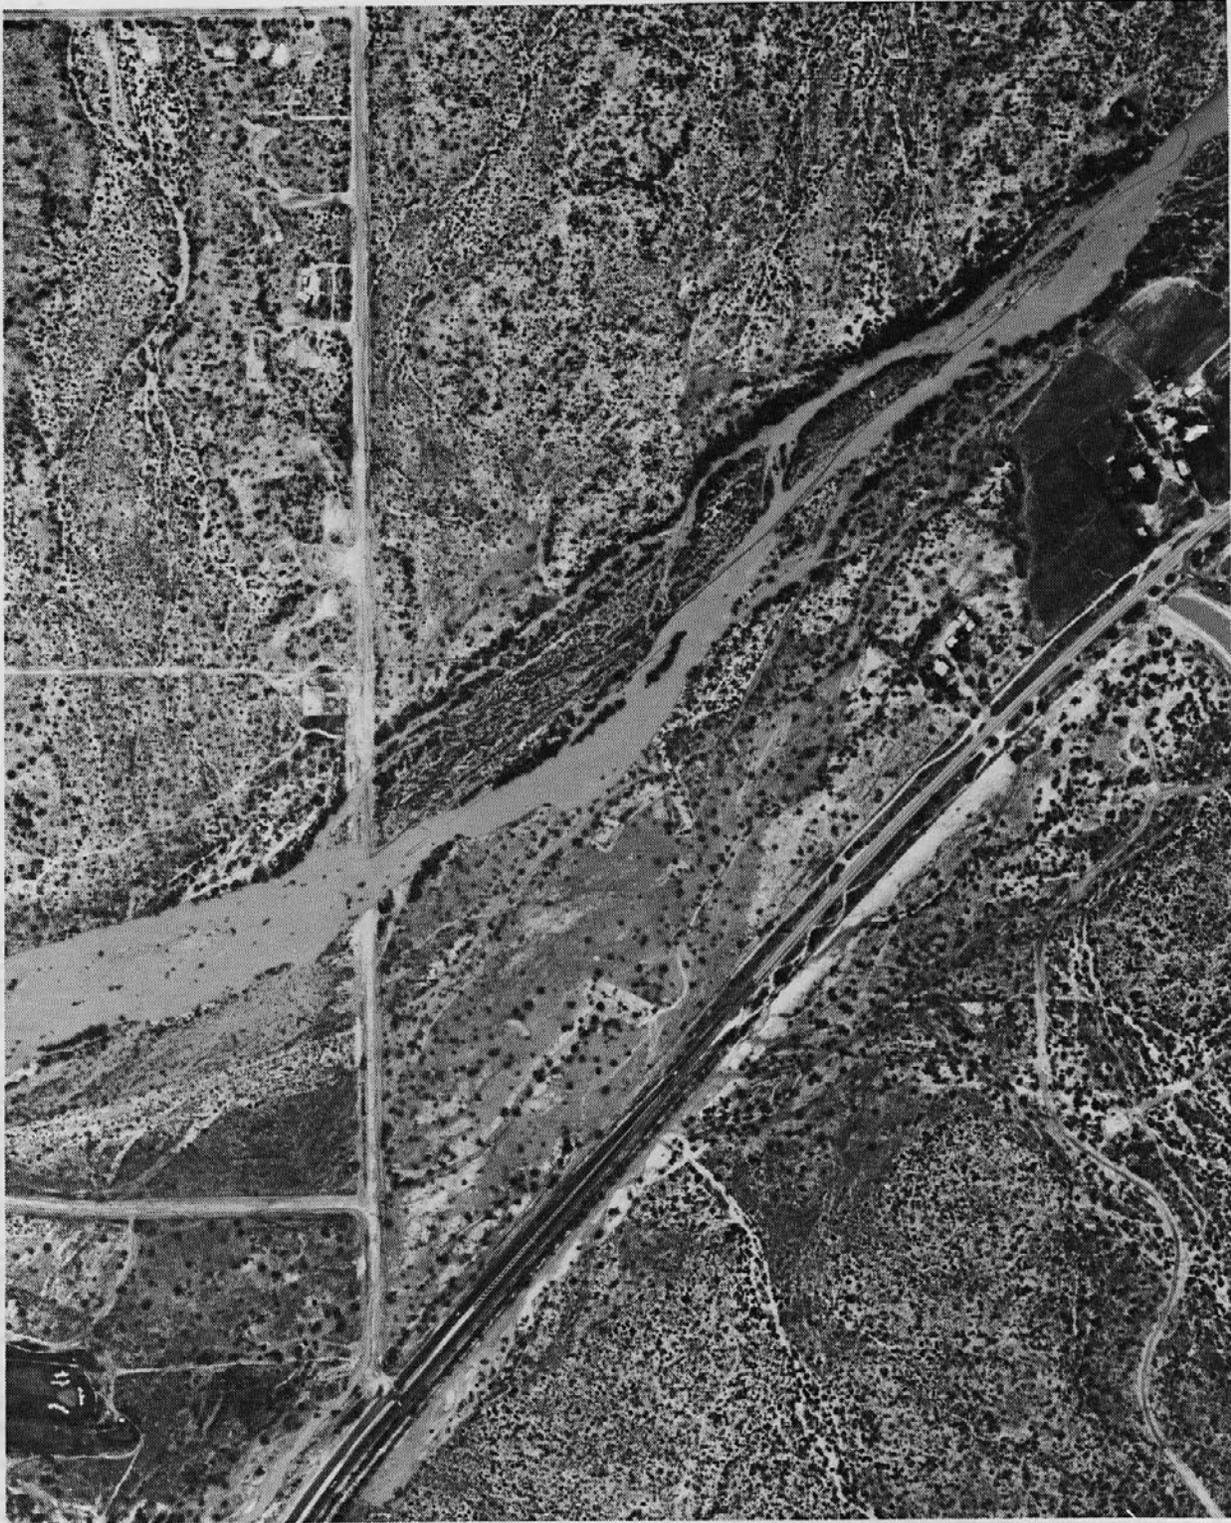
FIGURE 8.30

Figures 8.30 - 8.33 show flood photographs from the October 1983 Flood and the January 1993 Floods at selected locations, for comparison purposes.

Canada del Oro at First Avenue
October 3, 1983

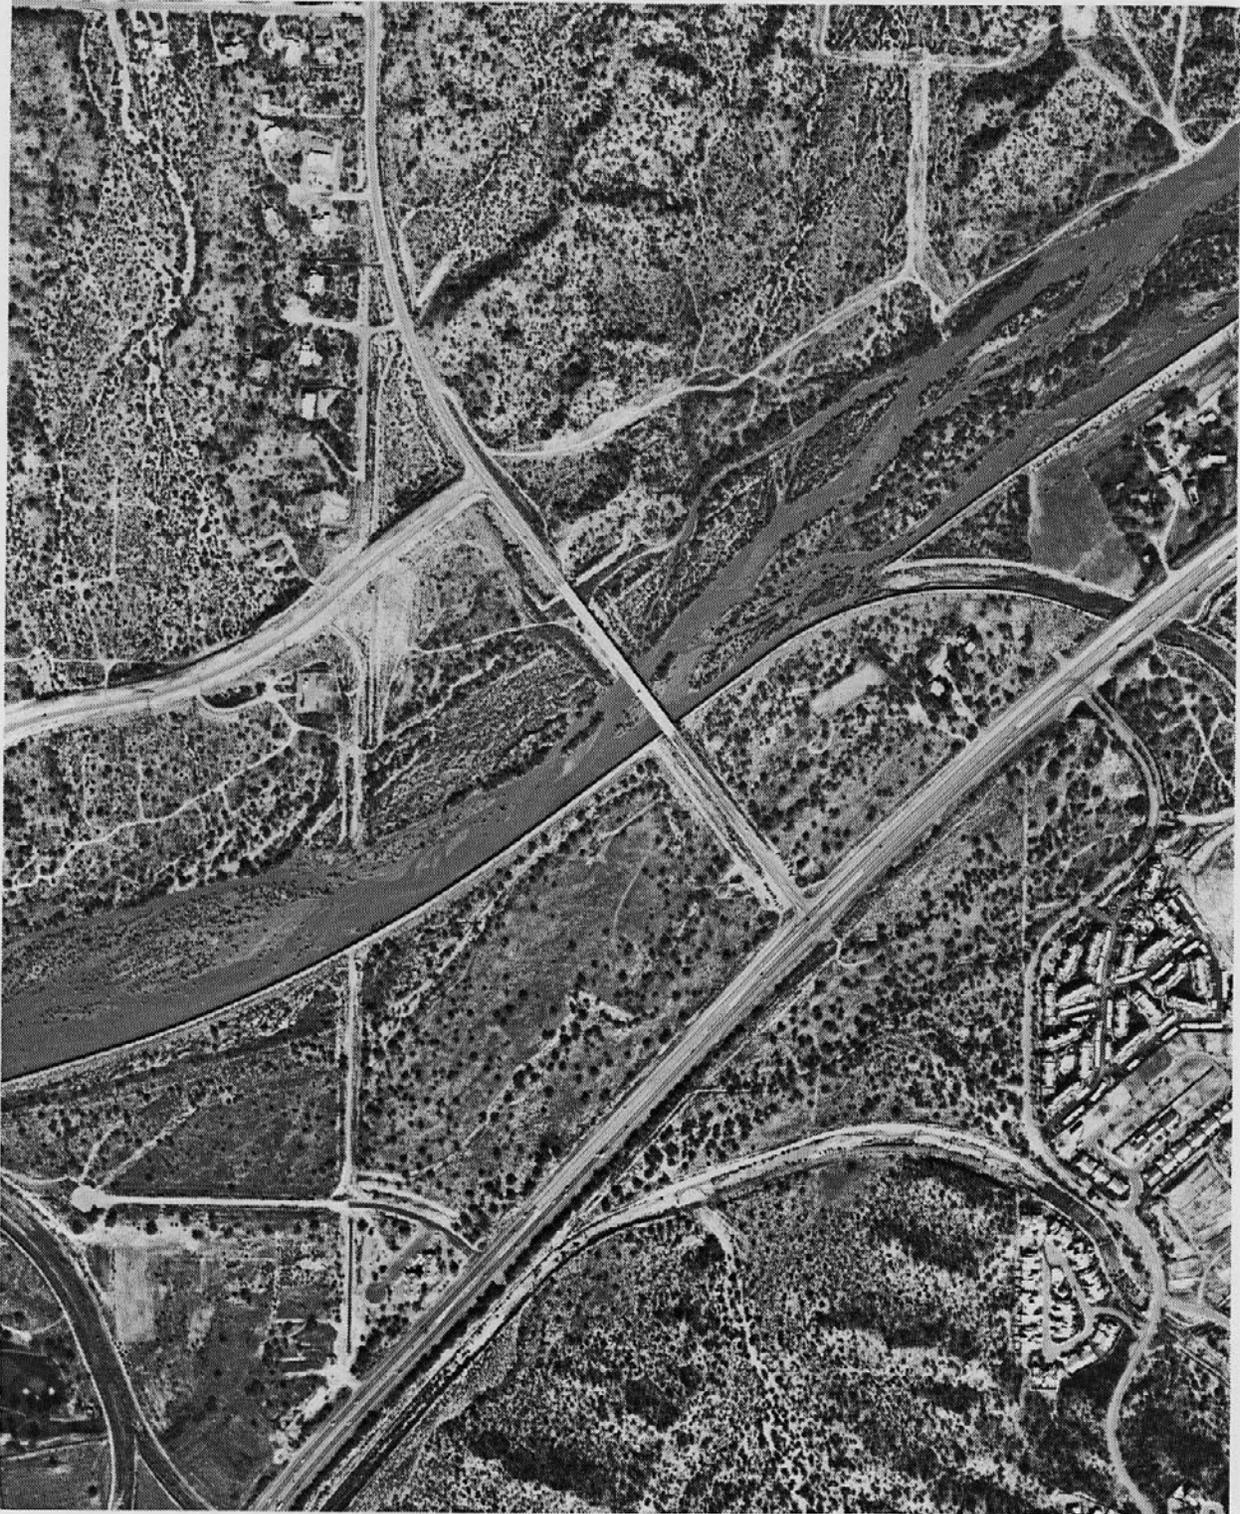
FIGURE 8.31

Canada del Oro at First Avenue
January 20, 1993

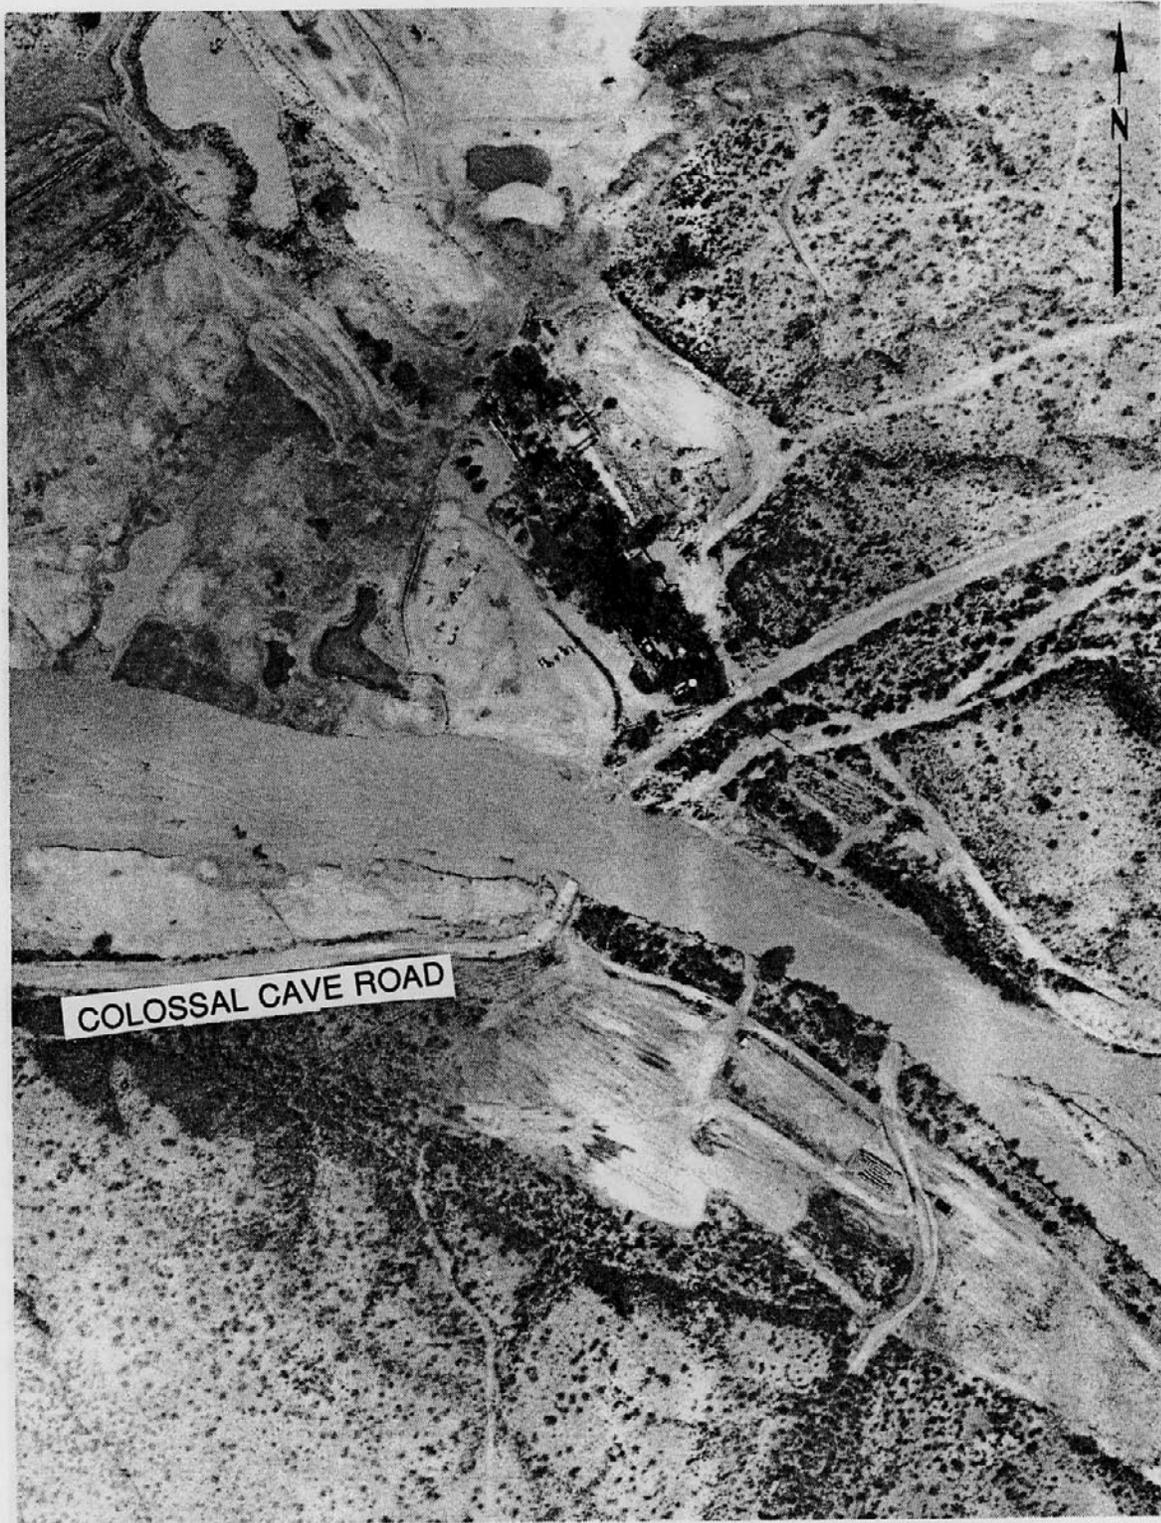
FIGURE 8.32

Pantano Wash at Colossal Cave Road
October 3, 1983

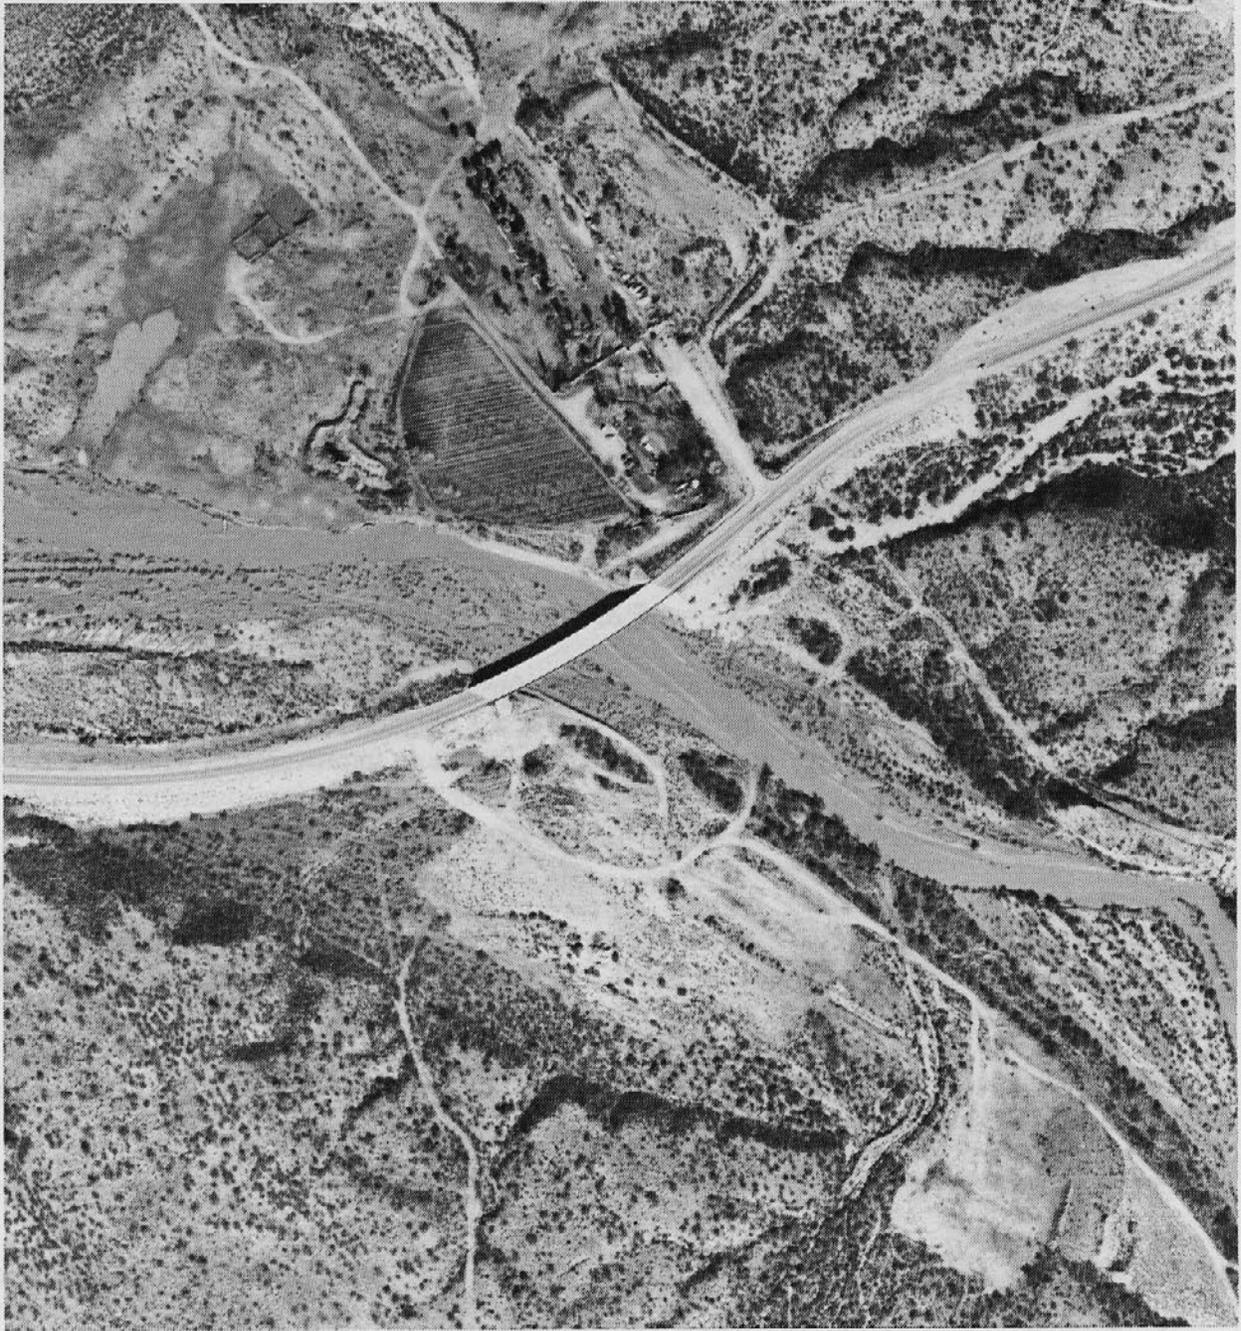
FIGURE 8.33

Pantano Wash at Colossal Cave Road
January 20, 1993
